Subject: Radio Software Version Y171 – Multiple Updates

This Service Bulletin replaces PIT5999, PIT6008, and PIT6032. Please discard all copies of PIT5999 and PIT6032 and PIT6008.

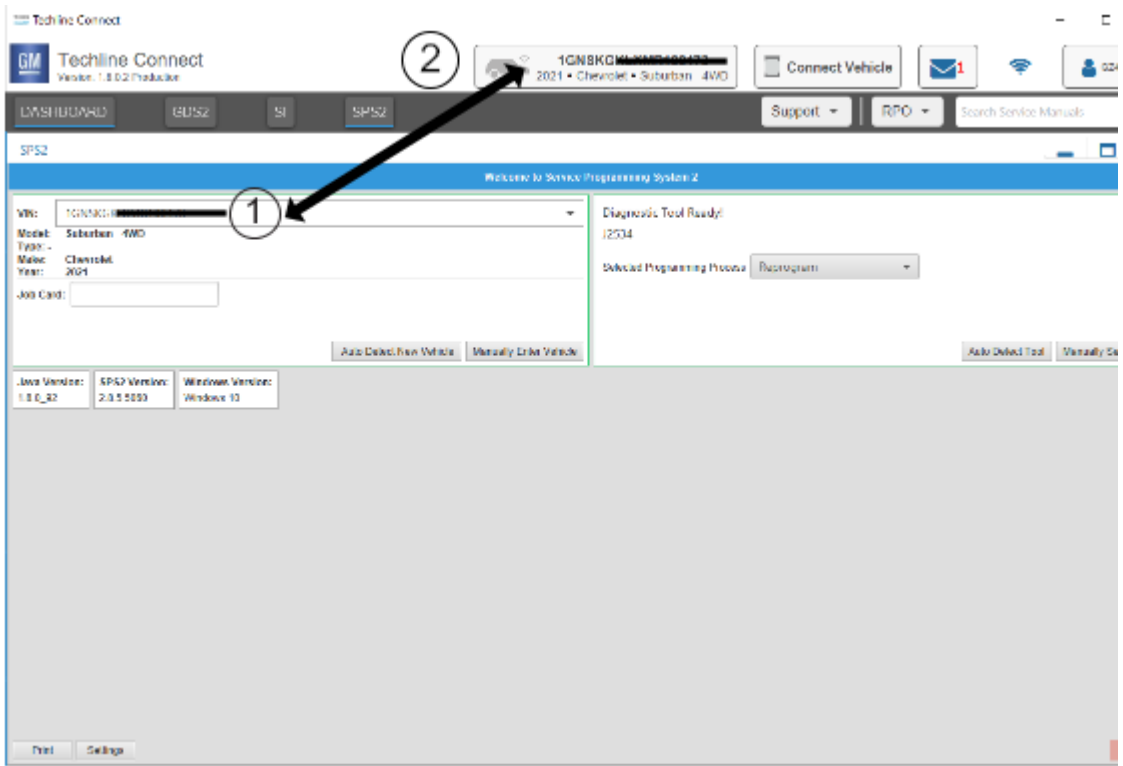
5743643

Caution: Be sure the VIN selected in the drop down menu (1) is the same as the vehicle connected (2) before beginning programming.

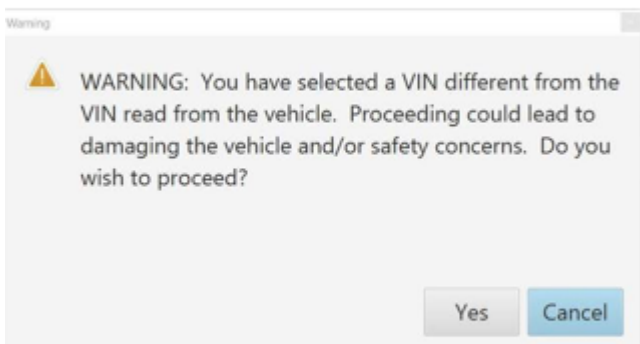
5877000

Important: If the vehicle VIN DOES NOT match, the message below will be shown

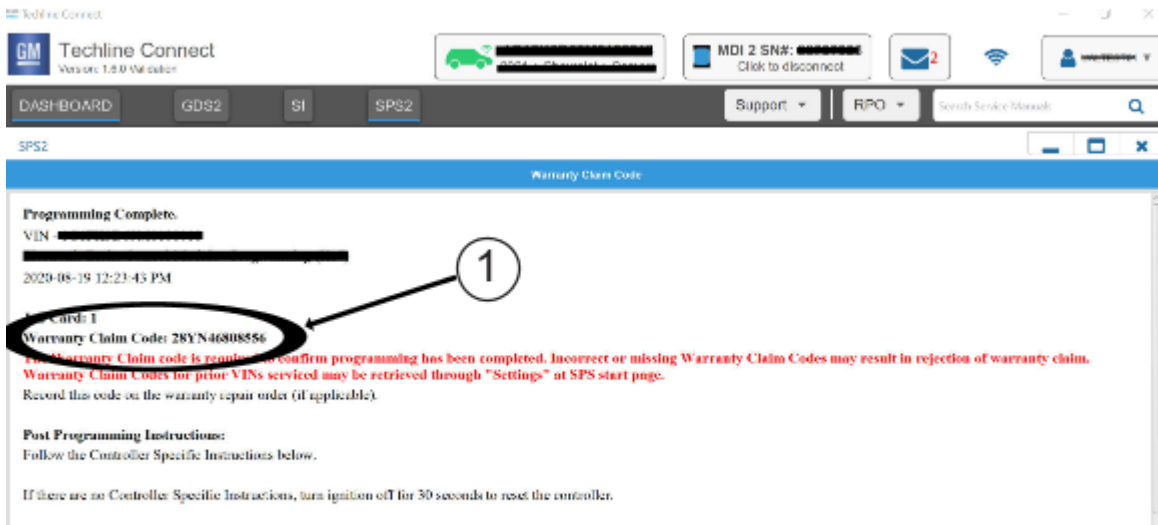
5644478

Important: To avoid warranty transaction rejections, you **MUST** record the warranty claim code provided on the Warranty Claim Code (WCC) screen shown above on the job card. Refer to callout 1 above for the location of the WCC on the screen.

- Record SPS Warranty Claim Code on job card for warranty transaction submission.

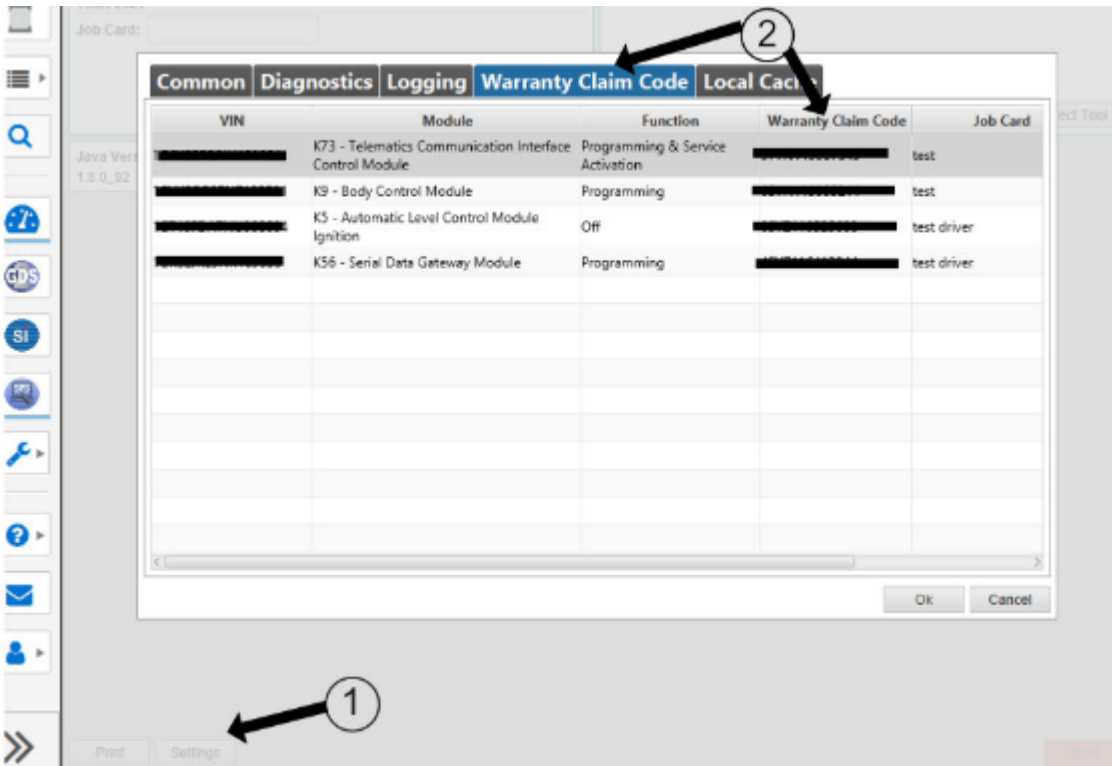
6125774

If the Warranty Claim Code was not recorded on the Job Card, the code can be retrieved in the SPS2 system as follows:

1. Open TLC on the computer used to program the vehicle.
2. Select and start SPS2.
3. Select Settings (1).
4. Select the Warranty Claim Code tab (2).
