# Service Bulletin

Bulletin No.: 21-NA-155

**Subject: Information on Check Trailer Wiring Message and/or Service Trailer Brake Displayed on Driver Information Center (DIC) - DTC C1114 Set**

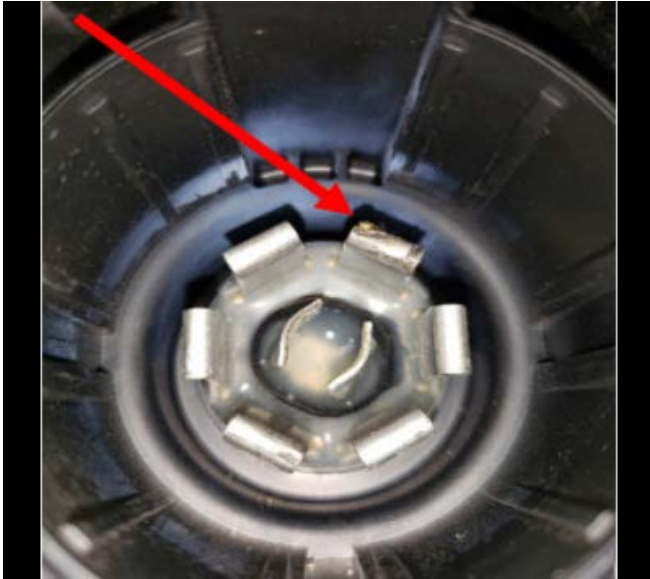
5867917

1. Short on trailer side damaged the terminal – Trailer side connector is loose/worn – **Non-Warranty Issue.**

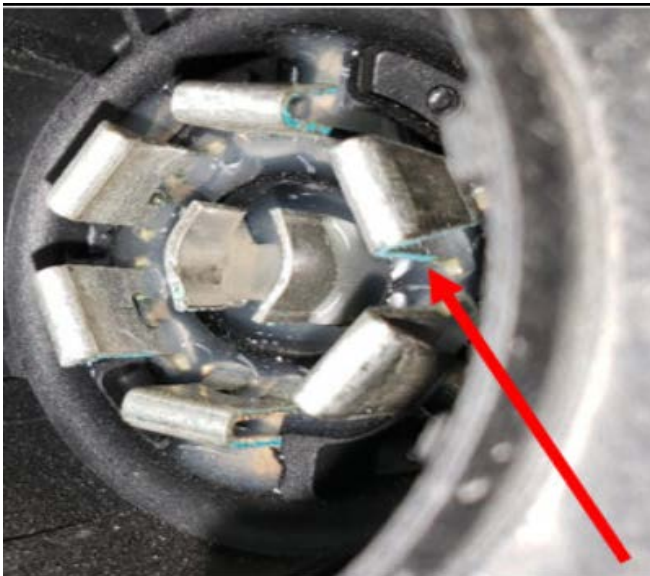
5867994

2. The blue/green is expected, and this small amount of corrosion does not impact function of connector – **Non-Warranty Issue.**

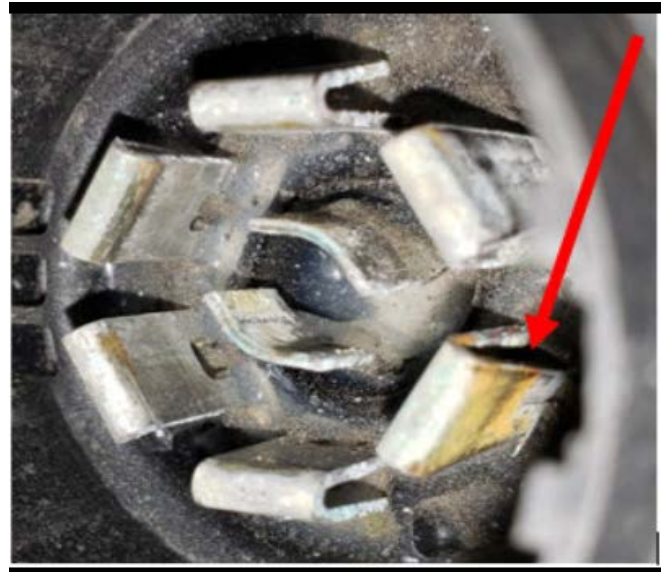
5867995

3. Trailer side connector is damaged/deformed causing removal of protective plating. This is the result of the trailer side connector is moving or bouncing when connected (excessively worn connector) – **Non-Warranty Issue.**

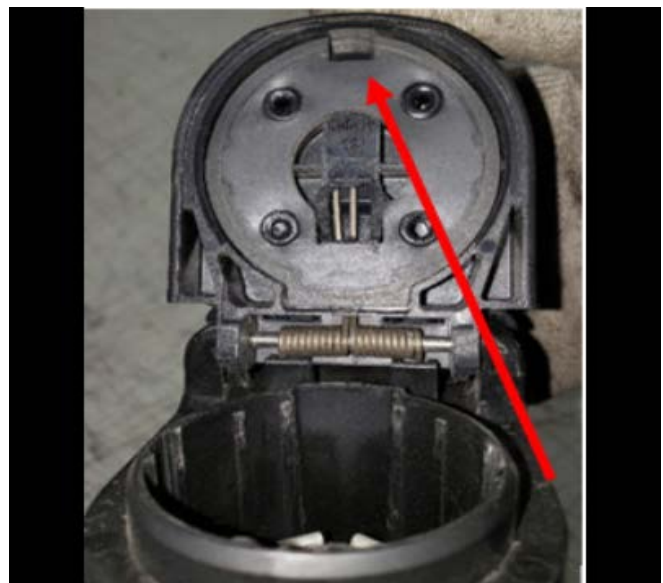
5867997

4. Trailer side harness retention tab has been broken off cover which is the result of customer pulling away from trailer without releasing the trailer harness – **Non-Warranty Issue.**

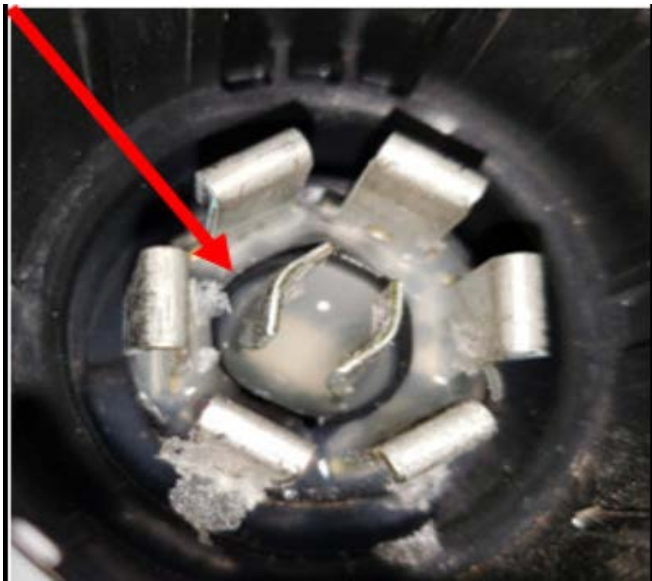
5867998

1. Sealant from part on terminals, would cause intermittent connection issues connecting to trailer – **Subject to terms of warranty.**

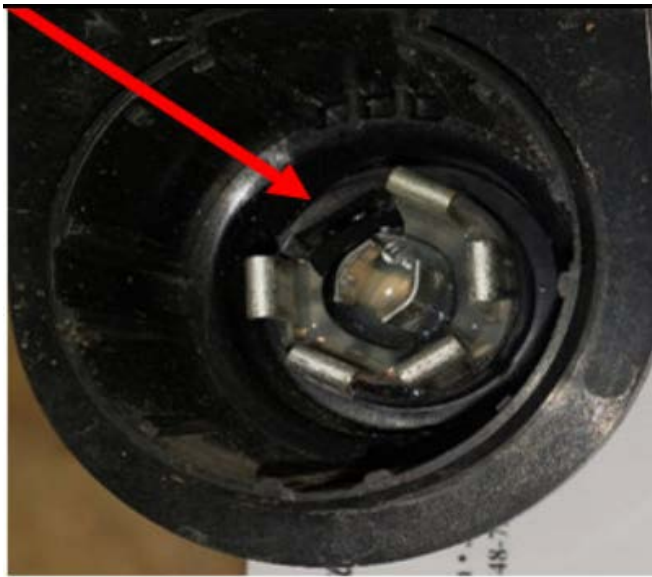
5868000

2. Terminal is pushed out – **Subject to terms of warranty.**
