Service Bulletin

Bulletin No.: 22-NA-186

Date: January, 2024

Subject: IPC Displays Service Camera System Message or Various IPC Drive Modes Cannot Be Selected and/or DTC U0155 Set

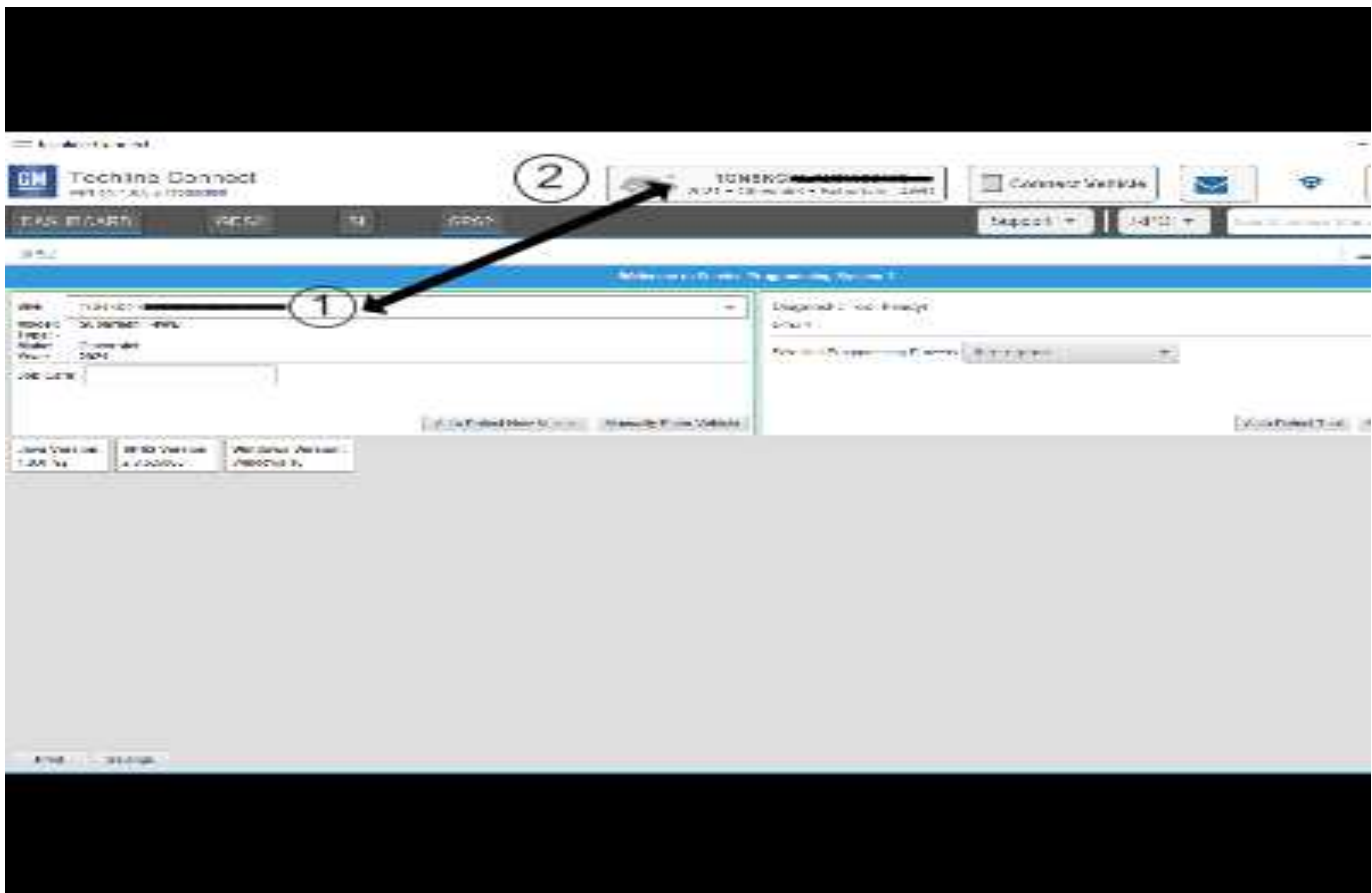
Caution: Be sure the VIN selected in the drop down menu (1) is the same as the vehicle connected (2) before beginning programming.
