**Diagnostic Sheet**

# Difficulty opening doors

DATE: DECEMBER 8 2023

**CASE 1: (Page 1) Levante (M161)** from MY21 onwards equipped with "Soft Door Close" (Opt. 228+)

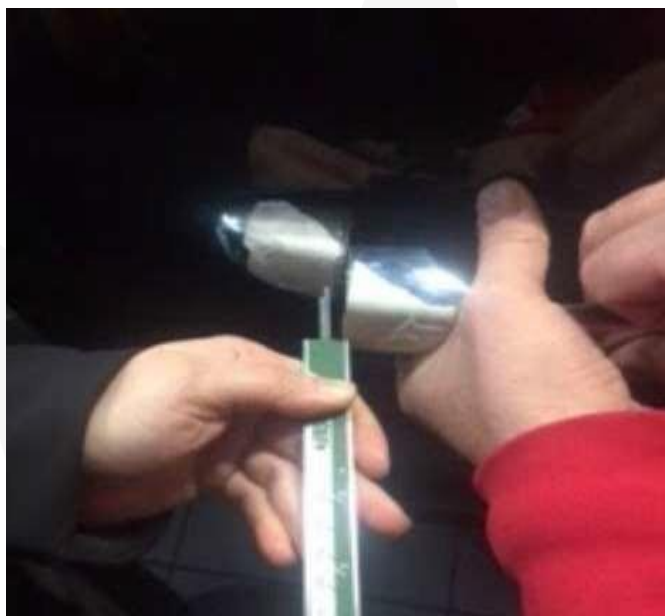
- Slowly pull the handle until the door, if possible, is unlocked;
- Measure the stroke with a caliper, as shown in the following image;

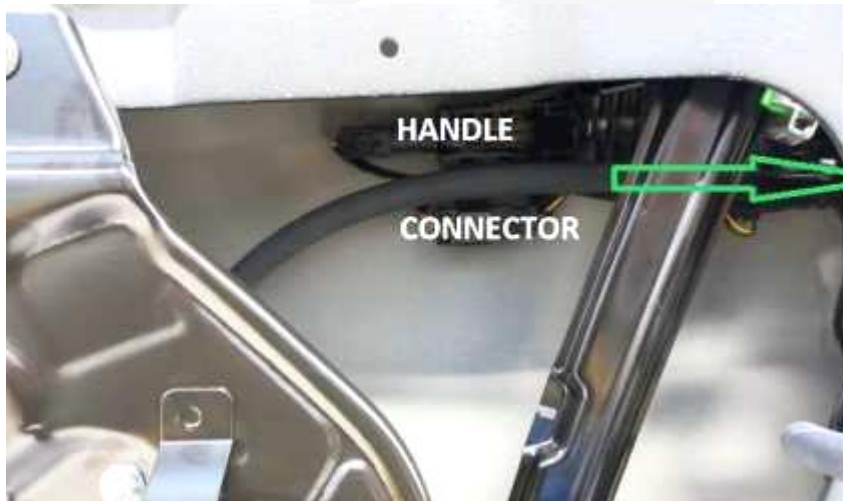
Picture 0

In this case the Door Lock Bowden Cable has the correct layout between the connector and the handle.

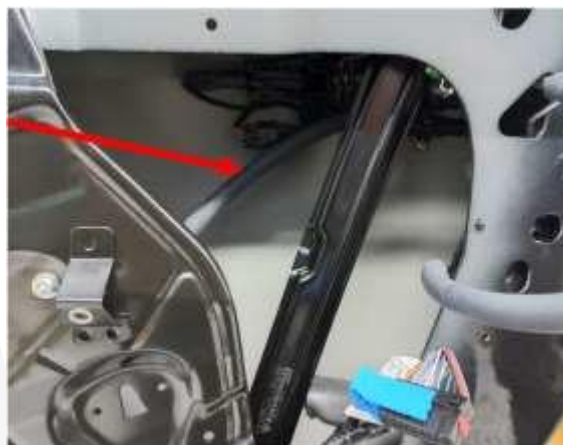
In this case, as shown in **Picture 1**, the Door Lock Bowden Cable is “**too low**” if compared to the position of the connector and the handle. This wrong positioning could take to a difficult or not possible door opening from the outside, by increasing the Door Handle stroke. See below “**HOW TO FIX**” to reposition the Bowden cable and solve the Customer Concern.

In order to reposition the Door Lock Bowden Cable in Picture 1 and 2, you'll have to pull and let it to slide through the **white clamp** into the **Picture 3** until the Bowden cable reaches its correct position (as per **Picture 0**).

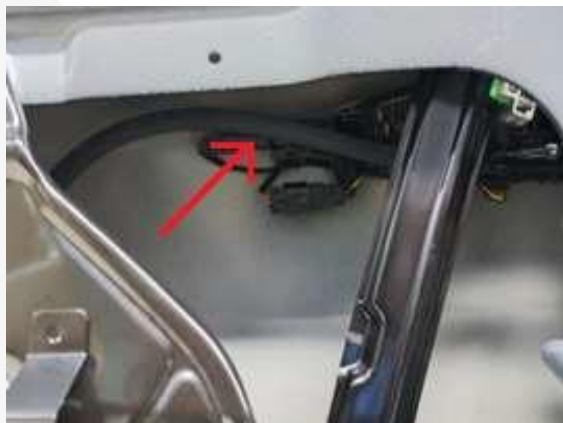
In this case, as shown in **Picture 2**, the Door Lock Bowden Cable is “**too high**” if compared to the position of the connector and the handle. This wrong positioning could take to a difficult or not possible door opening from the outside. See below “**HOW TO FIX**” to reposition the Bowden cable and solve the Customer Concern.

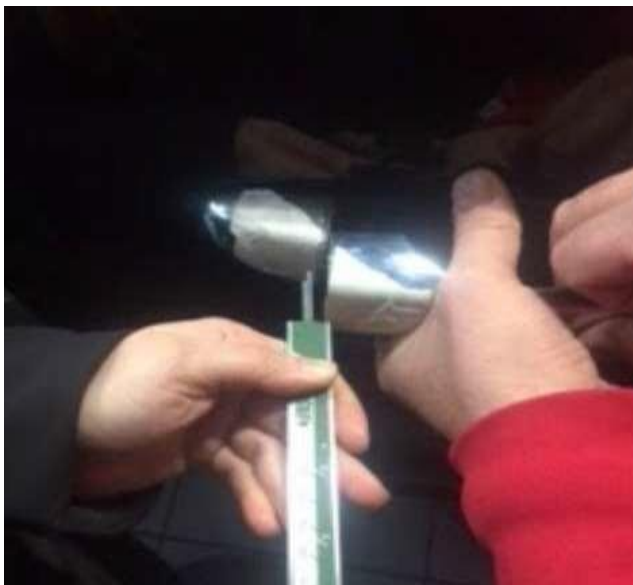
- Slowly pull the handle, if possible, until the door is unlocked;
- Measure the stroke with a caliper, as shown in the following image;

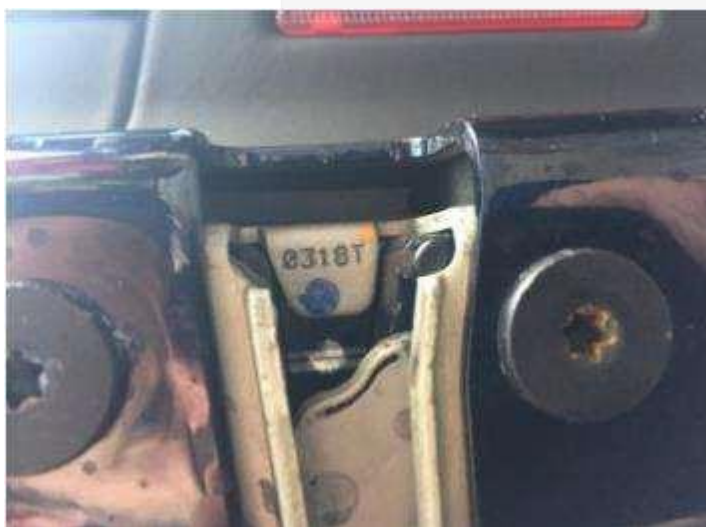
6) Take a picture of the traceability code, when the Door Lock gets removed to perform the repair action, as shown below; to be attached to the BOL.

5) Replace the defective Door Lock;
