Technical Service Bulletin

57F5 UPDATE – Door Pad (NVLW)

December 03, 2014

Model(s)	Year	VIN Range	Vehicle-Specific Equipment
Audi Q7	2015	See Campaign/Action screen in Elsa	None

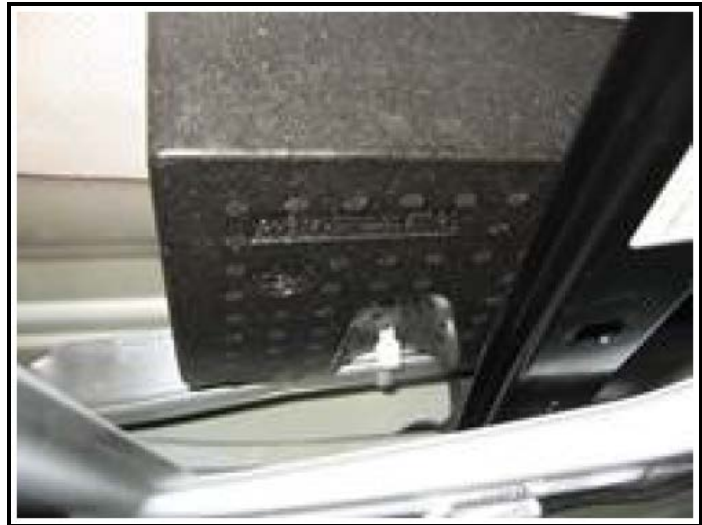
3. With the cover removed the lower pad will be visible. It is secured to the impact beam using a zip tie.
