Technical Service Bulletin

40 Creaking noises from front of the vehicle when driving - Q7, Q8, A8, e-tron

40 24 70 2058489/7 January 12, 2024. Supersedes Technical Service Bulletin Group 40 number 22-44 dated July 12, 2022 for reasons listed below.

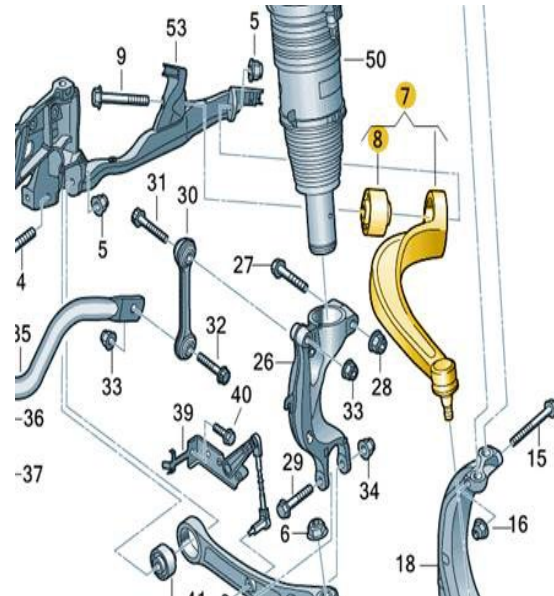
Figure 1. Hydro-bush.

The noises can be generated on the lower-left guide in the area of the hydro-bushing. (Figure 1, Positions 7 and 8).

The noises from the guide link can be transmitted into the vehicle interior by the connection of the subframe on the body and are noticeable in the footwell.

1. Replace the hydro-bushing on the guide link in pairs (Figure 1, Position 8) according to the instructions in the ELSA Repair Manual at *Chassis >> Suspension >> Wheels, Steering >> 40 Front Axles >> Lower Control Arm and Ball Joint >> Guide link bonder rubber bushing, Removing and Installing.*
2. If repeat repairs are necessary and the hydro-bushing has already been replaced (pressed out/in), the complete guide link has to be replaced (Figure 1, Position 7). Refer to the instructions in the ELSA Repair Manual at *Chassis >> Suspension >> Wheels, Steering >> 40 Front Axles >> Lower Control Arm and Ball Joint >> Guide link, Removing and Installing.*

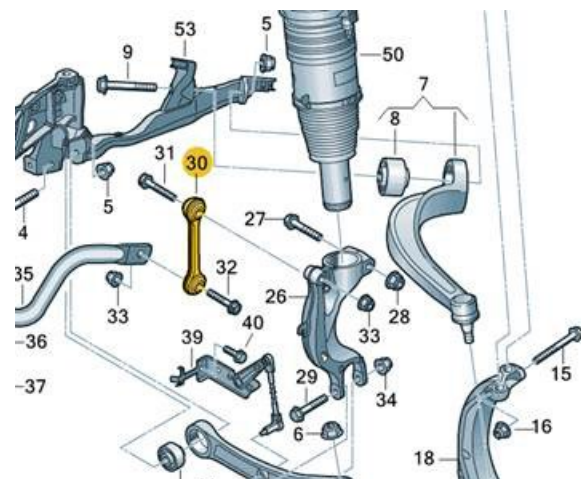
Figure 2. Coupling rod.

Parts such as the coupling rod (Figure 2, Position 30) are usually replaced by mistake, presenting no problems.
