Technical Service Bulletin

85 Whistling noise in vehicle interior when HVAC blower is active

85 24 27 2072609/1 January 4, 2024.

Model(s)	Year	VIN Range	Vehicle-Specific Equipment
Q8 e-tron, and Q8 Sportback e-tron	2024 – 2025	All	Not Applicable

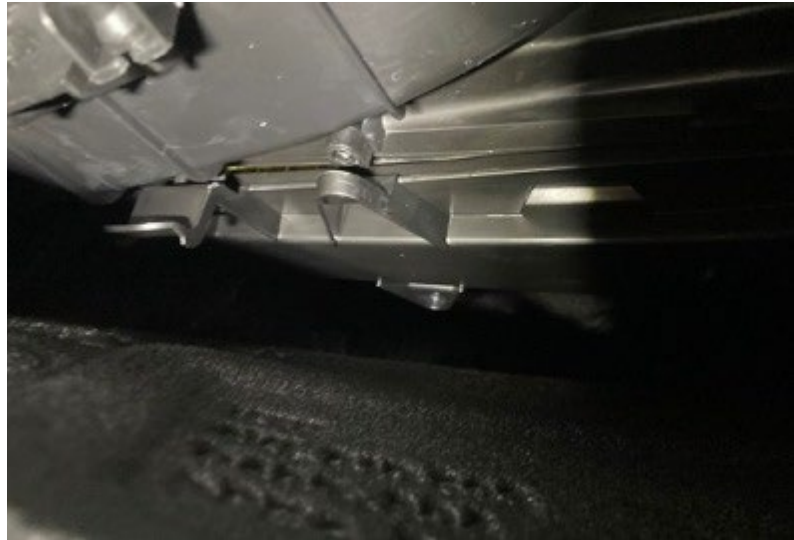
The cover for the dust and pollen filter is not fully engaged into the air intake housing.

1. Check the dust and pollen filter cover. It may not be fully engaged in the air intake housing. Figure 1 shows a visible gap in the cover. This gap causes a whistle type noise during HVAC blower operation.

Figure 1. Cover for the dust and pollen filter not fully engaged.

3. Press the interior wiring harness away from the dust and pollen filter opening. Then install the cover until it is completely engaged in the air intake housing and fully seated. It is not necessary to replace the dust and pollen filter in these cases. Run the HVAC system briefly and ensure that the whistle noise is eliminated.

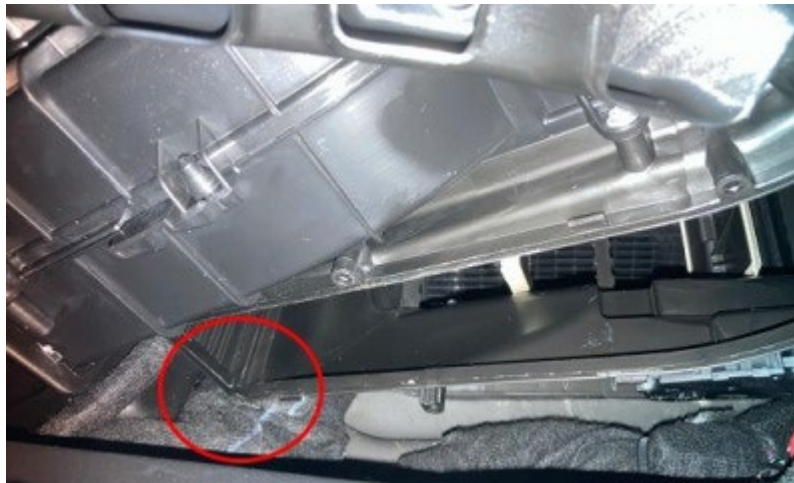
2. The cause of the incomplete fitment is interference between the interior wiring harness and the cover. Remove the dust and pollen filter cover. Figure 2 shows the harness routing preventing proper clearance for complete cover installation into the air intake housing.

Figure 2. Interior wiring harness impingement into the dust and pollen filter cover mating surface to the air intake housing.
