**Upper front suspension creaking/knocking noise**

<b>REF NO:</b> TJ 36527.5.0	<b>ISSUING DEPARTMENT:</b> Technical Service	<b>CAR MARKET:</b> United States and Canada	
<b>PARTNER:</b> 3 US 7515 Polestar		<b>ISSUE DATE:</b> 2024-01-02	<b>STATUS DATE:</b> 2024-01-24
<b>FUNC GROUP:</b> 7233	<b>FUNC DESC:</b> Mounting	<b>Page 1 of 4</b>

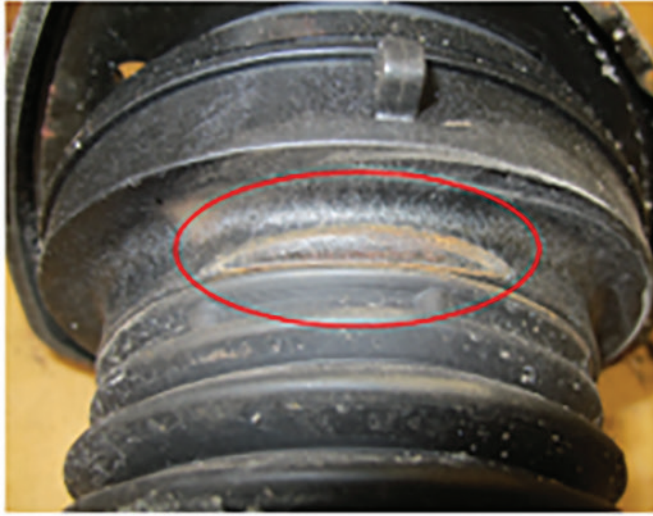
If there is a confirmed creaking/knocking noise from the upper front suspension:

- During acceleration/braking (knocking noise.MOV and picture 1)
- During (slowly) driving over bumps and into turns (knocking noise.MOV and picture 1)
- During turning to left or right when standing still (Creaking noise.mp4 and picture 2)
- During parking maneuvering (Creaking noise.mp4 and picture 2)

Do not replace any parts and do not fault trace due to this behavior except for, see under Note.

There will be a new upper bearing released year 2024 week 20.

**Note:** It is OK to replace the upper bearing.

- For critical customer.
- To prevent buyback.
