Service Action

Code: 82C9

Subject	Electric Passenger Compartment High-Voltage (HV) Heater																				
Document History	<table border="1"> <thead> <tr> <th style="background-color: #c00000; color: white;">Date</th> <th colspan="4" style="background-color: #c00000; color: white;">Summary</th> </tr> </thead> <tbody> <tr> <td>01/24/2024</td> <td colspan="4">Updated parts information and work procedure</td> </tr> <tr> <td>10/26/2023</td> <td colspan="4">Original publication</td> </tr> </tbody> </table>					Date	Summary				01/24/2024	Updated parts information and work procedure				10/26/2023	Original publication				
Date	Summary																				
01/24/2024	Updated parts information and work procedure																				
10/26/2023	Original publication																				
Affected Vehicles	<table border="1"> <thead> <tr> <th style="background-color: #c00000; color: white;">Country</th> <th style="background-color: #c00000; color: white;">Beginning Model Year</th> <th style="background-color: #c00000; color: white;">Ending Model Year</th> <th style="background-color: #c00000; color: white;">Vehicle</th> <th colspan="2" style="background-color: #c00000; color: white;">Vehicle C

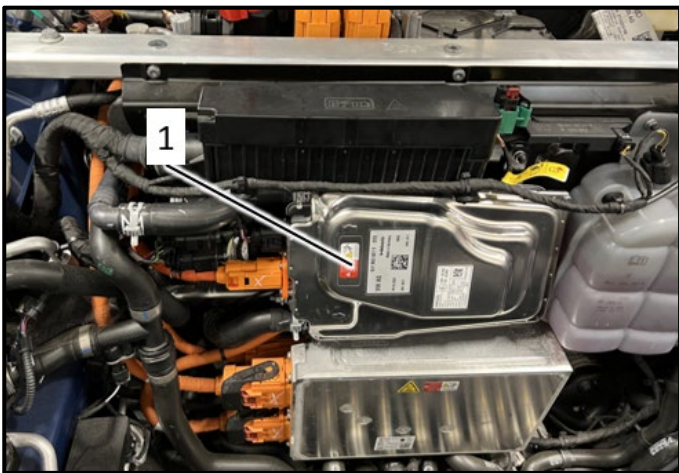
Z189 High-Voltage heater inspection:

- Locate the Z189 high-voltage heater <1>.

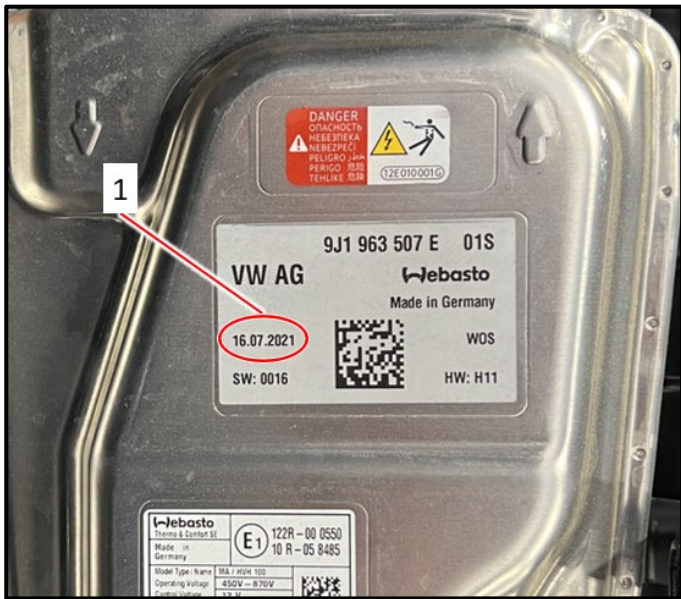
- Check the production date <1> of the Z189 high-voltage heater.
 - If the Z189 high-voltage heater was produced **BEFORE** 14/02/2023:
 - Replacement is required.
 - Proceed to section C.
 - If the Z189 high-voltage heater was produced **ON** or **AFTER** 14/02/2023:
 - Replacement is not required.
 - Continue with the reassembly instructions in this section.

NOTE
The production date on the label <1> is in the DD/MM/YYYY format.

- Reassemble the vehicle in the reverse order of removal.
- Tighten luggage compartment liner bolts to 8 Nm.
- Tighten luggage compartment lamp cover bolt to 3 Nm.
