**Volvo Car USA LLC****Quality Bulletin**

Bulletin Title Service Action A10246: Leaf Spring Inspect-Repair Model Year 2023 S60, V60, V60CC, V90CC, S90L, XC60, XC90		Group 72	NO A10246
Issuer (Dept.) Product, Safety and Compliance	Car Market United States and Canada	Issue Date 9/26/23	Status Date 12/1/23
Revisions Updated with new content		Page Page 1 of 4

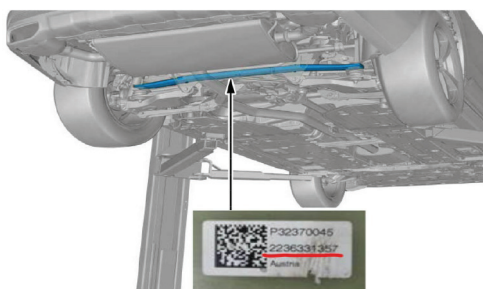
Volvo Cars quality investigations have identified that the wrong tool parameter setting was used during rear leaf spring production on vehicles built with rear leaf spring suspension. As a result, the rear suspension leaf spring may break.

The corrective action is to inspect the leaf spring and only replace if the matching serial number is found in the Serial Number Matrix located in TIE.

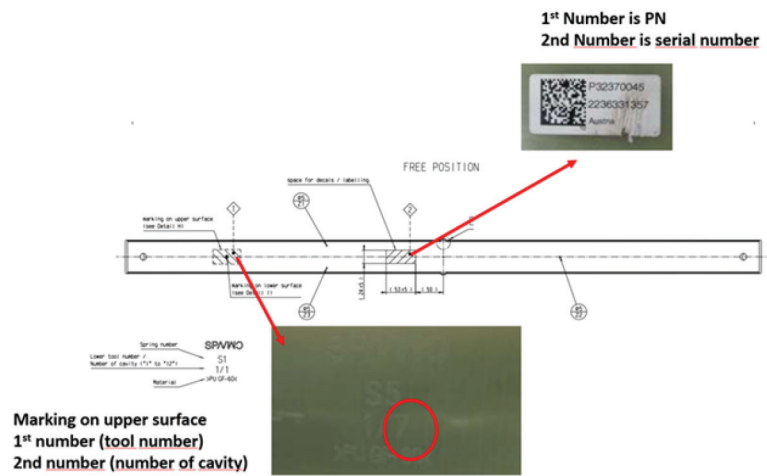
1. Inspect the “tool cavity” molded to the part (See circled Below). The Cavity is the second number in sequence i.e., 1/7.

2. If the cavity **shows** a **6 or 7**, the leaf spring should be **replaced**.
3. If the cavity **does not show** a **6 or 7**, the leaf spring is OK and should **not be replaced**.

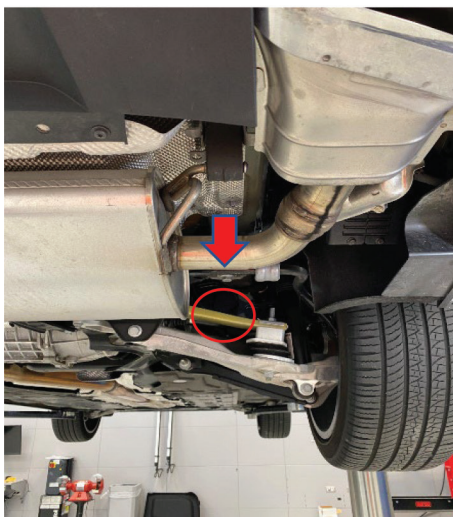
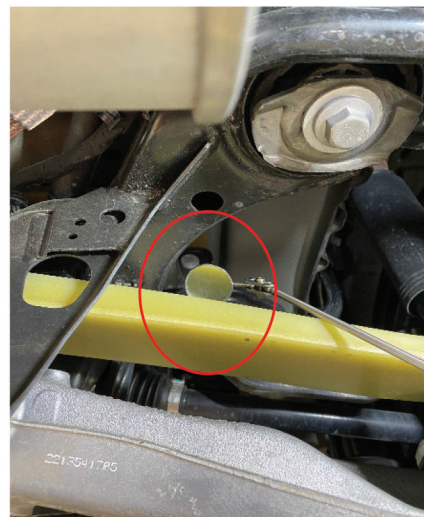
**Please note: The cavity mold can be read with mirror.**
