THIS IS A TECH TIP, NOT A TECHNICAL BULLETIN AS TITLED.

Applicable Vehicles					
Model(s)	Year	Eng. Code	Trans. Code	VIN Range From	VIN Range To
All	2015-2024	All	All	All	All

Revision Table			
Instance Number	Published Date	Version Number	Reason For Update
2055763/3	01/18/2024	87-19-02TT	Update to model and model year applicability.
2055763/2	8/11/2022	87-19-02TT	Update to model and model year applicability.
2055763/1	7/26/2019	87-19-02TT	Original publication.

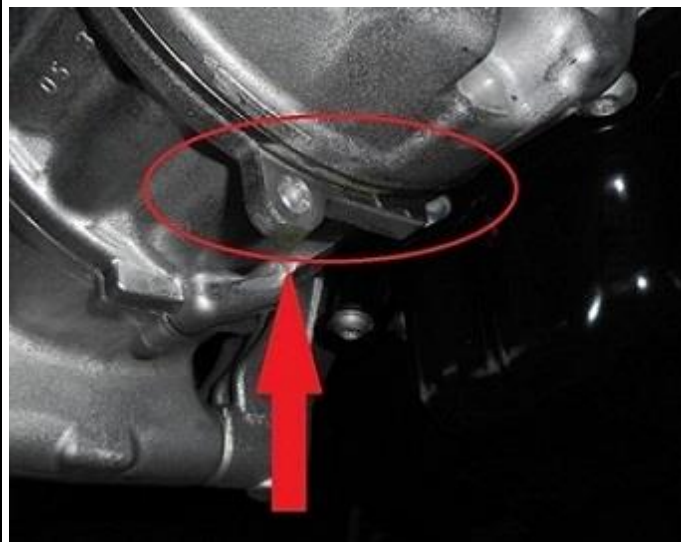
Figure 1

While verifying a low refrigerant condition the - **V454** Air Conditioning Compressor sometimes appears to be leaking at the case seals (Figure 1).

Oil found at bottom of compressor.

Before the replacement of any compressor for a possible leak the leak must first be verified by injecting dye into the Air Conditioning system after refrigerant recovery to verify the refrigerant level

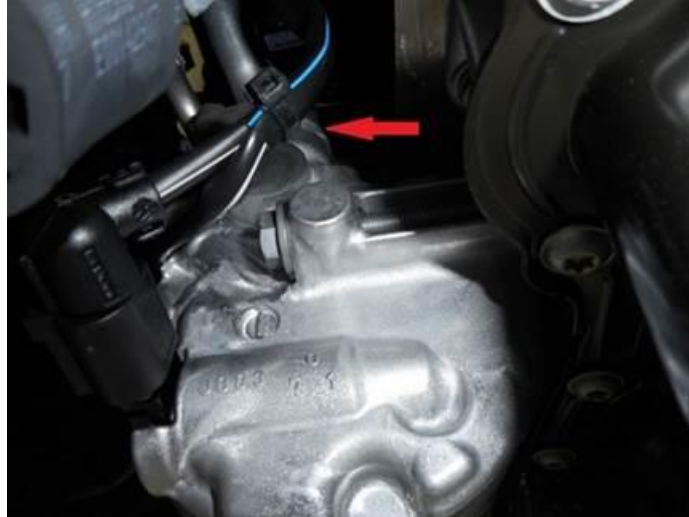
Figure 2

The oil found at the bottom of the compressor (Figure 1) can be caused by a leaking low pressure compressor O-ring. (Figure 2-3).

Leak found at low pressure compressor connection.

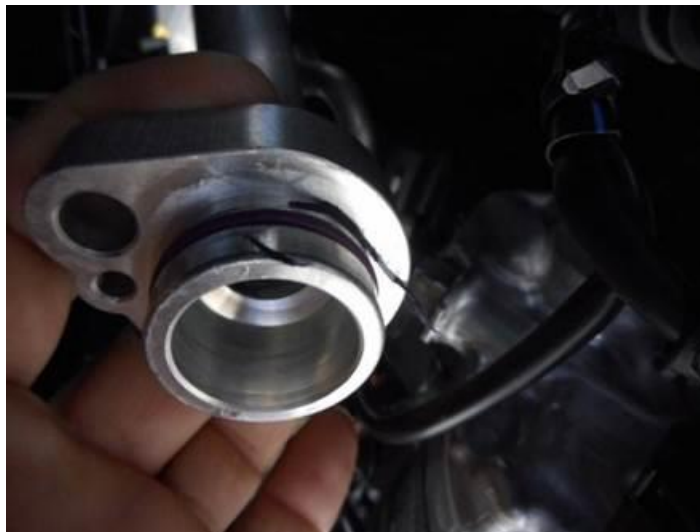
Figure 3

Cause: O-ring torn on low pressure AC hose connection to compressor.
