SIB 12 01 24

SERVICE ACTION: CHECK AND REPLACE IGNITION COIL

High levels of silicone inside the ignition coil can lead to premature failure.

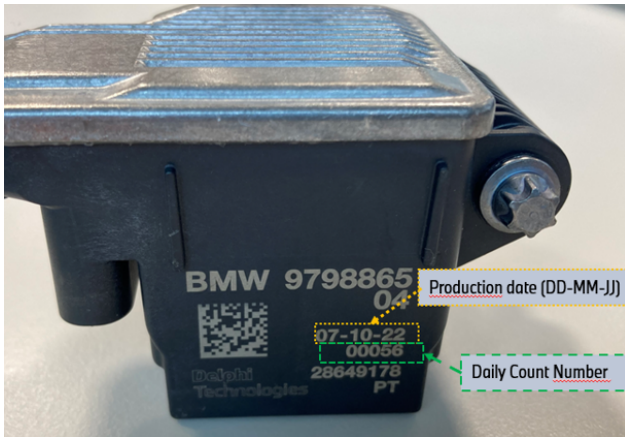
2. Inspect and record the ignition coil production date codes and the daily count numbers.

The daily count number is the serial number of the ignition coil.

Ignition coil production date = 15-09-23
 Ignition coil serial number = 04569

This ignition coil must be replaced (see blue arrow).

3. If the combination of the date code and serial number matches any of the combinations shown in the table, then that ignition coil needs to be replaced.

4. Replace the affected ignition coil as per Repair Instruction 12 13 511 “Replacing an ignition coil”.
5. Reinstall the acoustic cover as per Repair Instruction 11 12 070 “Removing and installing the acoustic cover”.
6. If the vehicle has stored faults in the DME for the ignition coil, perform a vehicle test and clear the fault memory.
