Service Bulletin

Bulletin No.: 23-NA-222

Date: January, 2024

Subject: Radio Software Version W26E-172.4.2-M169-SQBR4-123.4 – Multiple Updates for IVD

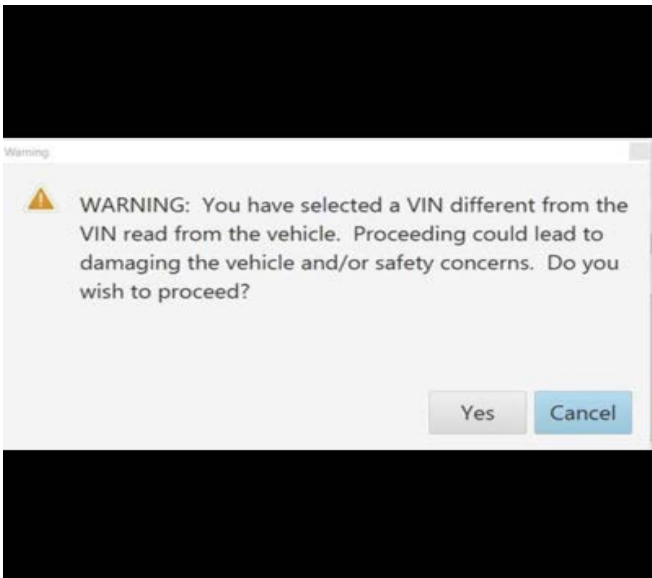
5877000

Important: If the vehicle VIN DOES NOT match, the message below will be shown.

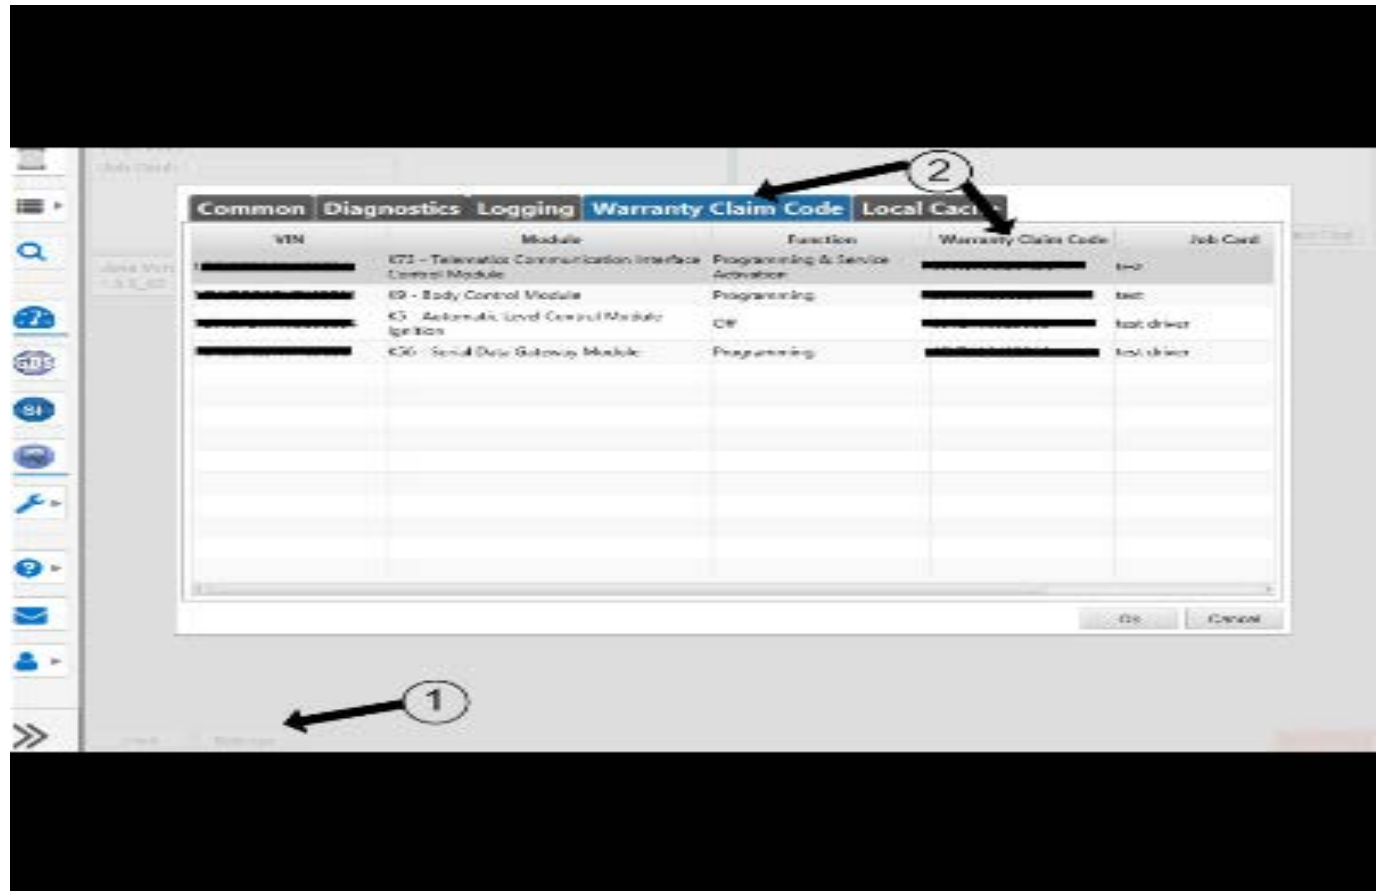
6125774

If the Warranty Claim Code was not recorded on the Job Card, the code can be retrieved in the SPS2 system as follows:

1. Open TLC on the computer used to program the vehicle.
2. Select and start SPS2.
3. Select Settings (1).
4. Select the Warranty Claim Code tab (2).

The VIN, Warranty Claim Code and Date/Time will be listed on a roster of recent programming events. If the code is retrievable, dealers should resubmit the transaction making sure to include the code in the SPS Warranty Claim Code field.
