## Model Series 223: Front Armrest Difficult To Open

Topic number	LI68.10-P-077315
Version	1
Function group	68.10 - Instrument panel
Date	1/22/24
Validity	Model series 223
Reason for change

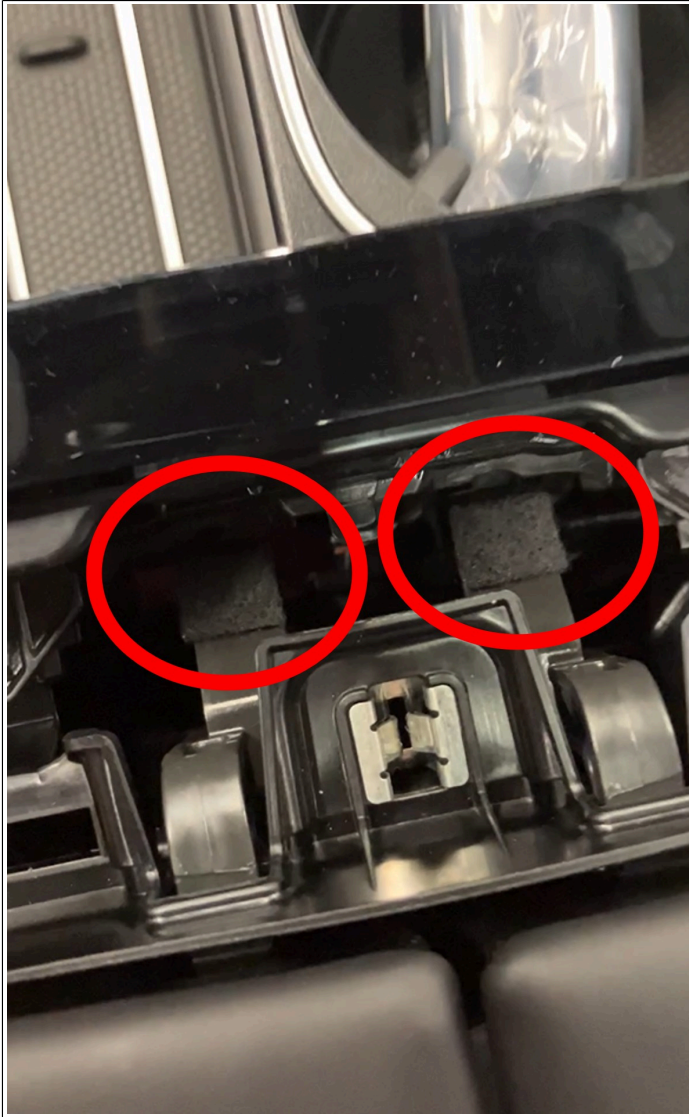
Front armrest cap (butterfly compartment) only opens when pressed strongly.

Unfavorable tolerances

Attachments	
File	Description
<a href="#">geklebte Filze.jpg</a>	Bonded felt on the trigger mechanism

Place two pieces of felt (12mmx12mm) on the trigger mechanism as seen in the attached picture. This will reduce the distance between the pushbutton switch and the trigger mechanism.
