## TGW Will Not Connect After SIM Card Replacement

Published 18 Janurary 2024

Volvo models VNR,VNX,VNL,VNM,VAH,VHD Model Years 2010 to current Mack models CHU,CXU,PI,GR,GU,LR,TD,MRU,TE,AN Model Years 2013 to current

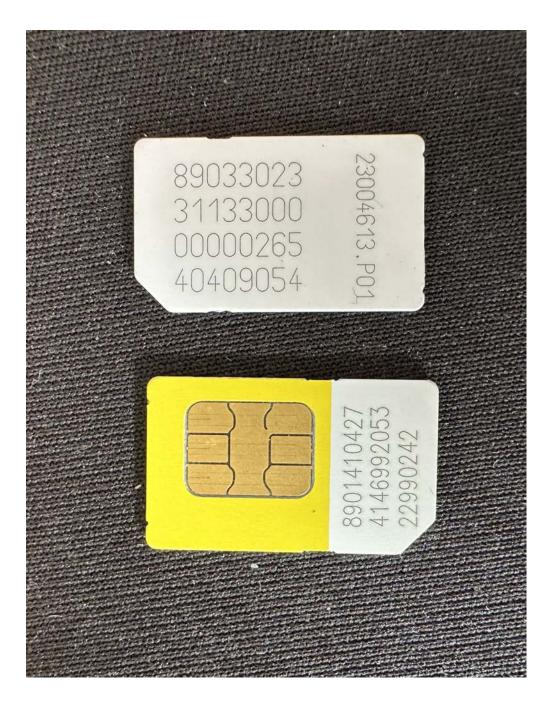
TGW Connectivity issues may be encountered when moving from SIM card P/N 22990242 Yellow) to SIM card P/N 23004613(White). When changing from SIM card P/N 22990242 (Yellow) to SIM card P/N 23004613(White), run the conversion kit P/N 85165543 as an accessory kit using Premium Tech Tool (PTT).

**NOTE:** Confirm the TGW has been programmed to the latest software version before running the conversion kit.
