Technical Service Bulletin

19 Coolant warning light on OR Coolant pump replaced due to a coolant leak - 4.0 TFSI

19 24 48 2065040/3 January 30, 2024. Supersedes Technical Service Bulletin Group 19 number 22-30 dated August 31, 2022 for reasons listed below.

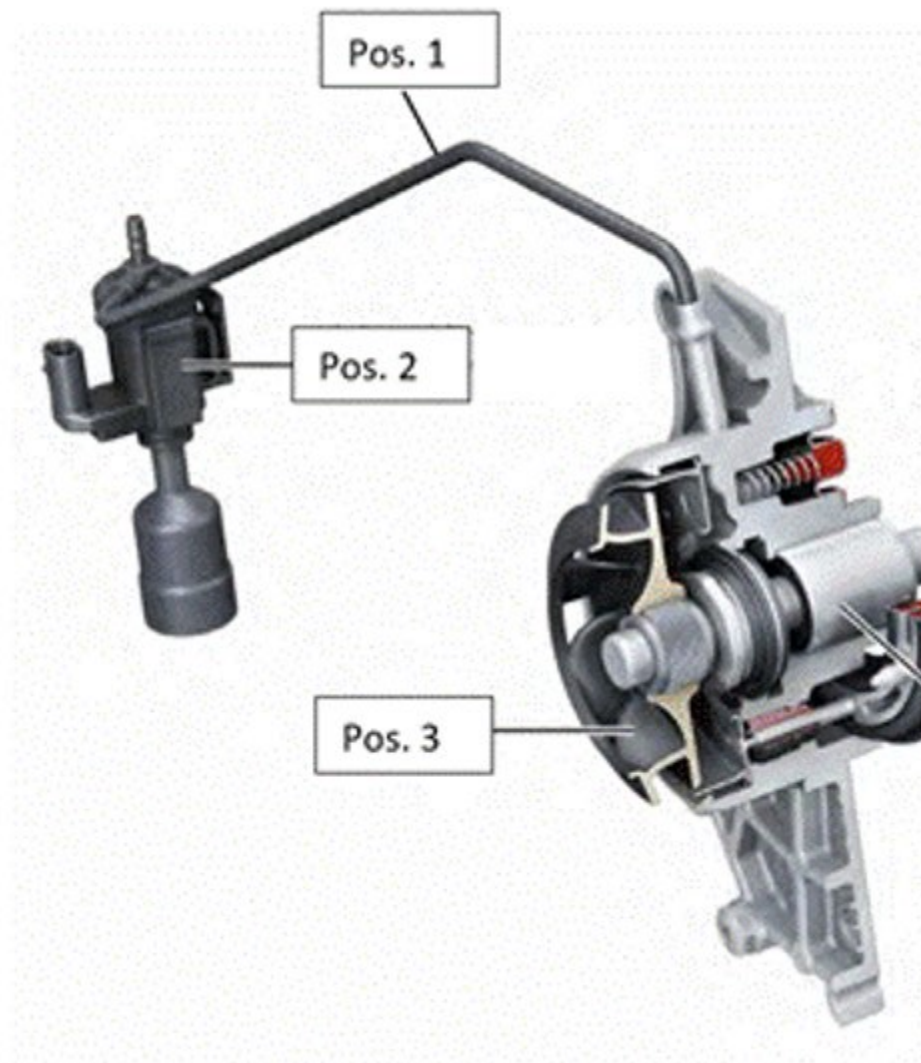
Figure 1. Mechanical coolant pump.

- The coolant pump is identified as cause of coolant leak.

- Position 1 – control line.
- Position 2 – switch valve for mechanical coolant pump N649.
- Position 3 – mechanical coolant pump.

When performing work on the cooling system which requires the mechanical coolant pump to be replaced, it must be ensured that there is no coolant residue or fluid in the control line (Figure 1, position 1). If there is, switch valve N649 must also be replaced in addition to the coolant pump and the control line must be cleaned/dried.
