# Service Bulletin

Bulletin No.: 21-NA-120

**Subject: Diagnostic Tip for Noise, Vibration and/or Harshness Issues/Clunk Noise Heard During Coast Down Event**

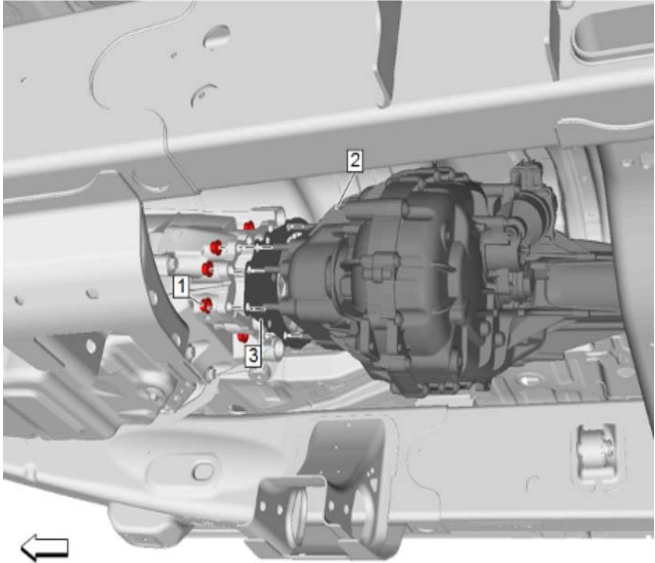
<p><b>Correction</b></p>	<div style="text-align: right; margin-bottom: 10px;">5411622</div>

<b>Involved Region or Country</b>	North America, Middle East, Israel
<b>Additional Options (RPOs)</b>	NQF (TRANSFER CASE-ELECTRIC SHIFT CONT, TWO SPEED, ALUM) NQH (TRANSFER CASE-ACTIVE, TWO SPEED, SWITCH ACTIVATED, ALUM)
<b>Condition</b>	Some technicians or customers may comment on one or more of the following conditions after the transfer case was removed from the transmission and reinstalled during a recent repair: <ul style="list-style-type: none"><li>• Harsh downshift during a coast down event</li><li>• Noise during a coast down event</li><li>• Vibration during a coast down event</li><li>• Harshness issues such as a clunk noise heard during coast down event</li></ul>
<b>Cause</b>	This condition may be caused by a misalignment between the transmission output shaft and the transfer case input. ⇒ Transfer case to transmission misalignment could cause the transfer case shift collar to slip out of engagement.

<ol style="list-style-type: none"> <li>1. Connect the GDS Scan Tool and monitor transmission shift data.</li> <li>2. Drive the vehicle and duplicate the condition while monitoring transmission shift data to determine if the noise/clunk/roughness occurs during the downshift or if the noise/clunk/roughness occurs randomly during the de-acceleration event.</li> </ol> <p>⇒ If it is determined that the noise/clunk/roughness does not occur at a transmission downshift, shift point follow published Service Information for Transfer Case Assembly Replacement (with MGM, MGU, MKM Automatic Transmission).</p> <p><b>Note:</b> The transfer case does not need to be completely removed from the vehicle. The attaching bolts must be loosened (not removed) to allow the transfer case to be separated from the transmission a minimum of a ½ (13mm) but no more than 1 inch (25mm). The use of transmission jack or adjustable jack stand may provide support in holding the transfer case to the transmission. Proper transfer case to transmission bolt installation, tightening sequence and proper torque must be followed.</p> <p>If the noise/clunk/roughness is occurring during a transmission downshift, shift point, refer to SI for further diagnostics.</p>
