Service Bulletin

Bulletin No.: 22-NA-112

Subject: 2020 - 2022 Silverado and Sierra Equipped with Diesel Engine Setting DTCs P20BB or P20C3

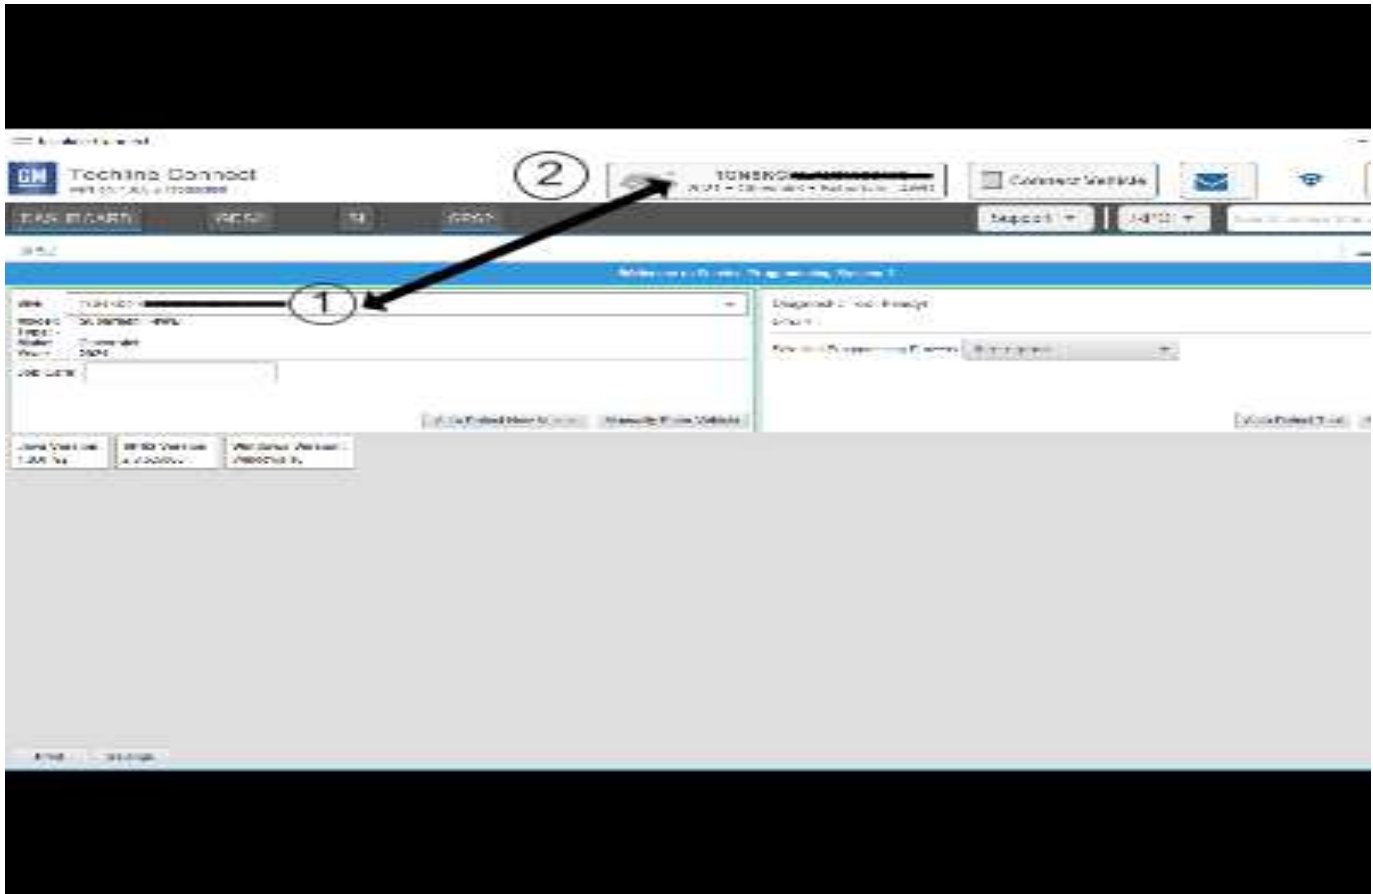
5743643

Caution: Be sure the VIN selected in the drop down menu (1) is the same as the vehicle connected (2) before beginning programming.

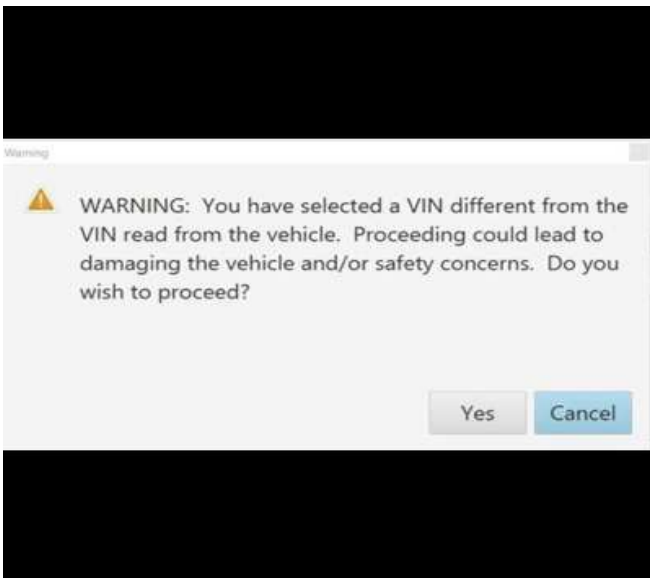
5877000

Important: If the vehicle VIN DOES NOT match, the message below will be shown

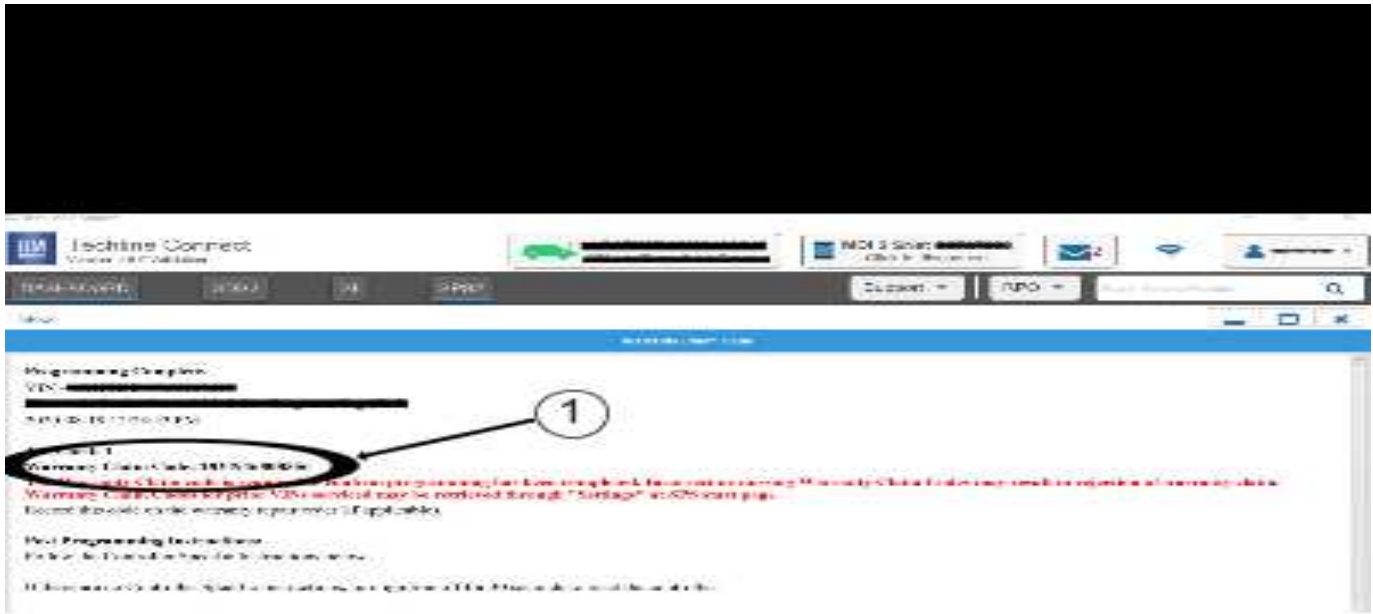
5644478

Important: To avoid warranty transaction rejections, you **MUST** record the warranty claim code provided on the Warranty Claim Code (WCC) screen shown above on the job card. Refer to callout 1 above for the location of the WCC on the screen.

- 2. Record Warranty Claim Code on job card for warranty transaction submission.
