TIB-24-80-12-01

# Technical Information Bulletin

## Software Update – OTA v2.0.56 Performance Improvements & Optimizations

2023	Faraday Future	FF-91	Alliance
------	----------------	-------	----------

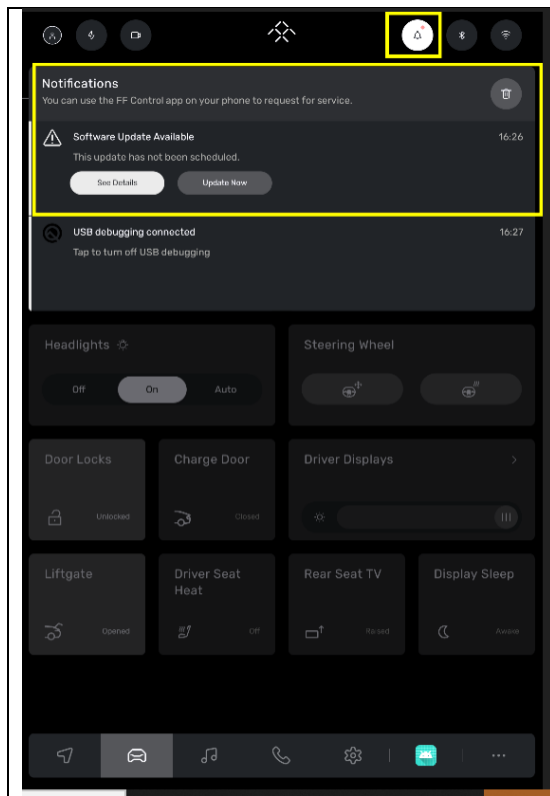
1. Determine the vehicle’s current software (sw) integration level:

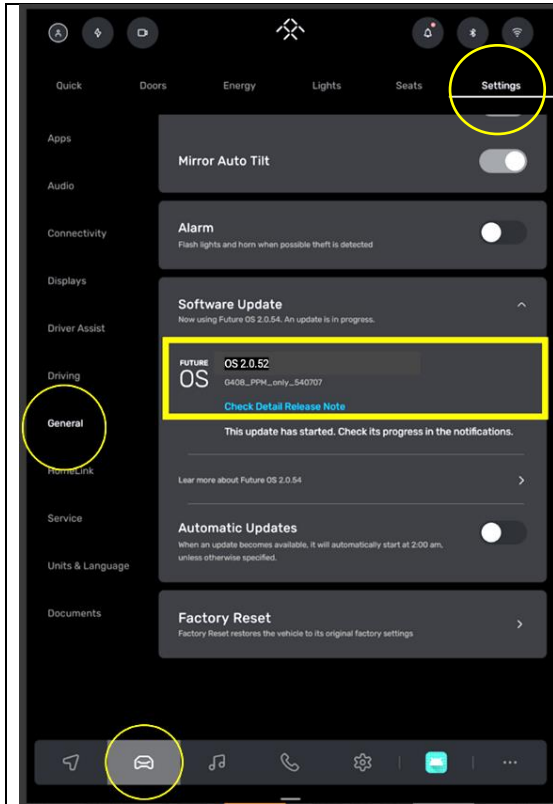
2. When a new software update is “pushed” to the car, “Software Update Available” notification may be displayed during the next vehicle start-up.

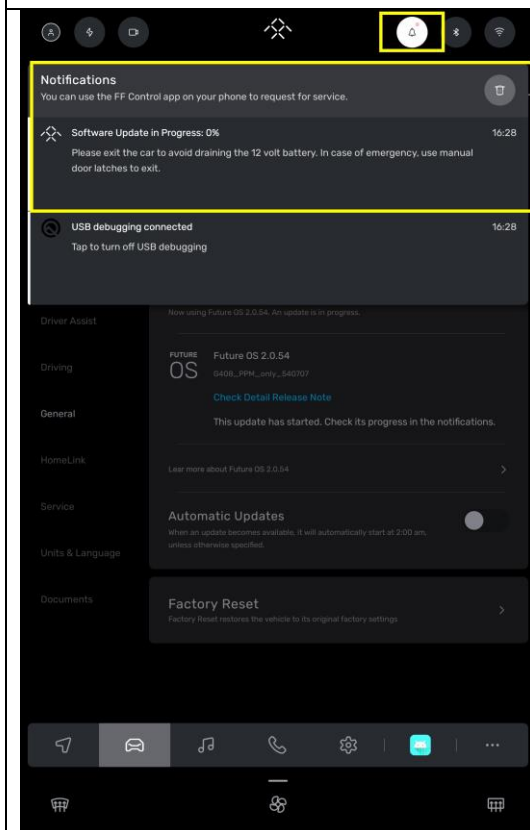
4. If the current software level is v2.0.55 or lower, proceed to update the vehicle.

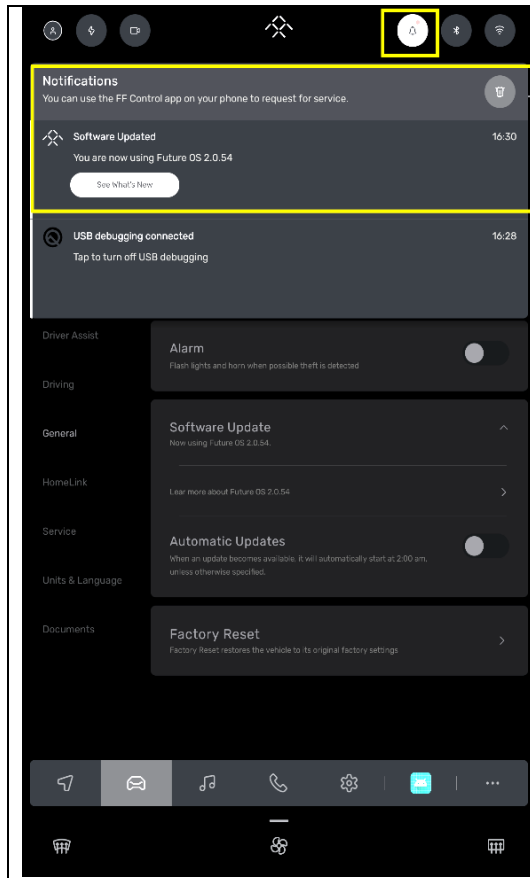
5. "System Update in Progress" notification will be displayed showing the progress %.
