TSB-24-60-76-01

Service Campaign: Checking and Sealing Water Leak at LIDAR Cover

2023	Faraday Future	FF 91 2.0	Alliance
------	----------------	-----------	----------

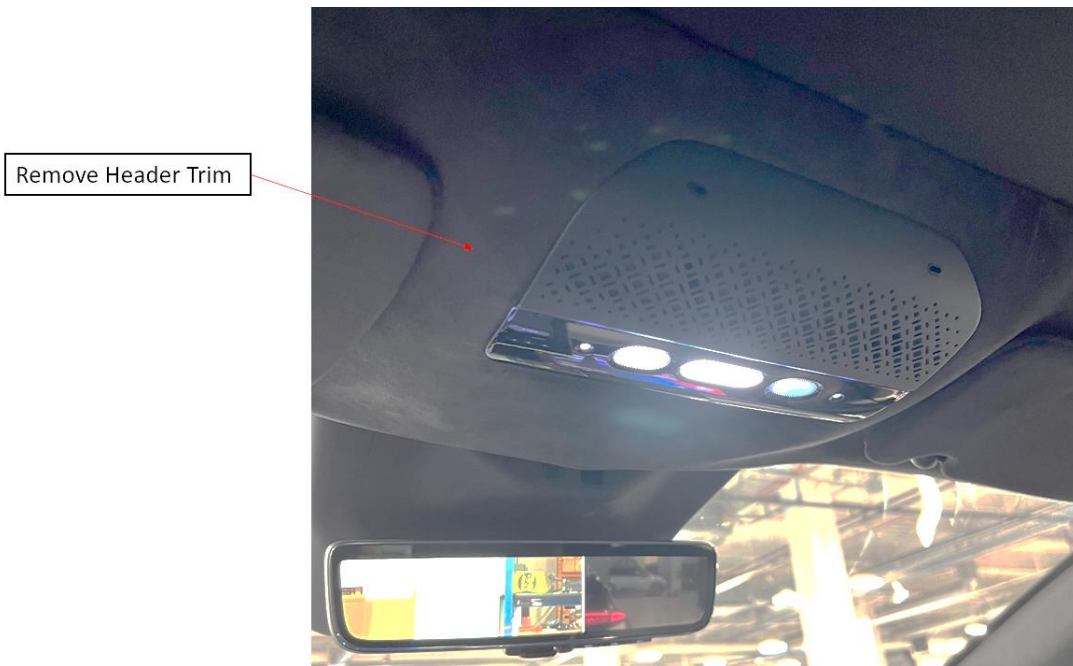
1. Remove Header Trim panel:

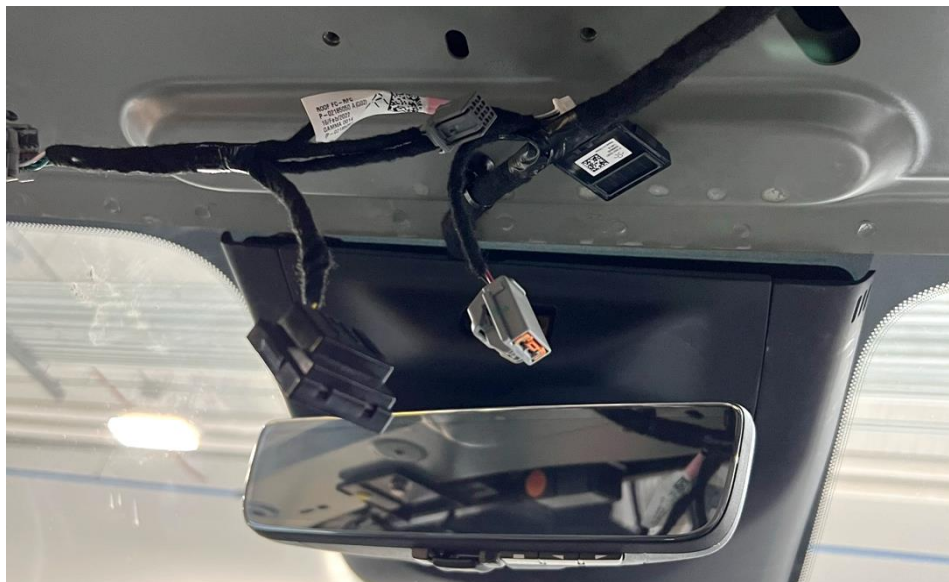
2. Disconnect harness connectors from upper header console / Header Trim:

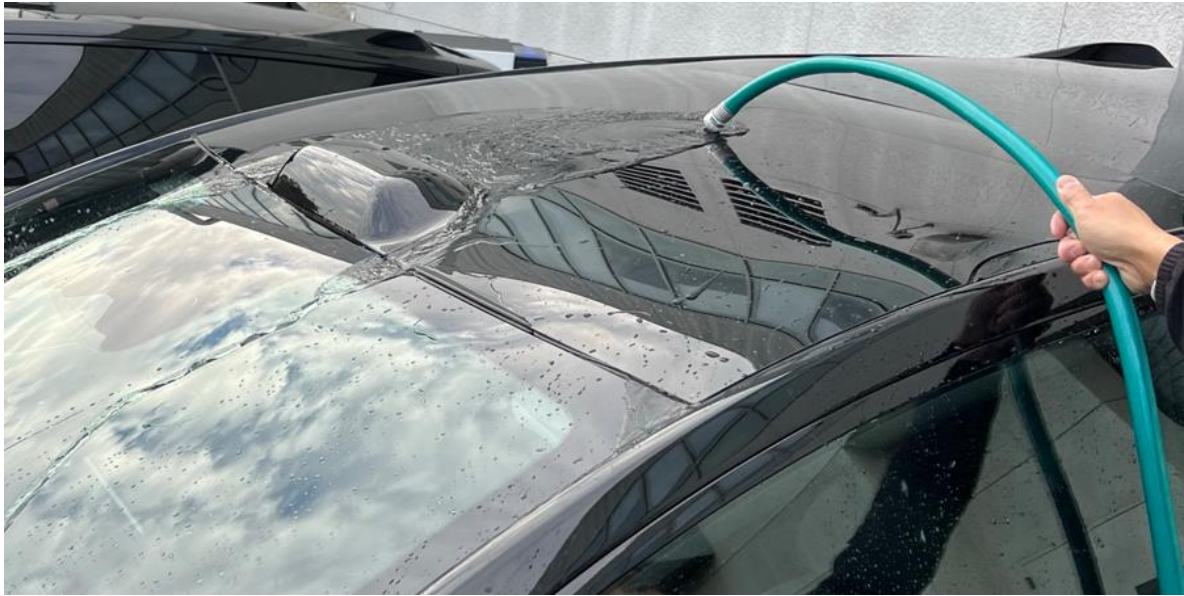
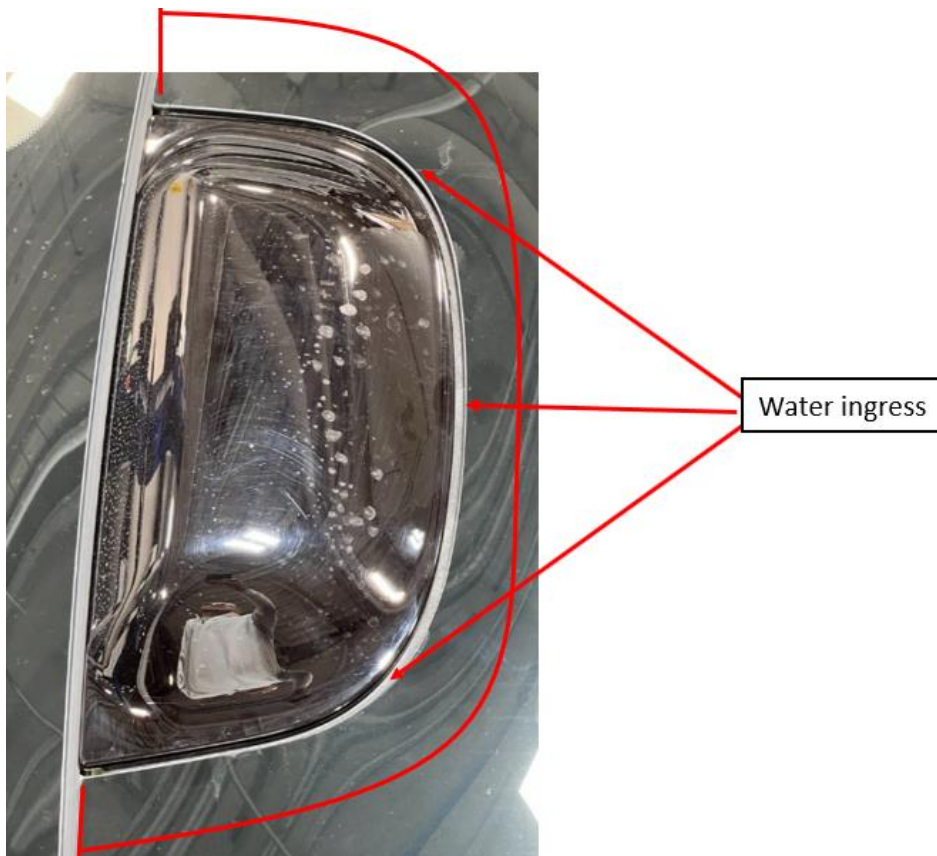
3. Run a consistent flow and volume of water to ensure complete water immersion around LIDAR cover mounting area.

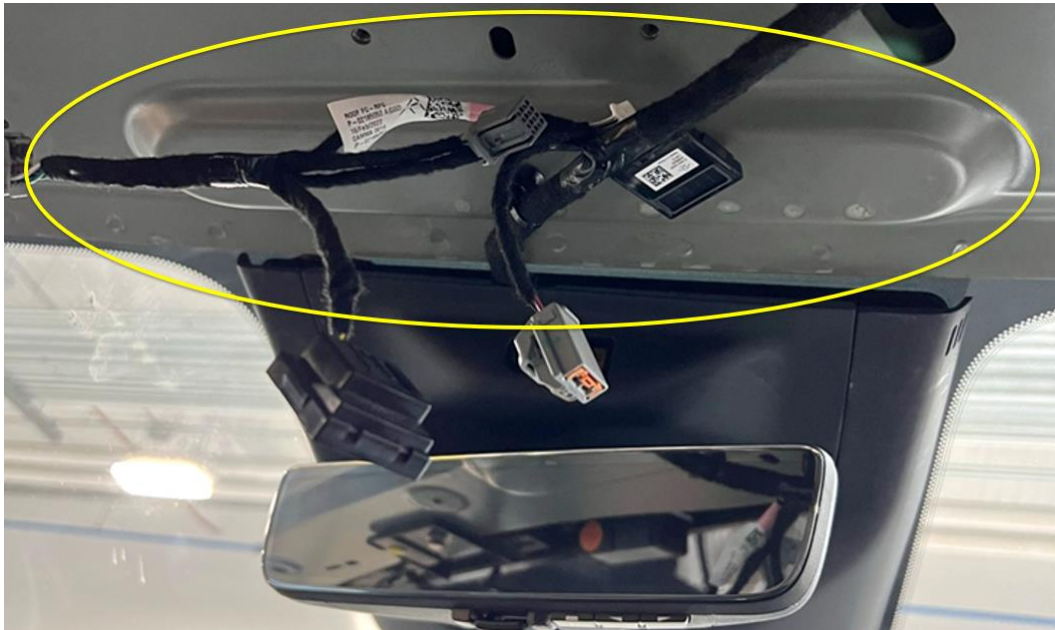
Water leaking into cabin around the rearview mirror area and front header trim.

4. Check inside cabin for water leaks around LIDAR area shown below:

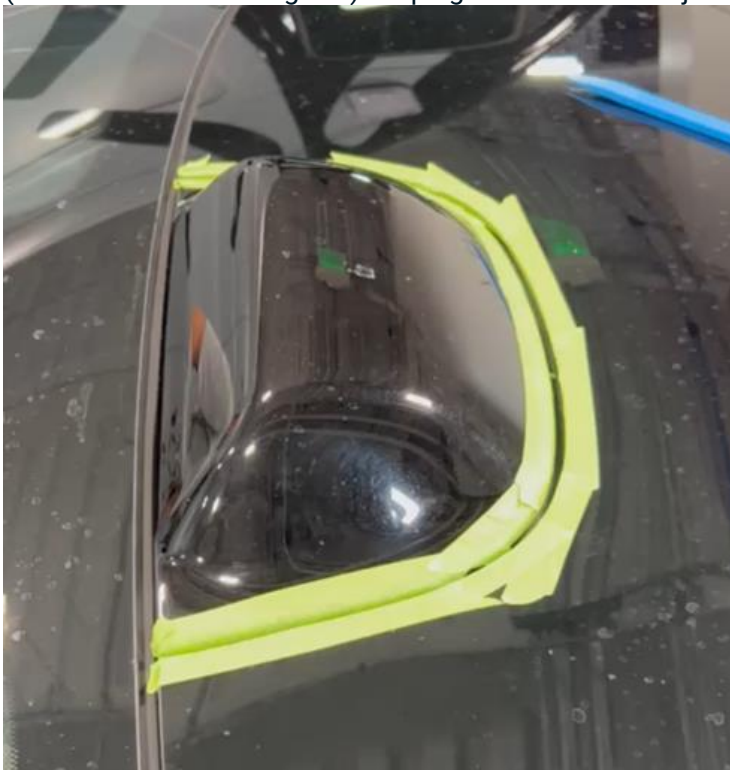
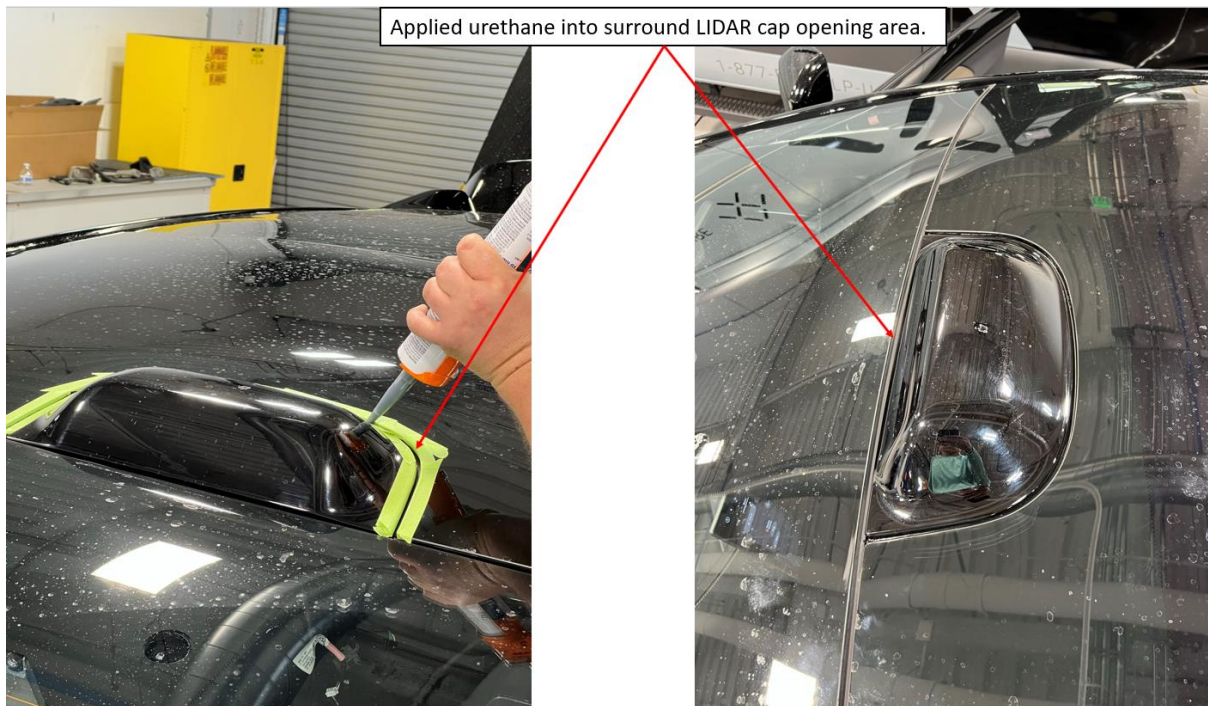
Urethane application during manufacturing process to seal LIDAR cap to roof glass carrier.

5. Once leak path is confirmed originating from the LIDAR seal area, *thoroughly dry* the exterior area around LIDAR cover.
6. Tape/Mask around LIDAR cap opening area to prevent urethane overflow onto surrounding parts (LIDAR cover and roof glass) keeping the cover to roof joint exposed (see Parts Information).

7. Lay a thin bead of Urethane sealant in the LIDAR cover to roof glass seam to ensure a watertight joint.
8. Remove tape before Urethane sets. Allow 24 hours to dry.
9. Repeat water test (outlined above) after 24 hours to ensure area has been 100% sealed.
10. If there are no leaks, re-install interior Header trim. Header trim clips are reusable if not damaged during removal.
