## Technical product information

<b>Topic</b>	Rear door soft close function is not operating to specification
<b>Market area</b>	Australia E04 Bentley rest Asia and Australia (6E04),China 723 Volkswagen (Anhui) Automotive CO (6723),China 796 VW Import Comp. Ltd (Vico), Beijing (6796),Germany E02 Bentley rest Europe (6E02),Japan E03 Bentley Japan (6E03),Korea, (South) E08 Bentley South Korea (6E08),United Arab Emirates E06 Bentley Middle East and Africa (6E06),United Kingdom E01 Bentley UK (6E01),United States E05 Bentley USA and rest America (6E05)
<b>Brand</b>	Bentley
<b>Transaction No.</b>	2069592/3
<b>Level</b>	EH
<b>Status</b>	Approval
<b>Release date</b>

Rear door soft close function is not operating to specification

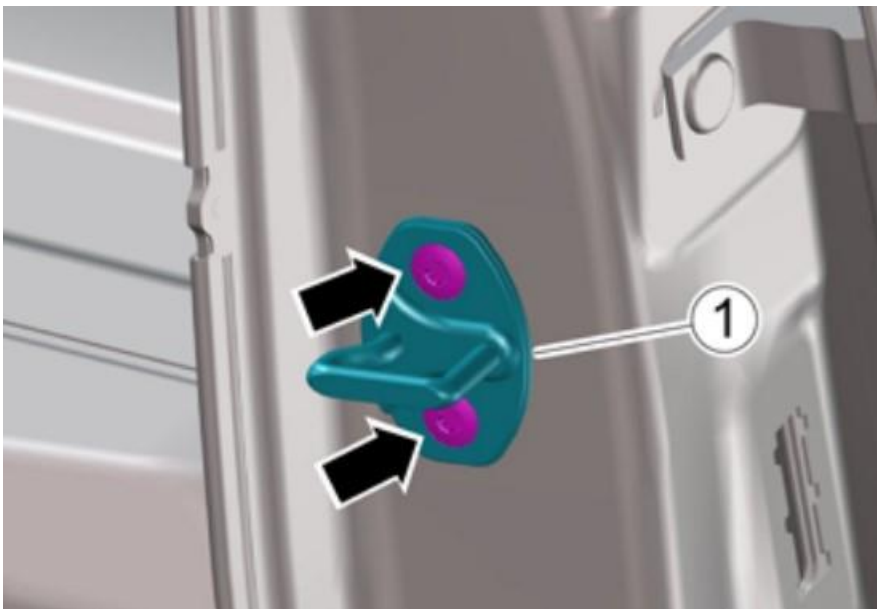
Figure 1

The rear door soft close function is not operating to specification (left and/or right hand side)

- Loosen but do not remove the fixings (Figure 1)
