**Complaint - Oil Leaks on Double Clutch Transmission (Porsche Doppelkupplung (PDK)):  
Observe Specified Procedure (88/20)**

Revision: This bulletin replaces bulletin Group 3 88/20, dated September 8, 2020.

Model Line: **911 Carrera (992)**

Subject: **Double clutch transmission (PDK)**

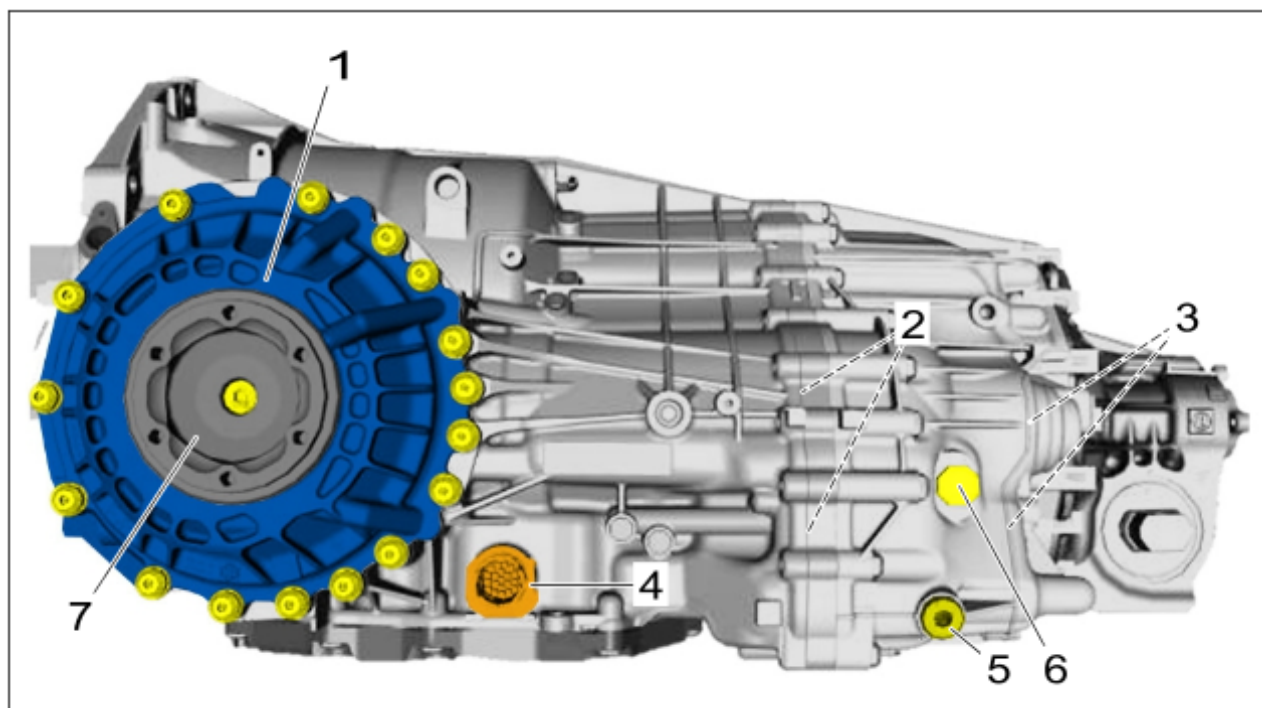
Right side of transmission

Position	Leak area	Possible cause(s)	Repair measure
⇒ Right side of transmission-1-	Differential cover 1A - 1C	Sealing ring damaged (A)	Replace sealing ring, see ⇒ Workshop Manual '391555 Replacing flanged-shaft sealing ring'.
		Screw loose (B)	Replace screws, see ⇒ Workshop Manual '391555 Replacing flanged-shaft sealing ring'.
		O-ring damaged (C)	Replace O-ring, see ⇒ Workshop Manual '391555 Replacing flanged-shaft sealing ring'.
⇒ Right side of transmission-2-	Rear transmission housing seal 2A - 2B	Screw loose (A)	Replace double clutch transmission, see ⇒ Workshop Manual '373419 Removing and installing double clutch transmission'.
		Seal damaged (B)

⇒ Right side of transmission-3-	Front transmission housing seal 3A - 3B	Screw loose (A)	Replace double clutch transmission, see ⇒ <i>Workshop Manual '373419 Removing and installing double clutch transmission'</i> .
		Seal damaged (B)	
⇒ Right side of transmission-4-	Central connector at the left 4A - 4B	Sealing ring damaged (A)	Replace wire harness, see ⇒ <i>Workshop Manual '387719 Removing and installing transmission control mechanism'</i> . Tighten screws to 3 Nm (2 ftlb.).
		Connector leaking (B)	
⇒ Right side of transmission-5-	Screw plug	Sealing ring damaged	Replace screw and tighten to 27 Nm (20 ftlb.). Re-use spring and sleeve during installation.
⇒ Right side of transmission-6-	Oil filler screw	Sealing ring damaged	Replace screw and tighten to 27 Nm (20 ftlb.).
⇒ Right side of transmission-7-	Right halfshaft flange 7A - 7C	Sealing ring damaged (A)	Replace sealing ring, see ⇒ <i>Workshop Manual '392255 Workshop Manual '392255 Replacing sealing ring for right halfshaft flange - double clutch transmission'</i> .

Right halfshaft flange damaged (B)	Replace halfshaft flange, see ⇒ <i>Workshop Manual '392519 Workshop Manual '392519 Removing and installing right halfshaft flange - double clutch transmission'</i> .
		Screw loose, leaking (C)	Replace screw, see ⇒ <i>Workshop Manual '392519 Workshop Manual '392519 Removing and installing right halfshaft flange - double clutch transmission'</i> .

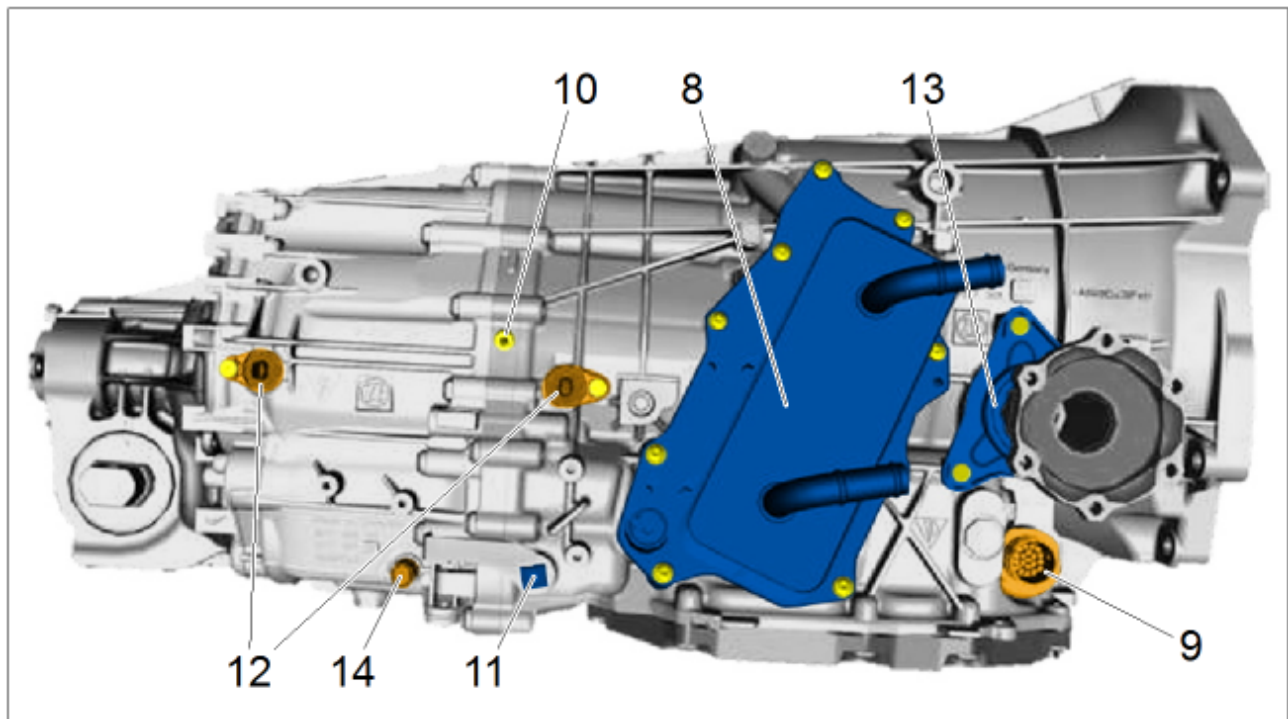
*Left side of transmission (with ATF cooler)*

Position	Oil leak	Possible cause(s)	Repair measure
⇒ Left side of transmission (with ATF cooler) -8-	ATF cooler 8A - 8C  If there are oil leaks in the ATF cooler area, see also ⇒ Left side of transmission (without ATF cooler) -15 - 16-.	Screw loose (A)	Replace screw, see ⇒ Workshop Manual '377219 Removing and installing transmission oil cooler'.
		Seal damaged (B)	Replace seal, see ⇒ Workshop Manual '377219 Removing and installing transmission oil cooler'.
		ATF cooler leaking (C)	Replace ATF cooler, see ⇒ Workshop Manual '377219 Removing and installing transmission oil cooler'.
⇒ Left side of transmission (with ATF cooler) -9-	Central connector at the right 9A - 9B	Sealing ring damaged (A)	Replace double clutch transmission, see ⇒ Workshop Manual '373419 Removing and installing double clutch transmission'.
		Connector leaking (B)	
⇒ Left side of transmission (with ATF cooler) -10-	Bleeder screw	Shaft sealing ring damaged	Replace double clutch transmission, see ⇒ Workshop Manual '373419 Removing and installing double clutch transmission'.

⇒ Left side of transmission (with ATF cooler) -11-	Selector shaft	Sealing ring damaged	Replace sealing ring, see ⇒ Workshop Manual '373355 Replacing selector shaft sealing ring'.
⇒ Left side of transmission (with ATF cooler) -12-	rpm sensor 12A - 12B	Sealing ring damaged (A)	Replace sealing ring.
		Screw loose (B)	Replace screw and tighten to 3.2 Nm (2.2 ftlb.) and a final tightening torque angle of 30°.
⇒ Left side of transmission (with ATF cooler) -13-	Left halfshaft flange	Grease leak on bearing	Replace bearing, see ⇒ Workshop Manual '392555 Replacing left halfshaft flange bearing'.
⇒ Left side of transmission (with ATF cooler) -14-	Temperature sensor 14A - 14B	Sealing ring damaged (A)	Replace temperature sensor, see ⇒ Workshop Manual '377419 Removing and installing transmission oil temperature sensor'.
		Connector leaking (B)

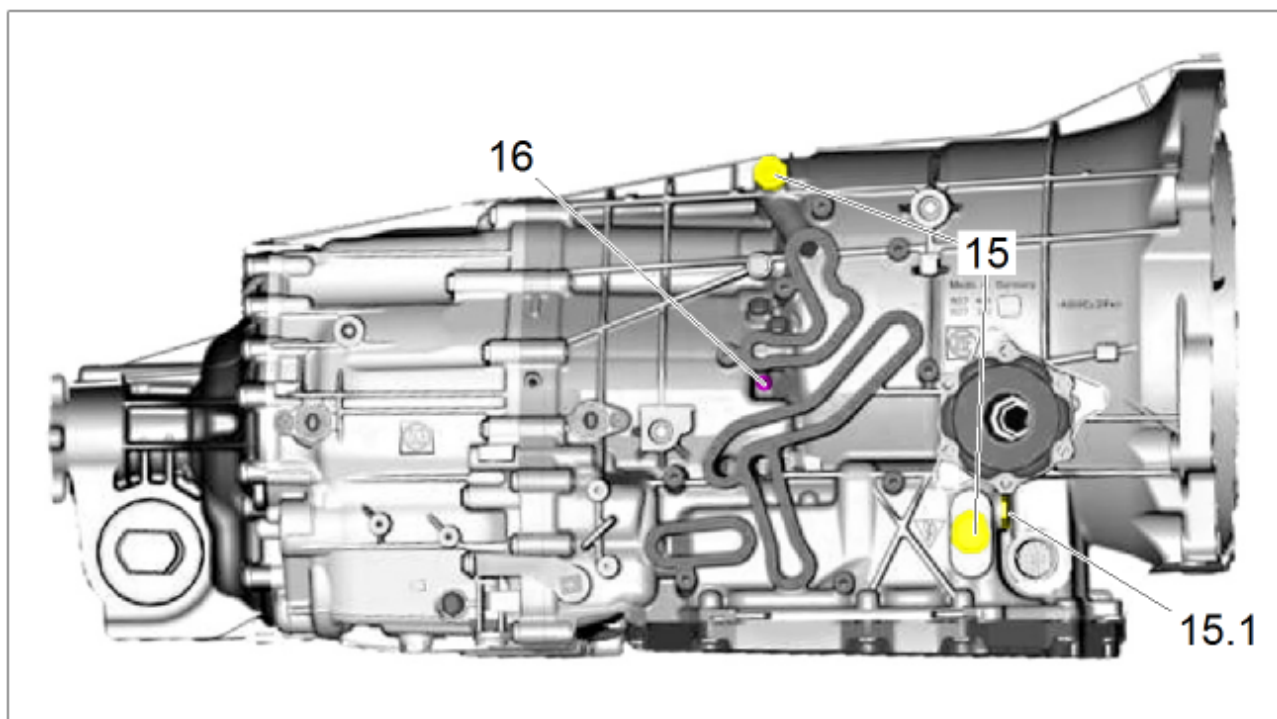
Position	Oil leak	Cause	Repair measure
⇒ Left side of transmission (without ATF cooler) -15-	Screw plug 15A - 15B	Screw loose (A)	Replace screw and tighten to 27 Nm (20 ftlb.).
		Sealing ring damaged (B)	
	Oil filler screw 15C - 15D	Screw loose (C)	Replace screw, see ⇒ Workshop Manual '370235 Checking and topping up ATF'.
		Sealing ring damaged (D)

⇒ <i>Left side of transmission (without ATF cooler) -15.1-</i>	Screw plug 15.1A - 15.1B	Screw loose (A)	Replace screw and tighten to 27 Nm (20 ftlb.).
		Sealing ring damaged (B)	
⇒ <i>Left side of transmission (without ATF cooler) -16-</i>	Oil chamber partition If there are oil leaks in this area, see also ⇒ <i>Left side of transmission (with ATF cooler) -8-</i> and ⇒ <i>Left side of transmission (without ATF cooler) -15 / 15.1-</i> .	Shaft sealing ring damaged	Check the area using an endoscope. Replace double clutch transmission if there are leaks, see ⇒ <i>Workshop Manual '373419 Removing and installing double clutch transmission'</i> .

If there is a leak around item 16, observe the specified procedure.

- Clean oil leak bore area and coat it directly with leak-locating spray
- Correct the oil level
- Perform a test drive
- Visually inspect the leak area of the oil leak bore

If the fault can be reproduced, the double clutch transmission must be replaced. If not, continue fault finding.

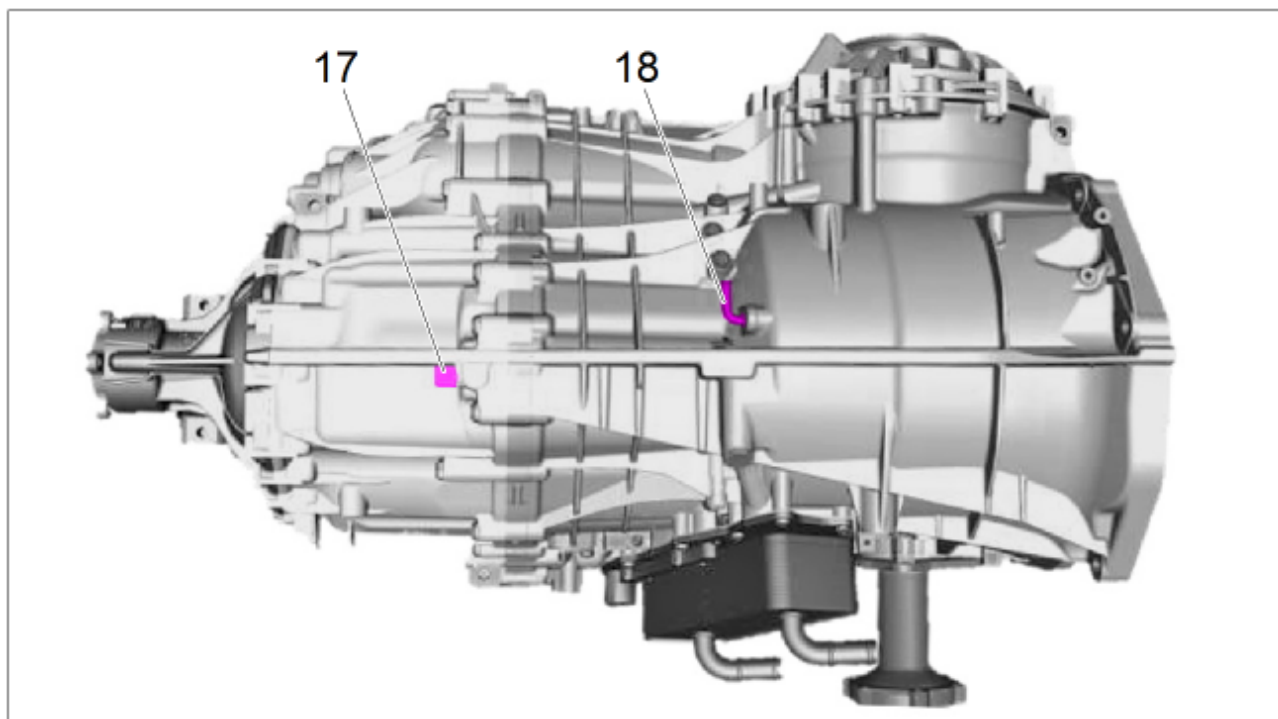
Position	Oil leak	Cause	Repair measure
⇒ Upper side of transmission -17-	Hydraulic chamber breather 17A - 17B	Oil over-filled (A)	Check oil level of hydraulic chamber and final drive, see ⇒ <i>Technical Information '373419 Concluding work'</i> .  <b>Oil level in hydraulic chamber too high and final drive OK:</b> Correct the oil level.  <b>Oil level in hydraulic chamber clearly too high and final drive too low:</b> Replace double clutch transmission, see ⇒ <i>Workshop Manual '373419 Removing and installing double clutch transmission'</i> .
		Insufficient defoamer (B)	Change ATF, see ⇒ <i>Workshop Manual '370255 Changing ATF'</i> .
⇒ Upper side of	Final drive breather	Oil over-filled	Check ATF and final drive oil level, see ⇒ <i>Technical Information '370255 Concluding work'</i> .

<i>trans- mission</i> -18-	<b>Oil level in final drive too high and ATF OK:</b> Correct the oil level.  <b>Oil level in final drive is clearly too high and ATF too low:</b> Replace double clutch transmission, see ⇒ <i>Workshop Manual '373419 Removing and installing double clutch transmission'</i> .
-----------------------------------	----------------------------------------------------------------------------------------------------------------------------------------------------------------------------------------------------------------------------------------------------------------------------------------

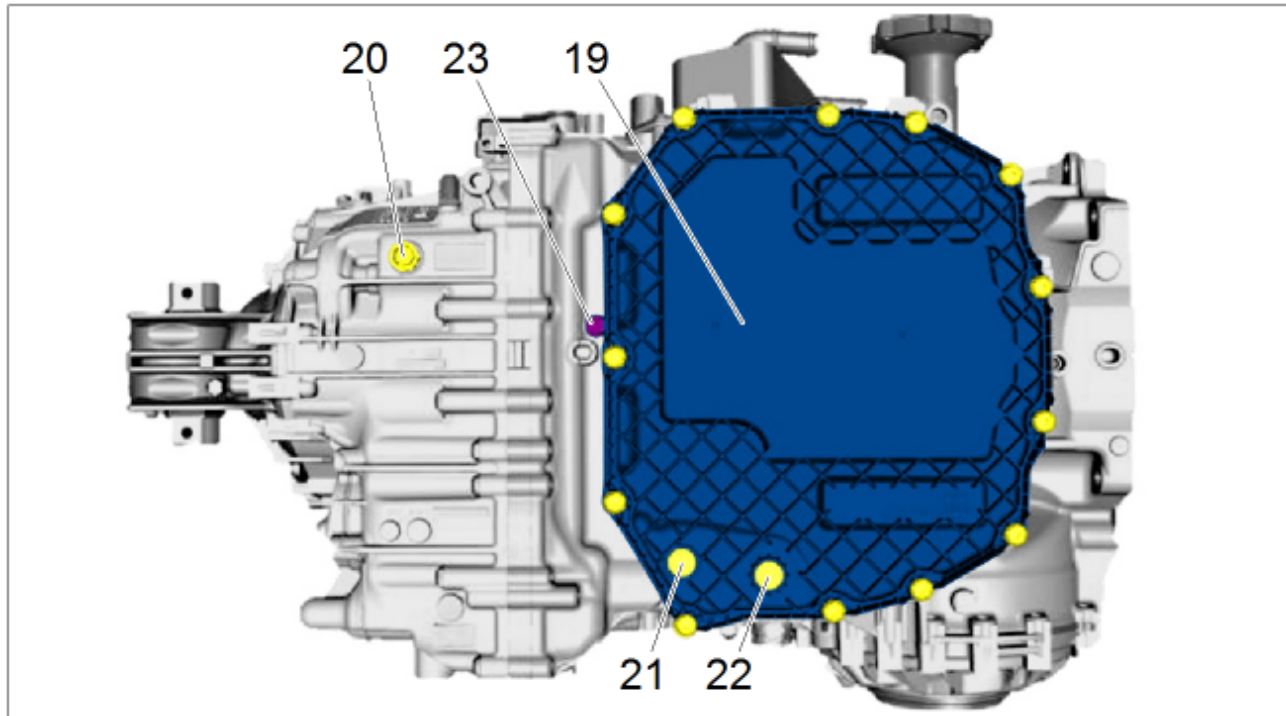
Position	Oil leak	Cause	Repair measure
⇒ Lower side of transmission -19-	ATF pan 19A - 19C	Screw loose (A)	Replace ATF pan, see ⇒ <i>Workshop Manual '375519 Removing and installing ATF pan'</i> .
		Seal damaged (B)	
		Traces of oil after opening the hydraulic chamber (C)	Clean the ATF pan.
⇒ Lower side of transmission -20-	Screw plug 20A - 20B	Screw loose (A)	Replace screw, see ⇒ <i>Workshop Manual '399035 Checking and topping up oil for final drive (PDK gear-wheel oil)'</i> .
		Sealing ring damaged (B)	
⇒ Lower side of transmission -21-	Screw plug 21A - 21B	Screw loose (A)	Replace screw, see ⇒ <i>Workshop Manual '370235 Checking and topping up ATF'</i> .
		Sealing ring damaged (B)

⇒ Lower side of transmission -22-	Oil drain plug 22A - 22B	Screw loose (A)	Replace screw, see ⇒ <i>Workshop Manual '370255 Changing ATF'</i> .
		Sealing ring damaged (B)	
⇒ Lower side of transmission -23-	Oil chamber partition	Shaft sealing ring damaged	Replace double clutch transmission, see ⇒ <i>Workshop Manual '373419 Removing and installing double clutch transmission'</i> .

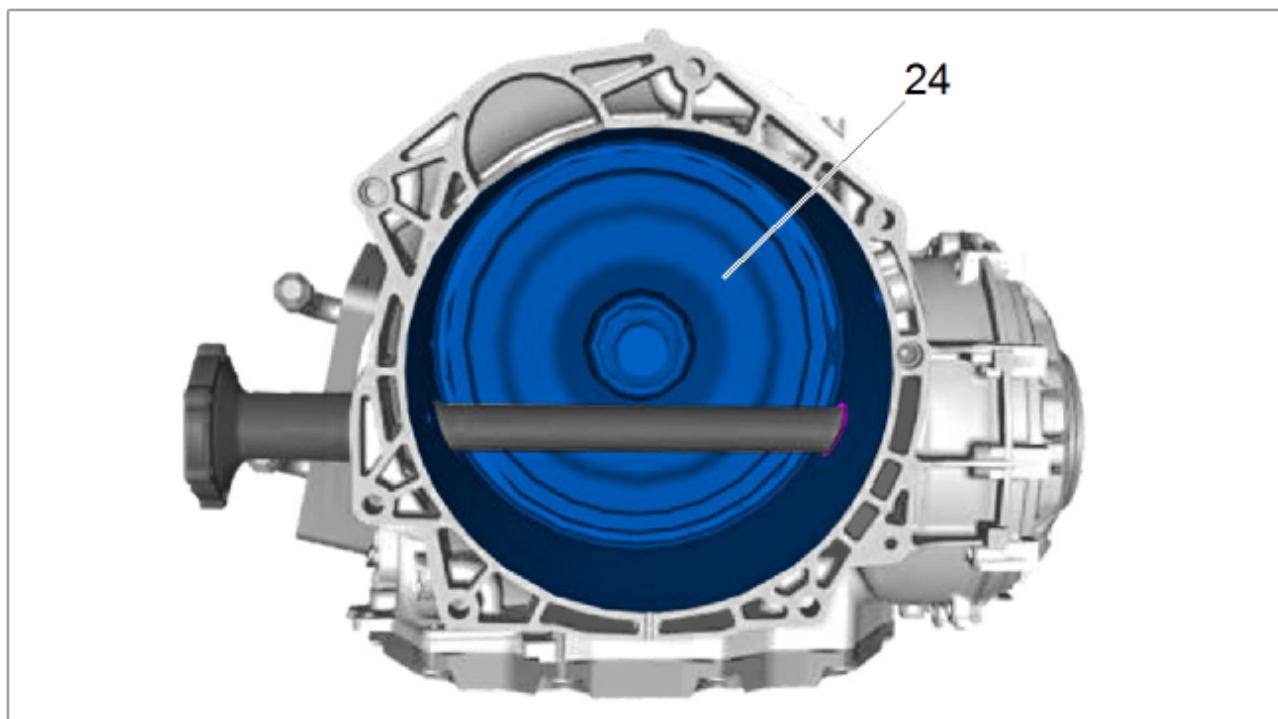
Position	Oil leak	Cause	Repair measure
⇒ Rear side of transmission -24-	Clutch bell-housing 24A - 24E	O-ring on clutch cover damaged (A)	Replace double clutch transmission, see ⇒ Workshop Manual '373419 Removing and installing double clutch transmission'.
		Intermediate shaft sealing ring damaged (B)	Replace sealing ring, see ⇒ Workshop Manual '386955 Replacing radial shaft seal'.
		Engine leaking (C)	Find oil leaks and fix them.
		Apparent preservative grease leak (D)	No action required.
		Flanged-shaft sealing ring damaged (E)	Replace sealing ring, see ⇒ Workshop Manual '391555 Replacing flanged-shaft sealing ring'.

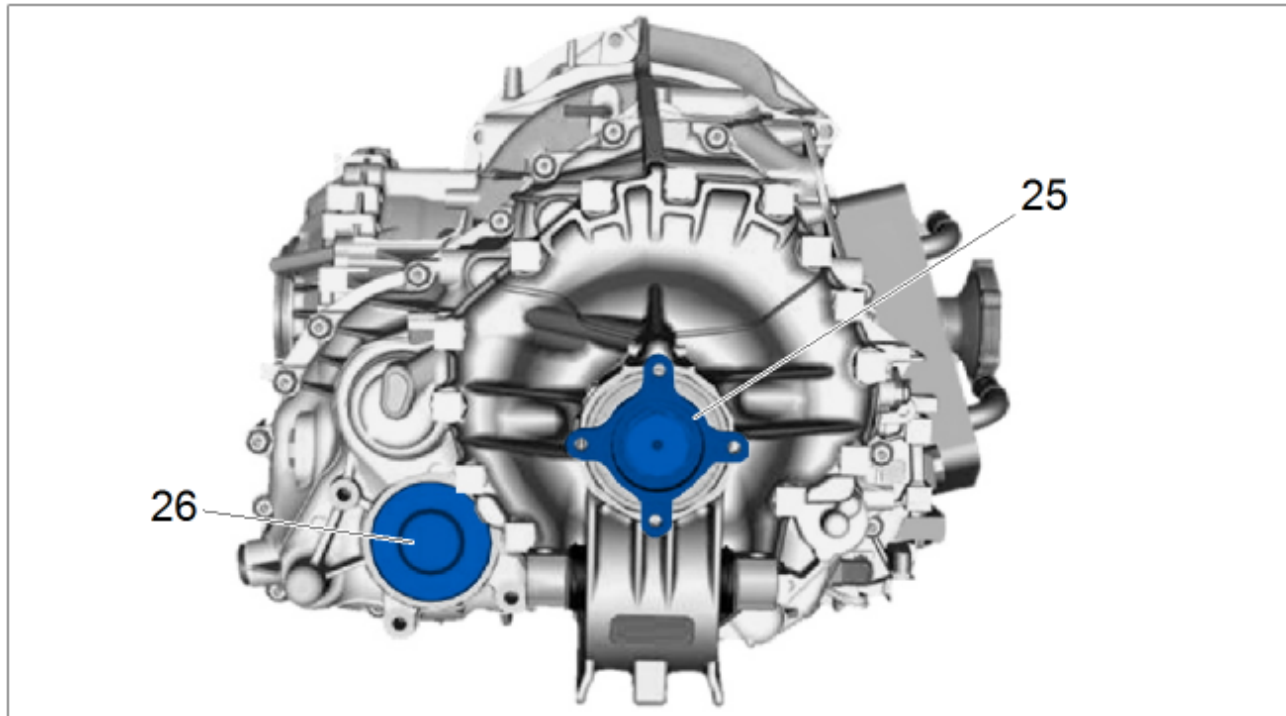
Position	Oil leak	Cause	Repair measure
⇒ Front side of transmission -25-	Output flange 25A - 25B	Sealing ring damaged (A)	Replace sealing ring and output flange, see ⇒ Workshop Manual '398255 Replacing cardan flange sealing ring'.
		Output flange leaking (B)	
⇒ Front side of transmission -26-	Cap	Cover damaged	Replace cover, see ⇒ Workshop Manual '374955 Replacing cover'.
