TECHNICAL SERVICE BULLETIN

RA23-003

DIAGNOSING REAR FINAL DRIVE ASSEMBLY LEAKS

APPLIED VEHICLES: 2016-2024 Titan (A61)
2016-2024 Titan XD (A61)

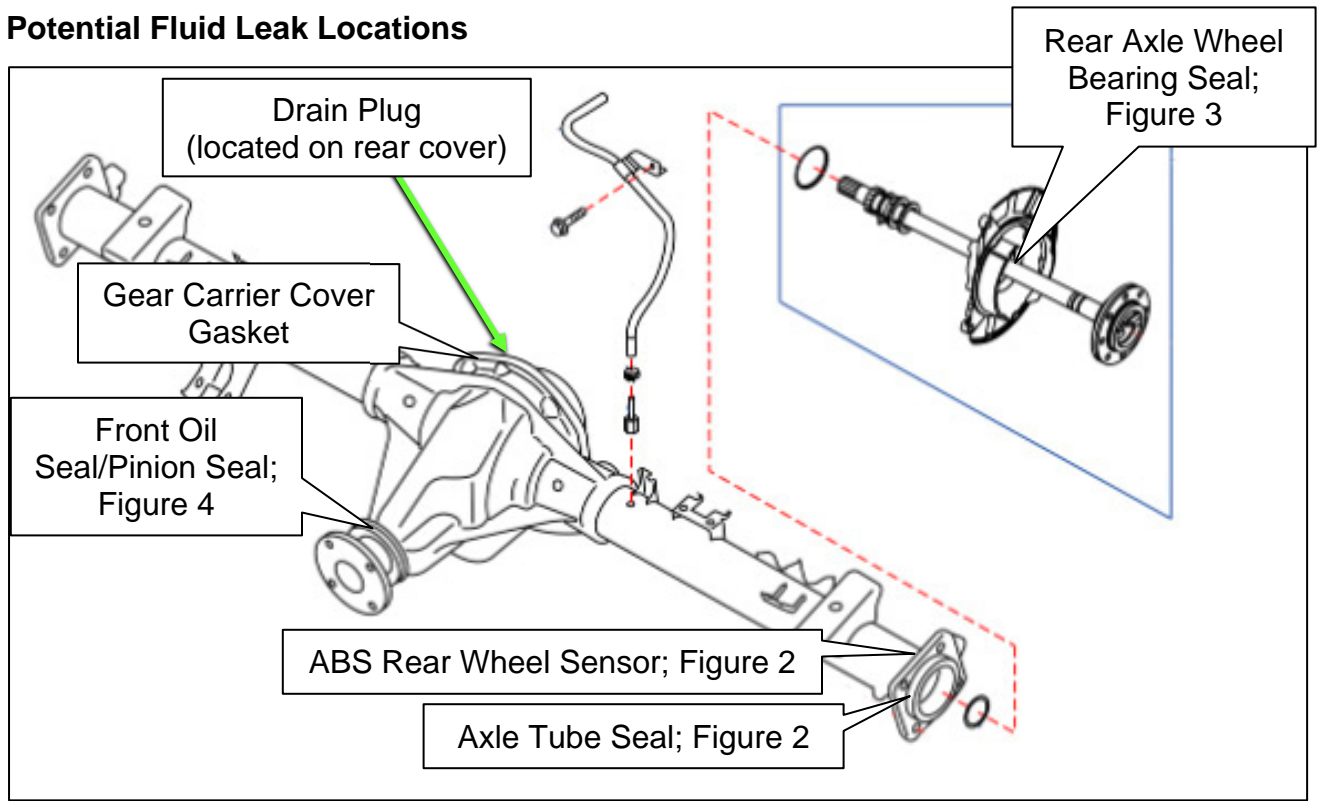
Figure 1

Axle Tube Seal Fluid Leak

- A fluid leak can occur at the flange where the internal axle assembly mounts to the axle tube. This is a single O-ring on the Titan, and an O-ring and Tube Seal on the Titan XD.

HINT: Make sure to clean the groove and take care during installation to not damage the seal(s).

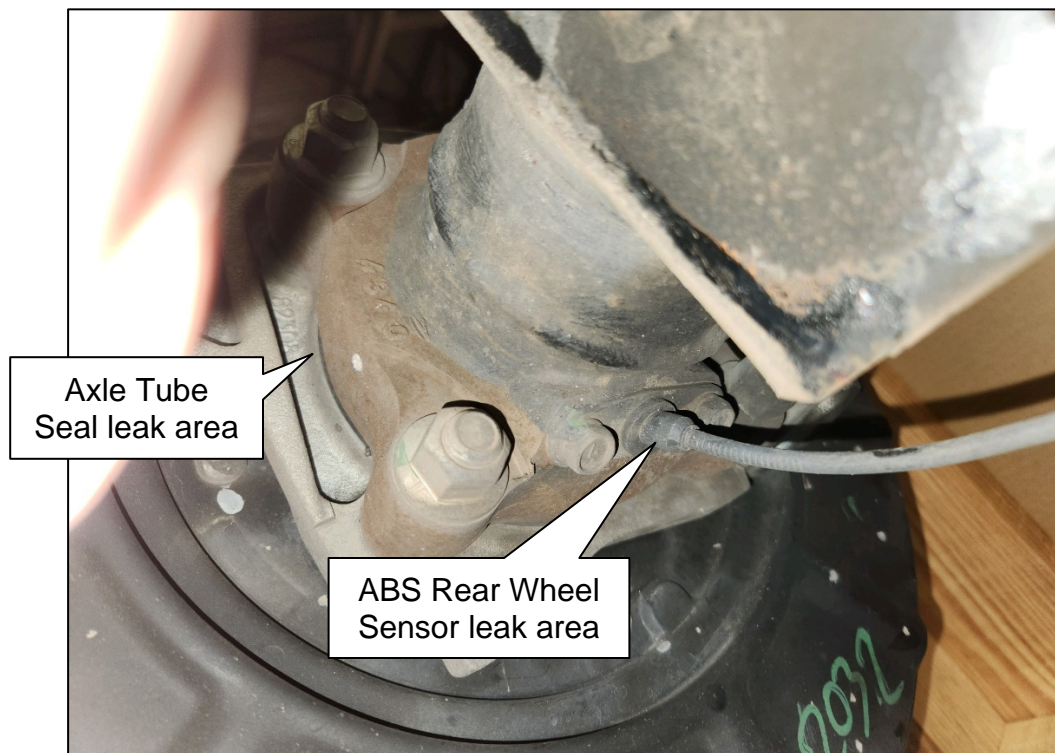
Figure 2

ABS Rear Wheel Sensor Fluid Leak

- If an ABS Rear Wheel Sensor body is cracked for any reason, or its O-ring damaged, a leak can occur.

HINT: Replace the ABS Rear Wheel Sensor and clean the sealing surface well.

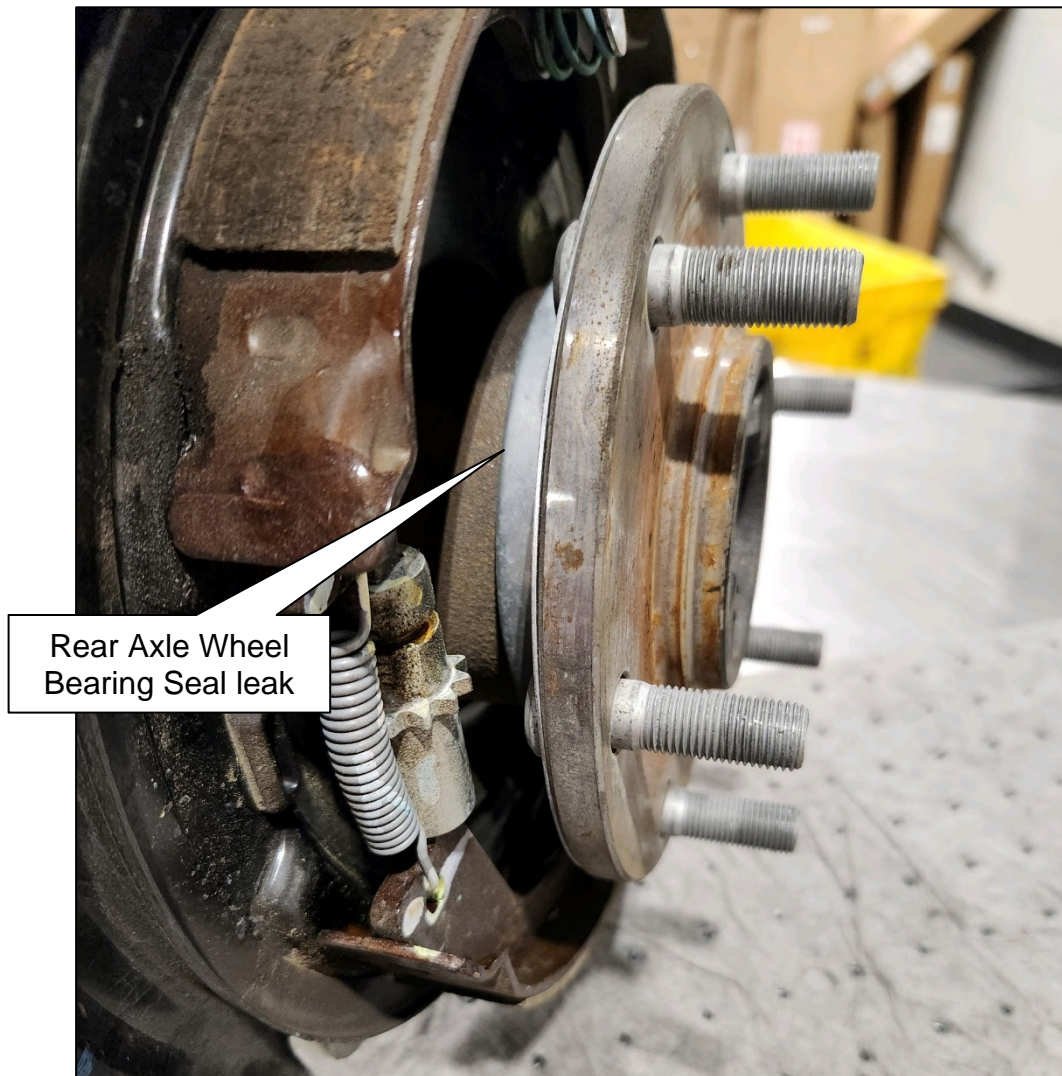
Figure 3

Rear Axle Wheel Bearing Seal Fluid Leak

- If a Rear Axle Wheel Bearing's seal is damaged for any reason, a fluid leak will appear behind the brake rotor, at the outer surface of the wheel/bearing hub assembly.

HINT: If this type of leak occurs, the Axle Shaft Assembly including the O-ring and, if applicable, the tube seal must be replaced.

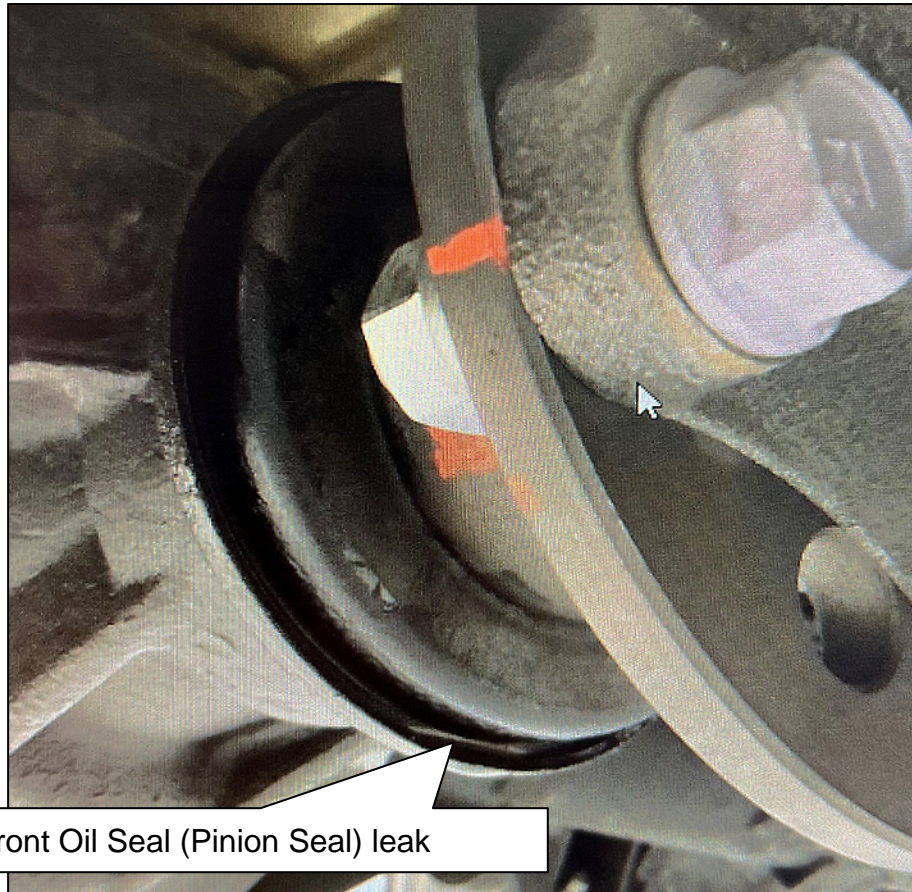
Figure 4

Front Oil Seal Fluid Leak (Pinion Seal)
