PIP5819B VT40 Transmission Setting DTC P2714

Product Investigation Review Required

Brand:	Model:	Model Years:	VIN:		Engine:	Transmissions:
			from	to		
Buick	Encore GX	2020 - 2023	All	All	All	VT40 CVT Automatic (MRG)
Chevrolet	Malibu	2019 - 2023	All	All	All	VT40 CVT Automatic (MRG)
Chevrolet	Trailblazer	2021 - 2023	All	All	All	VT40 CVT Automatic (MRG)

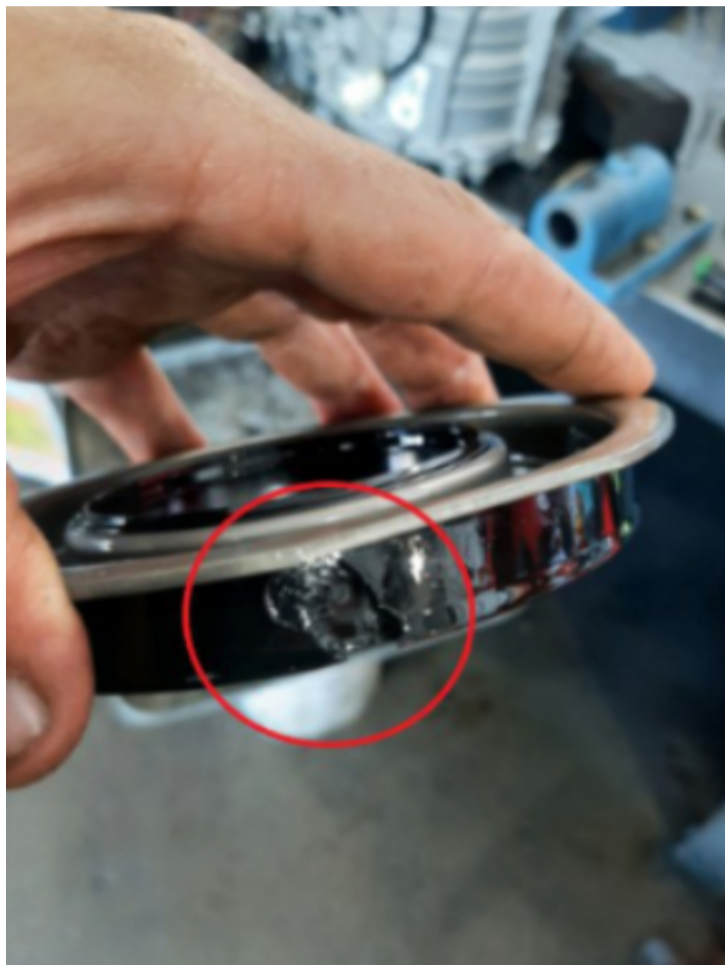
With the transmission disassembled, inspect the Forward Clutch Piston for damage along the side as shown.

If the Forward clutches are worn and there is damage seen to the Forward Clutch Piston then replace the Forward Clutch Piston and Housing and the applicable apply components as needed

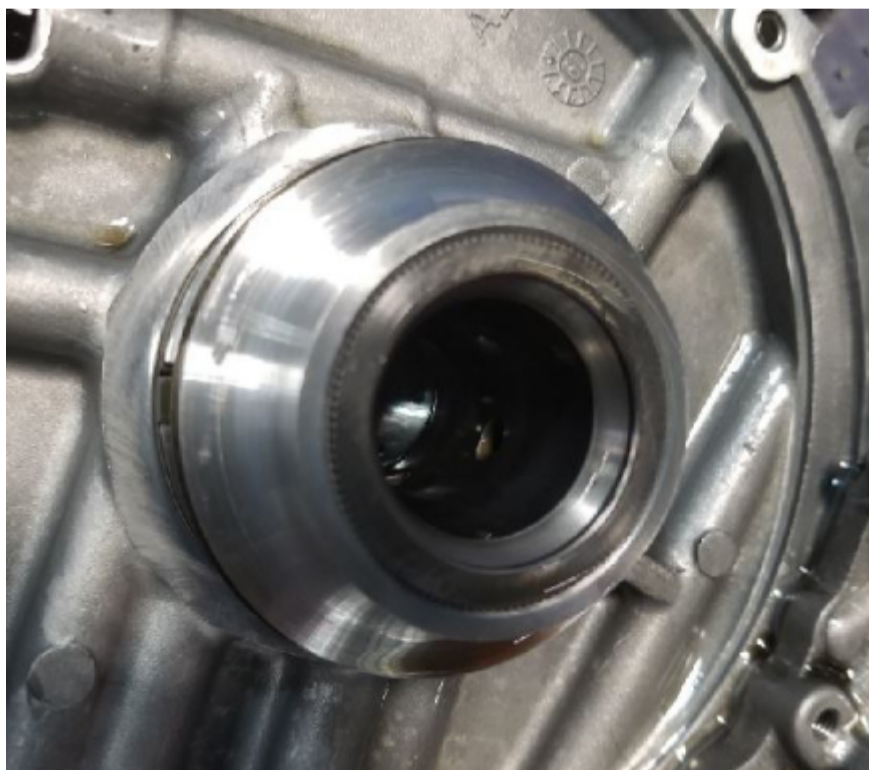
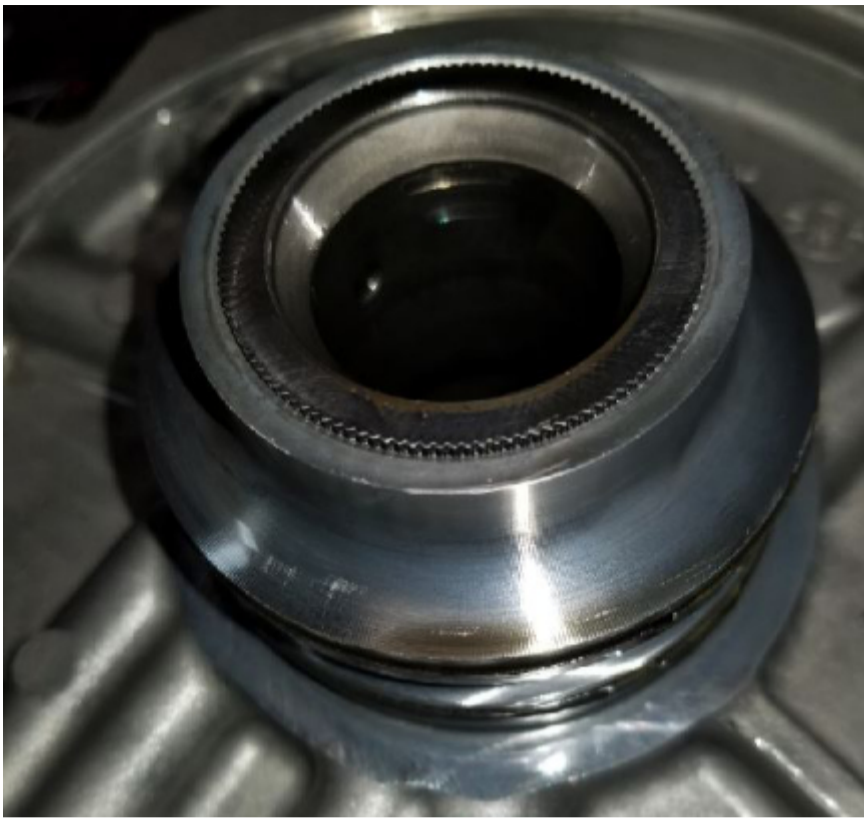
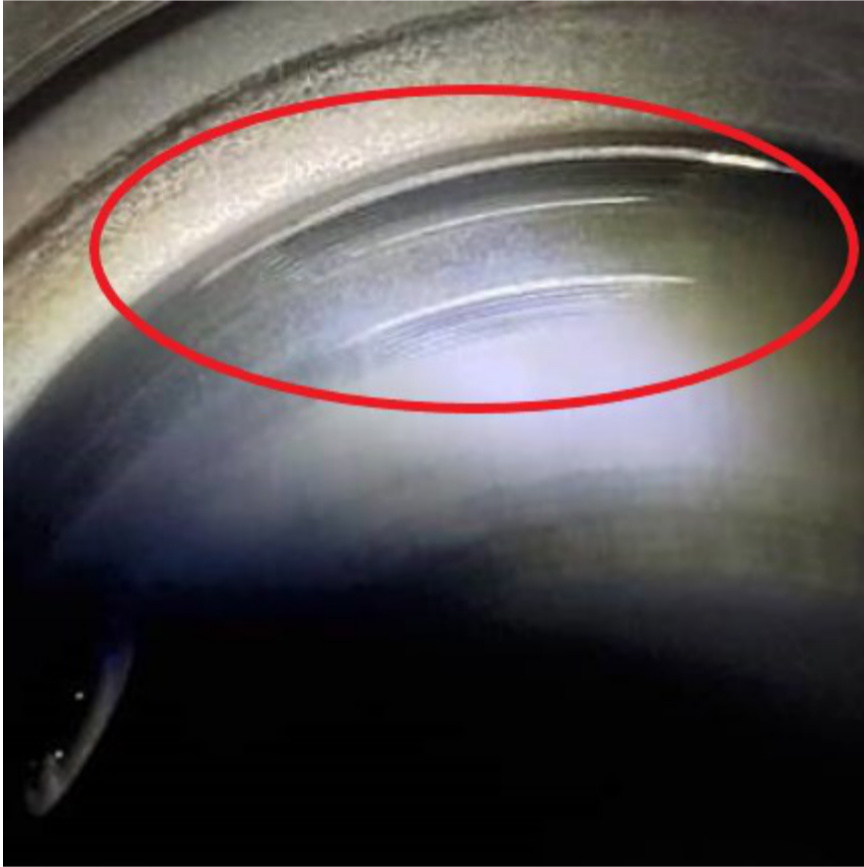
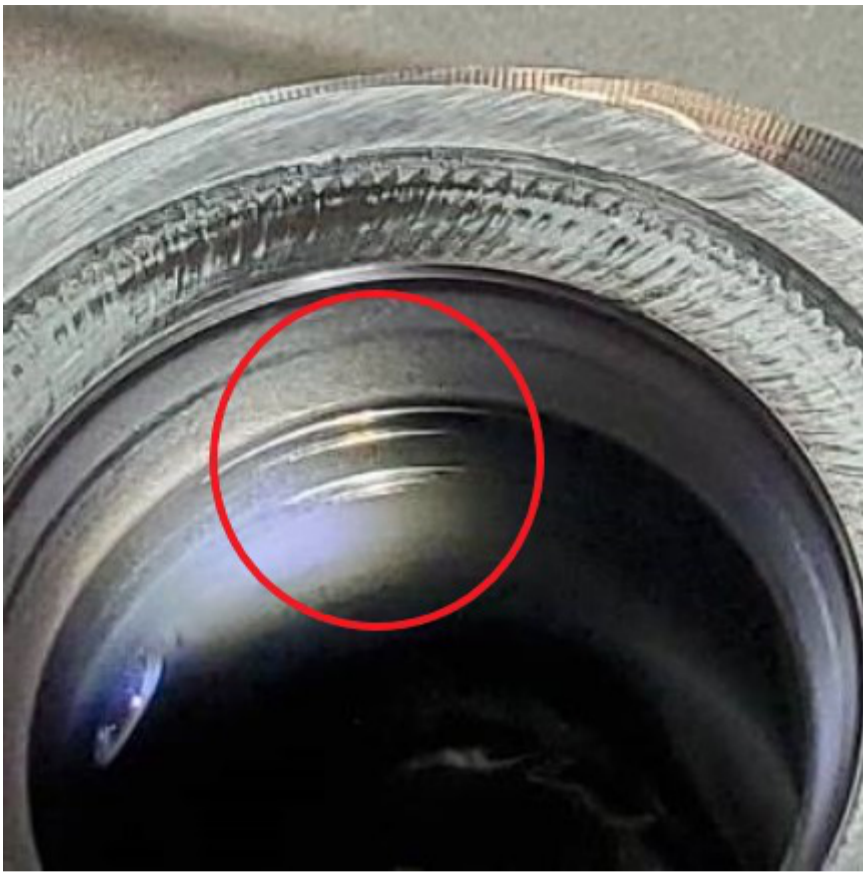
Note: The first 2 pictures show the outside of the pump, and the second 2 pictures show the wear that is found internal to the pump when wear to the Primary Pulley Bearing Bore is found .

If signs of wear are seen as shown, this indicates the Primary Pulley Bearing has spun in the bore and is allowing the Turbine Shaft to become off center. When this happens, it causes a pressure leak.

If this concern is found, the transmission will need to be replaced.
