Service Bulletin

Bulletin No.: 15-NA-051

Subject: No Start Condition - Seat Bracket Contacting Rear Electrical Center (REC)

Brand:	Model:	Model Year:		VIN:		Engine:	Transmission:
		from	to	from	to		
Buick	Lucerne	2008	2011			All	All

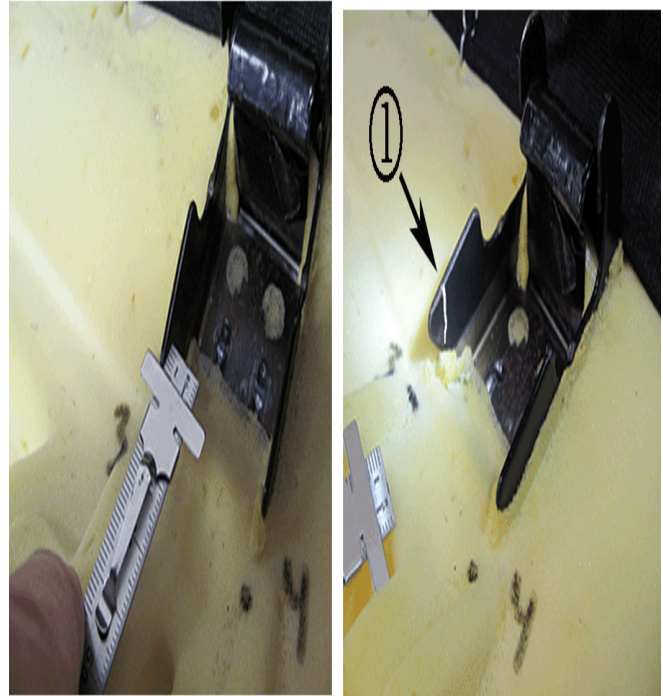
4294546

Condition	Some customers may comment on a no-start or stalling condition.
Cause	The rear seat bottom frame may come into contact with the rear electrical center (REC) cover. The contact/interface results in varying amounts of deflection of the fuel pump relay (FPR). The movement of the FPR causes potential wear of the male terminals on the FPR.

1. Open the rear door and remove the rear seat bottom cushion.
2. Disconnect the battery.
3. Remove the fuel pump relay from the rear body fuse block and discard. Refer to Relay Replacement (within an Electrical Center).
4. Install the new low profile fuel pump relay to the rear body fuse block and install the cover.
5. Connect the battery.
