Service Bulletin

Bulletin No.: 05500

Subject: 05500 — IGNITION DISTRIBUTOR SYSTEM CORROSION – INSPECT / REPLACE

Models: 2001-2003 CHEVROLET SILVERADO
2001-2003 GMC SIERRA
EQUIPPED WITH 4.3L V6 (RPO L35 - VIN W or RPO LU3 – VIN X) ENGINE

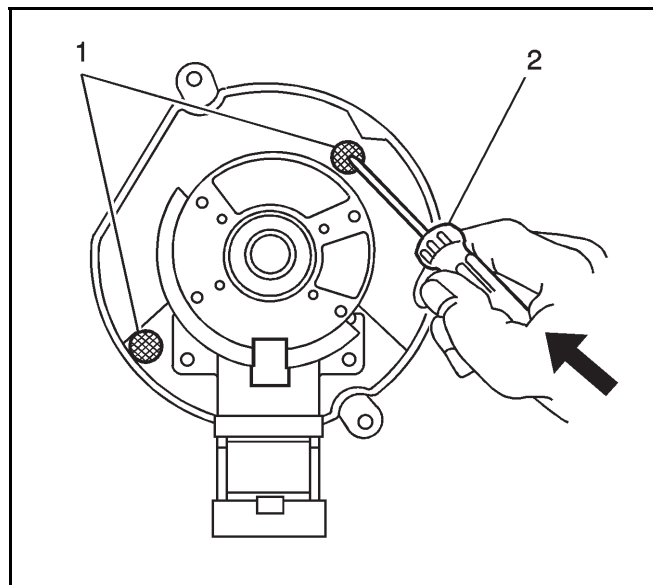
1580849

General Motors has decided to conduct a Voluntary Emission Recall involving **certain** 2001-03 Chevrolet Silverado and GMC Sierra model vehicles, equipped with a 4.3L V6 (RPO L35 – VIN W or RPO LU3 - VIN X) engine. The ignition distributor cap and rotor in these vehicles may corrode and cause ignition system failure. This condition may result in rough engine idle, misfire, stalls, engine cranks but does not run and/or illumination of the Malfunction Indicator Lamp (MIL).

3. Remove the vent screens (1), located in the base of the distributor, by inserting a plastic-handled, long blade awl or pick (2) into each of the two airflow vent holes and popping out the screen. If there are no EIP vent screens in the airflow vent holes, check the vent holes for debris and clear as necessary before reassembling the distributor.
