Service Bulletin

Bulletin No.: 16-NA-010

Subject: Front Strut Shaft Contacting Hood Due to Premature Strut Mount Wear

Brand:	Model:	Model Year:		VIN:		Engine:	Transmission:
Branu.	Wiodei.	from	to	from	to		
Chevrolet	Caprice PPV	2011	2013			All	All

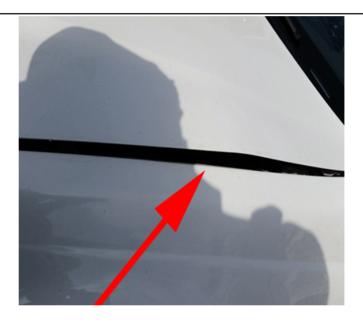
4356278

Some customers may comment that the front strut shaft has come free from the strut mount and made contact with the vehicles hood.

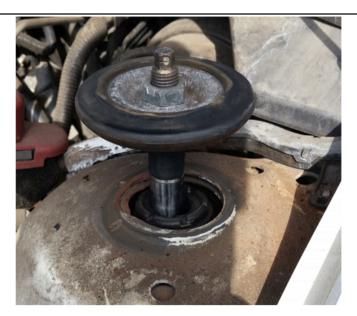
4356276

This may be caused by premature wear within the front strut mount.
