Technical product information

Bentayga EWB - New Flying Spur and New Continental GT Speed

Warnings within the DIP for the rear steering system - DTC B200096 and/or P060700 evident within diagnostic address 00CB

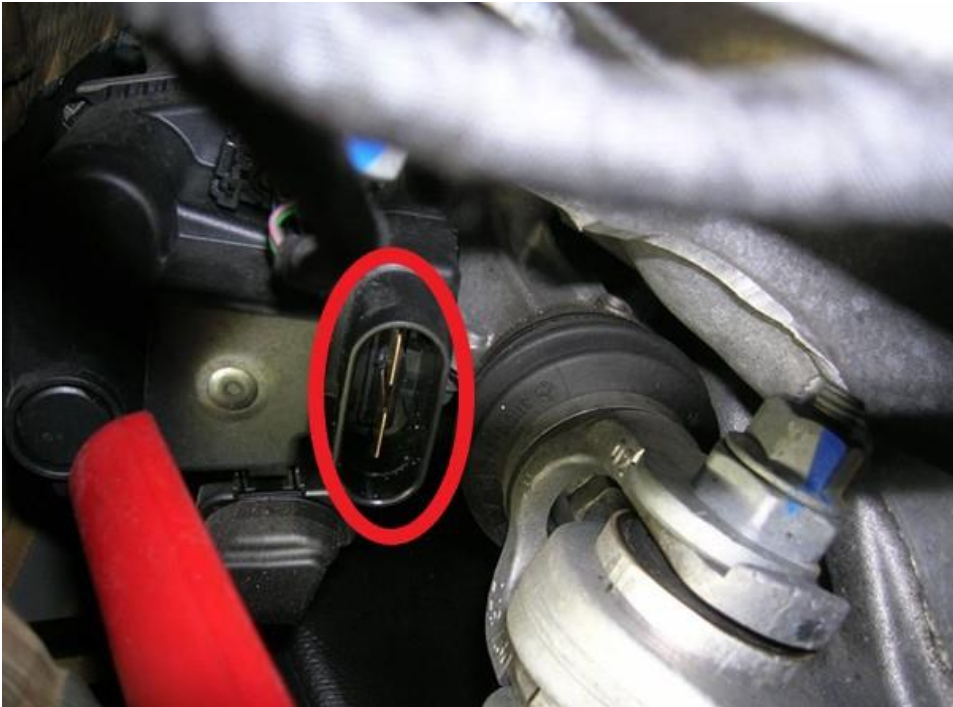
Figure 1

2) Referring to the applicable wiring diagram, conduct an electrical integrity check for the rear wheel steering control unit /J1019 (rear steering rack) in particular the 2-way 12V plug and connector (see the example shown in Figure 1) for any signs of corrosion or water damage

- Refer to the applicable wiring diagram - Check all applicable earth points of J1019 for Cleanliness, security and integrity - Rectify as applicable and retest to confirm if the DTC's are still evident
- If no faults were identified after conducting the wiring integrity checks the operative should confirm no faults were found and attach a current ODIS log to a new or existing DISS query
- The operative must await feedback from the new or existing DISS query before conducting any further work
