Service Bulletin

Bulletin No.: 22-NA-132

Subject: Information on Service Front Lift System Message on Driver Information Center (DIC), Fluid Leaking from Shocks - DTC C103C or C11AB and/or C103E or C11AE Set

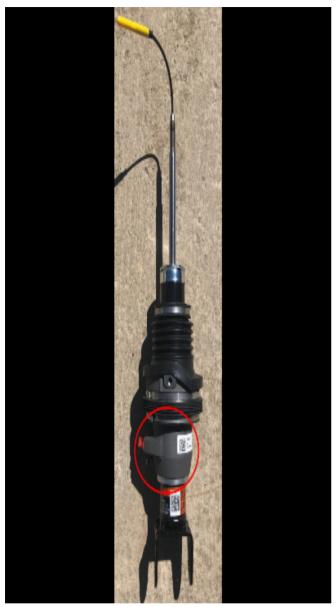
6101077

OEM Shock

- · Bright colored spacer under lift actuator.
- · Label under the lift actuator is fully exposed.

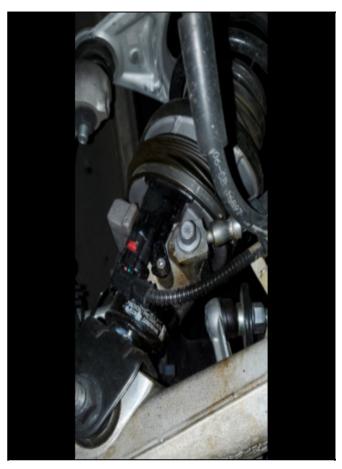
6101078

| Involved Region or Country | North America, Europe, Middle East, Japan, Australia/New Zealand | | | |
|---|--|--|--|--|
| Cause | This condition may be caused by the spacers on the shocks being removed. | | | |

Modified Shock with Spacer Removed

- Missing spacer under lift actuator.
- Label under lift actuator is no longer fully visible.

| Involved Region or Country | North America, Europe, Middle East, Japan, Australia/New Zealand | | | |
|---|--|--|--|--|
| Information | Before any diagnosis of the front lift system takes place, the front shocks should be inspected to confirm they have not been modified. The E60 front lift system shocks should not be modified to lower the vehicle in any way. Lowering the lift actuator may cause internal damage to the part. Repairs to the front lift system after the shocks modification should NOT be submitted a a warranty repair. Damage to suspension components caused by modifying vehicle height outside of factory settings will not be covered by the vehicle warranty. | | | |

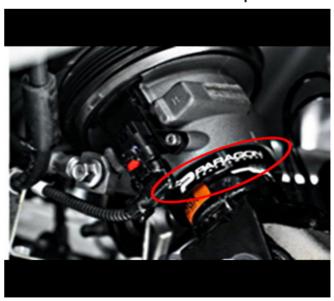
6101079

Modified Shock with Aftermarket Spacer

- Spacer under lift actuator may be black or have a supplier's name on the part.
- · Label under lift actuator is not fully visible.
