Service Bulletin

Bulletin No.: 21-NA-049

Subject: Diagnostic Aid – PicoScope Information and Setup for Transmission Related Concerns

Brand:	Model:	Model Year:		VIN:		Engine:	Transmission:
		from	to	from	to		
Chevrolet	Corvette	2020	2024	—	—	All	All

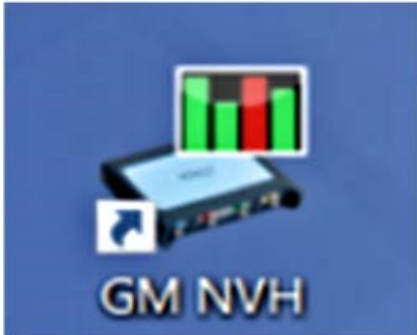
5751815

2. Open the most current version of GM NVH.

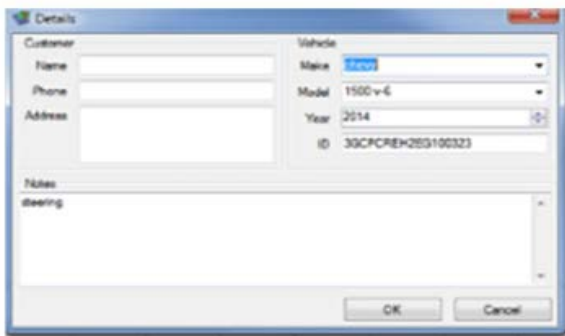
5751820

5. While the reviewed file is on the screen, click File Save. It should be formatted as .pddata
