GROUP	MODEL
ELE	2022MY EV6 (CV)
NUMBER	DATE
276 (Rev 3, 02/08/2023)	December 2022

TECHNICAL SERVICE BULLETIN

SERVICE ACTION: EXTERNAL AMP REPLACEMENT FOR NOISE/NO SOUND ISSUES (SA520)

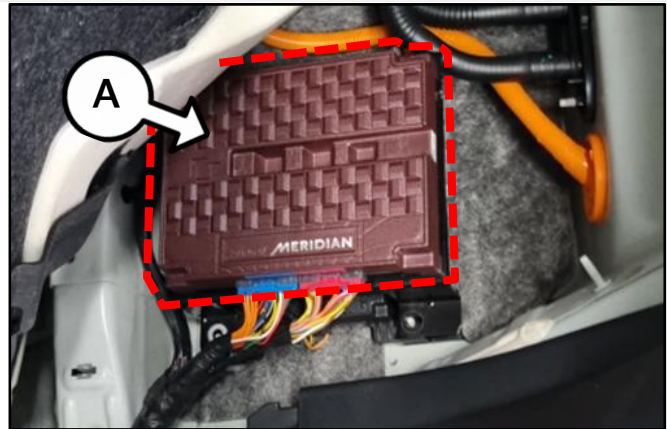
This bulletin provides the procedure to replace the external amplifier on some 2022MY EV6 (CV) vehicles produced from November 17, 2021 through January 7, 2022, that may exhibit symptoms of "noise", "no sound", "intermittent noise", and/or "intermittent no sound". Follow the procedure outlined in this publication to replace the external amplifier. If the vehicle does not exhibit the symptoms, the external amplifier still needs to be replaced if it is included in the list of affected VINs. Before conducting the procedure, verify that the vehicle is included in the list of affected VINs.

1. Replace the External AMP (A) by referring to "Body Electrical System → Audio/AVNT System → External AMP → Removal and Installation" in the applicable Shop Manual on KGIS.
