Service Bulletin

Bulletin No.: 24-NA-026

Subject: Convertible Top Water Leak Around Side Glass in High Pressure Car Wash

Brand:	Model:	Model Year:		VIN:		Engine:	Transmission:
		from	to	from	to		
Chevrolet	Corvette	2020	2024	—	—	All	All

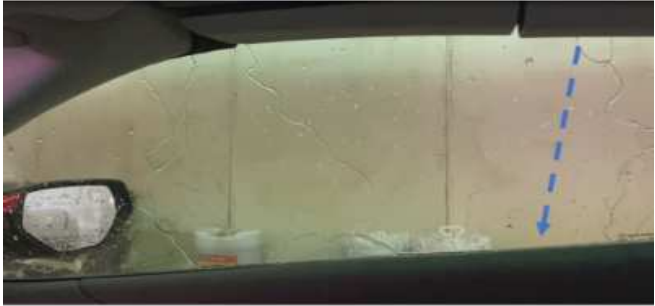
</div> <p style="text-align: right; font-size: small;">6543378</p> <p>Some customers may comment about a water leak from approximately the middle rear of the side glass area during a touch-less or other high pressure car wash.</p>
Cause	The cause of the condition may be due to slight variations in sealing between the roof panel seals.
Correction	Follow the Service Procedure outlined below to correct vehicles that may be experiencing this condition.
