MAS003824\_A RU 24-01

# Rapid Update 663 Grecale – ICS Software Update

DATE: JANUARY 23, 2024

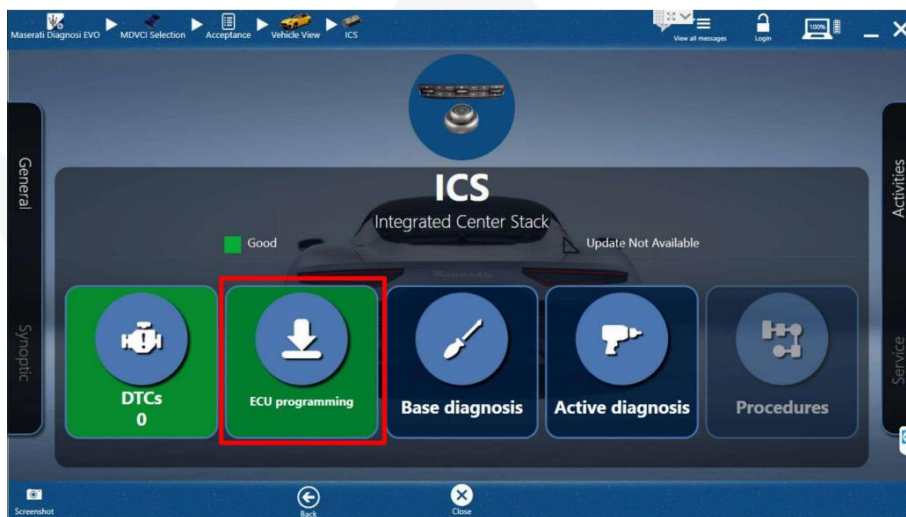
In rare instances, there could be a sensitivity issue and touch screen malfunction associated with the ICS module. This update is necessary to enhance the sensitivity of the touch screen.

1. Always check ModisCS+ to see if the vehicle is involved in this action and if it has not been previously performed.
2. Before proceeding, please ensure that the Engine is OFF.
3. Connect a battery maintainer to the 12V battery (It is recommended to always use the E-XTEQ MAXIMUS to maintain minimum voltage and current draw requirements)
4. Connect the EVO to the vehicle, ensure that battery voltage is around 12.5V then select **ICS** ► **ECU Programming** and follow the prompts.

*Software version to be installed (or newer)*

SW Source	Market	F188 Source	SW Target	F188 Target
5.6	ROW	670297896	<b>5.8</b>	<b>673015759</b>
6.2	ROW	670299122	<b>6.3</b>	<b>673015761</b>
