Technical Service Bulletin

00 Car wash brush bristles trapped in headlight to fender seam

00 12 40 2031473/1 October 31, 2012.

Model(s)	Year	VIN Range	Vehicle-Specific Equipment
A6	2012 - 2015	All	Not applicable
A7	2012 - 2015	All

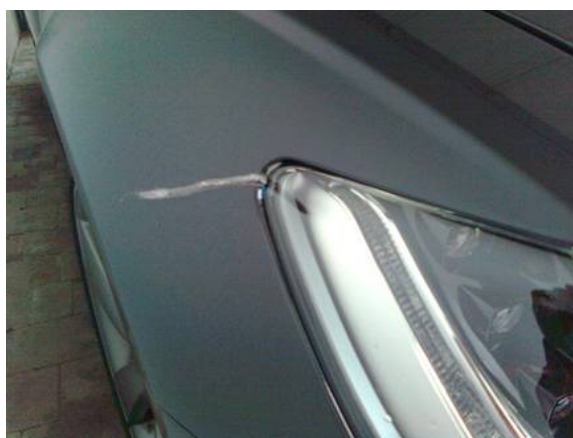
Bristles from car wash are discovered between headlight and front fender (Figure 1).

Figure 1. Car wash bristle stuck in body gap.

The vehicle design in the area around the headlights has a gap that, when the vehicle is washed in car washes having a particular bristle angle and type, can trap these bristles in this area, tear away from the mechanism and lodge in the gap between the headlight and fender.

Remove the bristle fragments from the headlight. Please explain the cause to the customer and suggest that they change the car wash used.
