GROUP	MODEL
ELE	2020-2024MY Multiple Models w/ AVN5W
NUMBER	DATE
303 (Rev 2, 2/09/2024)	August 2023

TECHNICAL SERVICE BULLETIN

SUBJECT: **AVN 5.0 WIDE NON-RESPONSIVE RADIO ICON (AM, FM, SXM)**

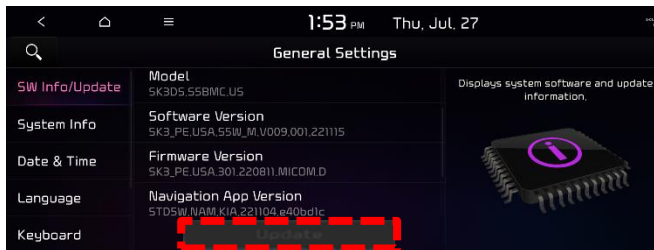
Note: If the USB Flash Drive is not recognized, the 'Update' button will not be activated, as shown. If this occurs, remove the USB Flash Drive and repeat steps 3-7.
