Service Bulletin

Bulletin No.: 16-NA-003

Subject: Chirp, Squeak Noise from Rear of Vehicle

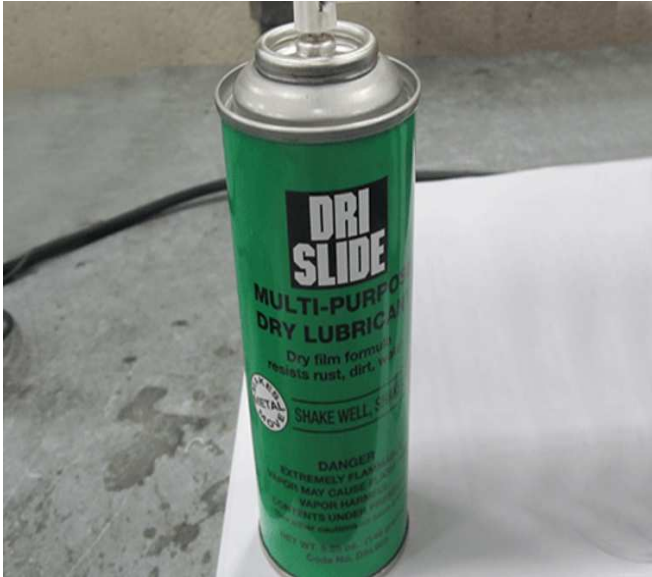
4340714

Additional Option (RPOs)	Chevrolet – Equipped with LT4 Engine, LGX Engine / NPP Exhaust, LT1 Engine / N10 Exhaust or LT1 Engine / NPP Exhaust Cadillac – Equipped with LF4 or LT4 Engine
Condition	Some customers may comment on hearing a squeak or chirp noise coming from the rear of the vehicle. The noise may be reported as being intermittent.
Cause	The noise may be caused by the opening/closing of the exhaust valves during normal performance.

Important: Regardless the noisy valve location, lubricate ALL exhaust valves on the system. Generously lubricate the forward, and rear if equipped, exhaust valves following the steps below:
