Technical Service Bulletin

48 Steering column adjustment does not work

48 24 60 2073033/1 February 19, 2024.

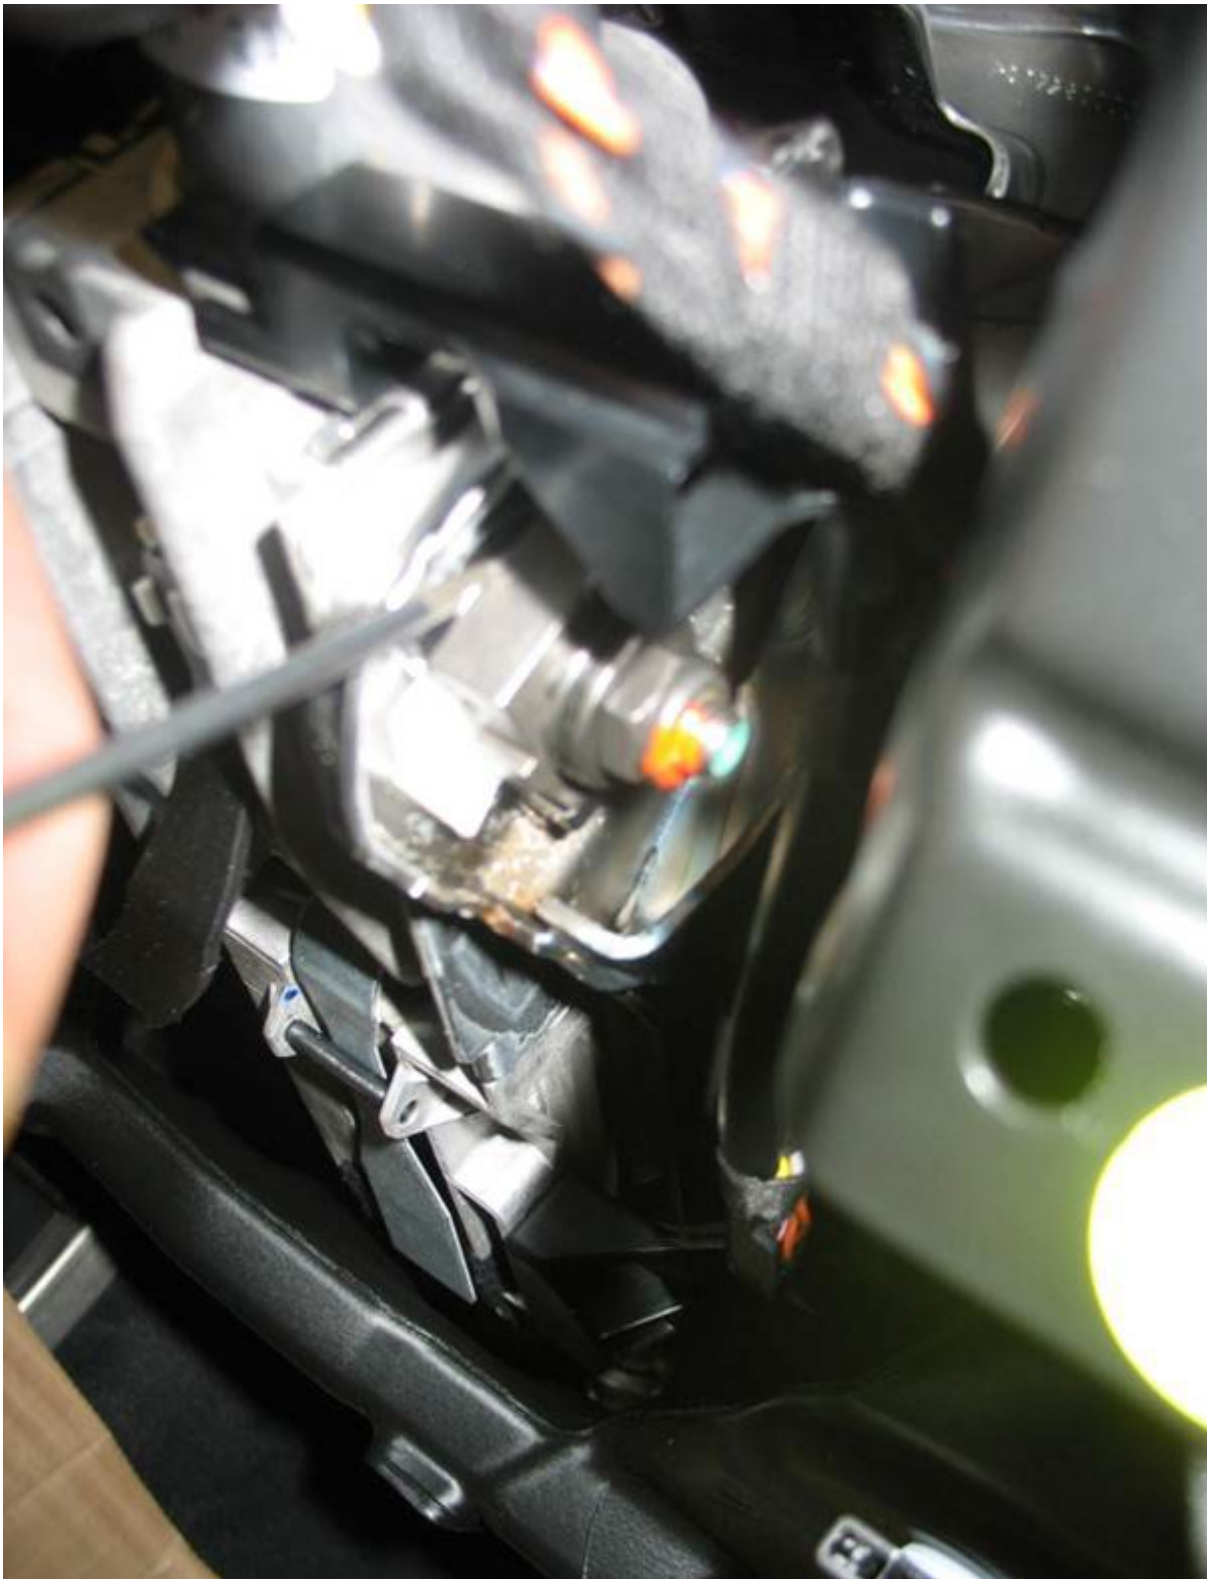
The wedge disk can become stuck due to external influences, thereby blocking steering column adjustment.

Figure 1: Steering column/wedge disk.

Release the lever of the steering column adjustment and loosen the wedge disk (Figure 1) with a screwdriver.

If this is not possible, replace the steering column.
