Technical Service Bulletin

48 Creaking or squeaking noises from steering column (sealing boot)

48 24 61 2034351/10 February 19, 2024. Supersedes Technical Service Bulletin Group 48 number 19-82 dated October 9, 2019 for reasons listed below.

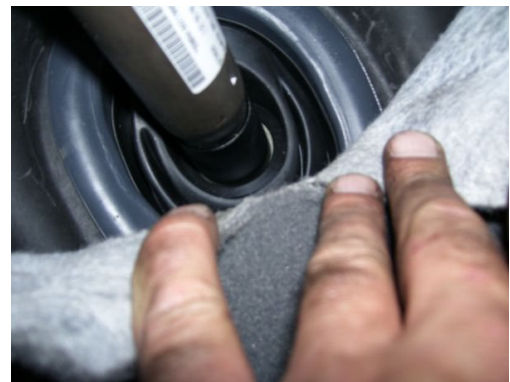
- There is a squeaking noise from the steering column when steering slowly. The noise can be duplicated while the vehicle is stationary if the steering wheel is turned slowly. The noise may get louder at higher temperatures or when the vehicle is driven for longer periods of time.
- The noise comes from the sealing sleeve/steering column opening on the bulkhead.

Insufficient lubrication of the intermediate steering shaft in the area of the sealing sleeve.

Figure 2. The sealing sleeve on the bulkhead.

1. Check the sealing sleeve for proper installation and fit (Figure 2).
2. To eliminate the noise, loosen the upper bolted connection of the steering intermediate shaft and the steering column. Pull the intermediate steering shaft out about 4 in (10 cm) and spray the special lubricant spray (**G052172M2**) in the area of the bearing ring and the black plastic sleeve. Push it in and pull it out a few times to distribute the spray on the intermediate steering shaft.

Do not lubricate the u-joints of the steering shaft.

3. Retighten the shaft with a new bolt on the steering column.
4. If the noise persists, replace the intermediate steering shaft.
