Technical Service Bulletin

55 Power rear lid not closing fully, rear lid lock not engaging secondary latch position, DTC B113E29, B12E015, B113E07

55 24 91 2064476/3 February 19, 2024. Supersedes Technical Service Bulletin Group 55 number 21-60 dated September 30, 2021 for reasons listed below.

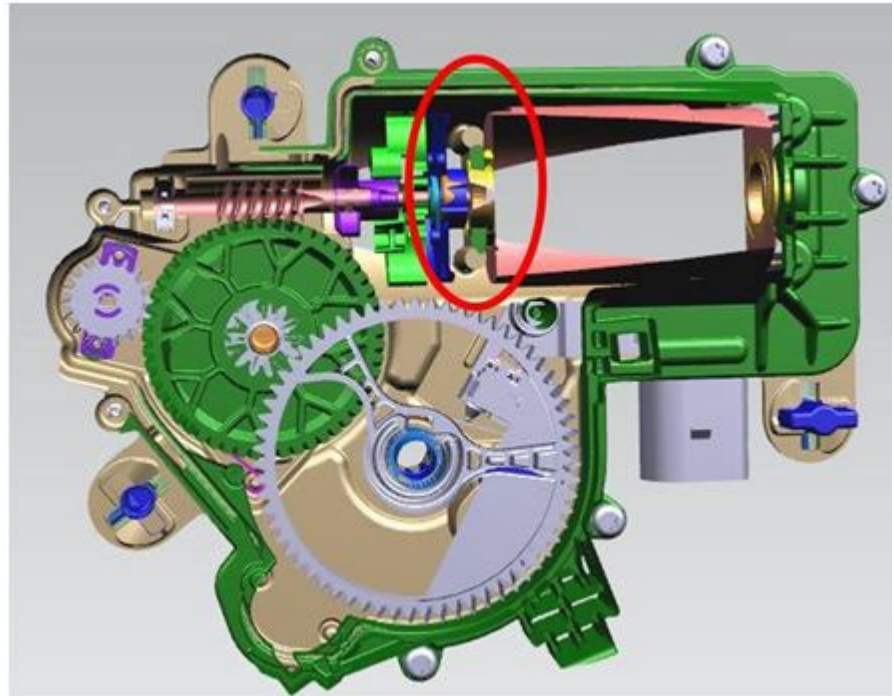
1. The internal clutch of the closing assist motor can be blocked due to a dimensional deviation. This failure mode could cause DTC B113E07 to store (Figure 1).

Figure 1. Blocked clutch due to a dimensional deviation.

Replace the rear lid closing assist motor according to the Elsa Repair Manual.

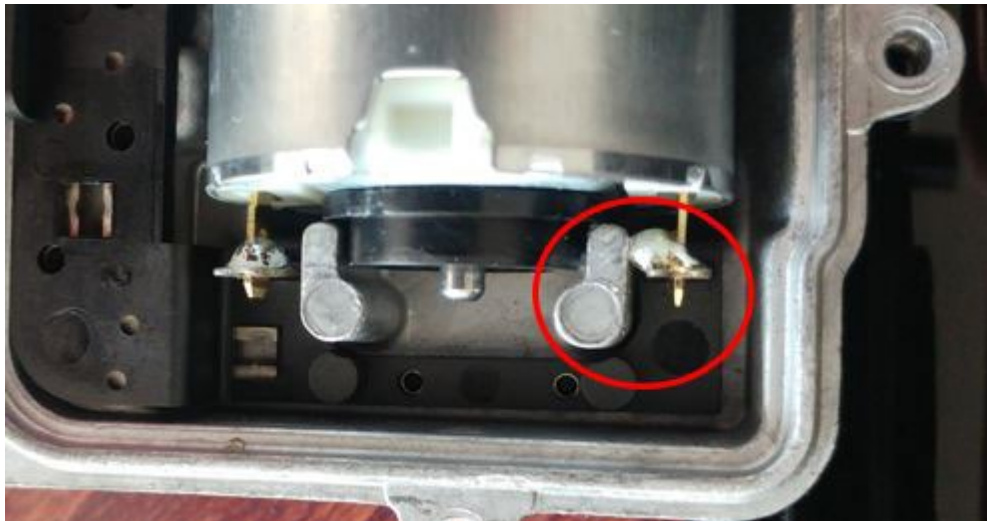
2. An improper solder joint inside the closing assist motor can cause a short circuit. This failure mode could cause DTC B12E015 to store (Figure 2).

Figure 2. Short circuit caused by solder joint.

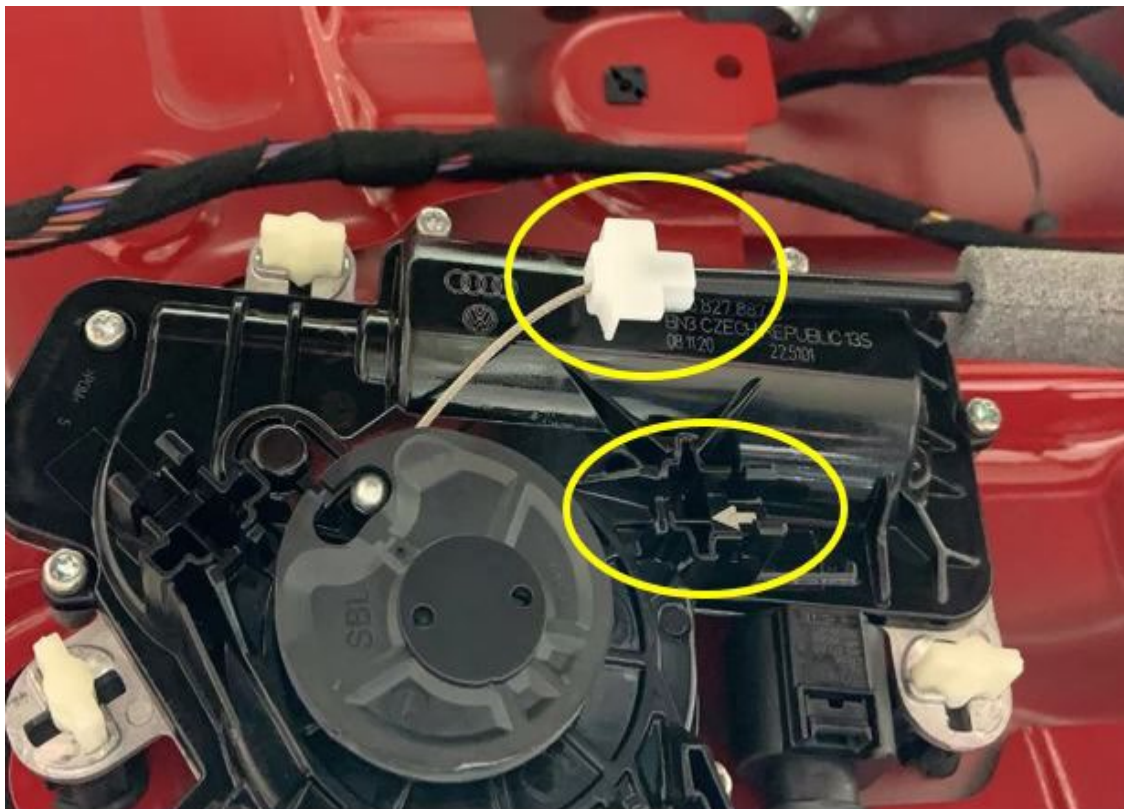
3. The Bowden cable clip has detached from the closing assist motor housing. This failure mode could also cause DTC B113E07 to store (Figure 3).

Figure 3. Detached Bowden cable clip.
