Service Bulletin

Bulletin No.: 22-NA-007

Subject: Poor Engine Performance in Extremely Cold Weather Conditions for LE2 Engines, Charge Air Cooler (CAC) Icing - Malfunction Indicator Lamp (MIL) Illuminated, DTC P0299, P0234, P0236, P2227, P00C7 Set

Brand:	Model:	Model Year:		VIN:		Engine:	Transmission:
		from	to	from	to		
Chevrolet	Cruze	2016	2019	—	—	1.4L Turbo (LE2)	—

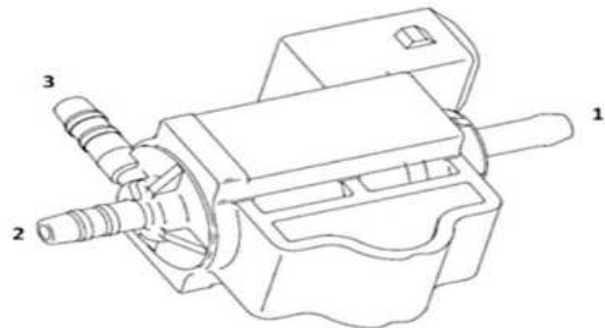
6055068

Note: Check port #2 to assure the spring gets lifted off the seat. This will be determined by the compressed air not dead heading when applied to port #2. When applying air to this port a small amount of air should be observed at port #3 and even less air will be noticed at port #1. If this does not happen, the TCV plunger may have hardened deposits from hot operating conditions

which will impede TCV plunger movement, and the turbocharger wastegate regulator solenoid valve should be replaced.

3. Using clean shop air regulated to 80-100 PSI, blow through all three ports (1, 2 & 3) for 5 seconds each.

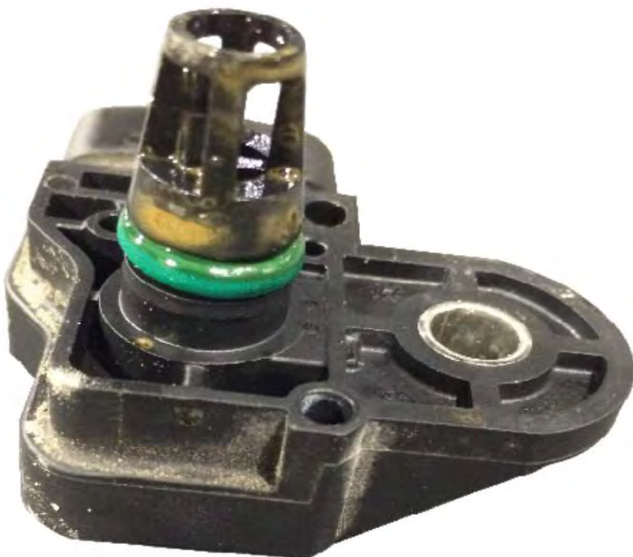
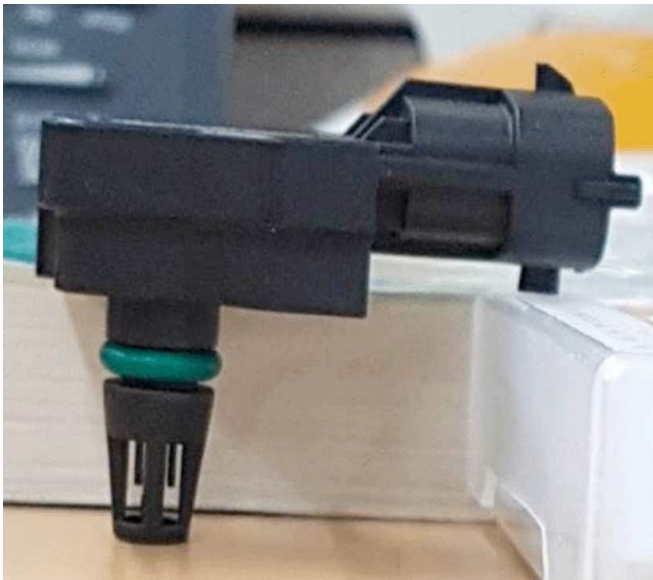
5020216

2. Inspect the sensor for any contaminants.

3. Allow time for any ice build-up to melt by placing the sensor port down.
4. Clean the sensor with a clean towel.
5. Install the sensor. Refer to *Turbocharger/ Supercharger Boost Pressure Sensor Replacement* in SI.
