# Service Bulletin

Bulletin No.: 22-NA-026

**Subject:** Information on Brake Pulsation, Noise and/or Visible Pitting Condition to Brake Rotor Surface

Brand:	Model:	Model Year:		VIN:		Engine:	Transmission:
		from	to	from	to		
Chevrolet	Corvette	2020	2024	—	—	All	All

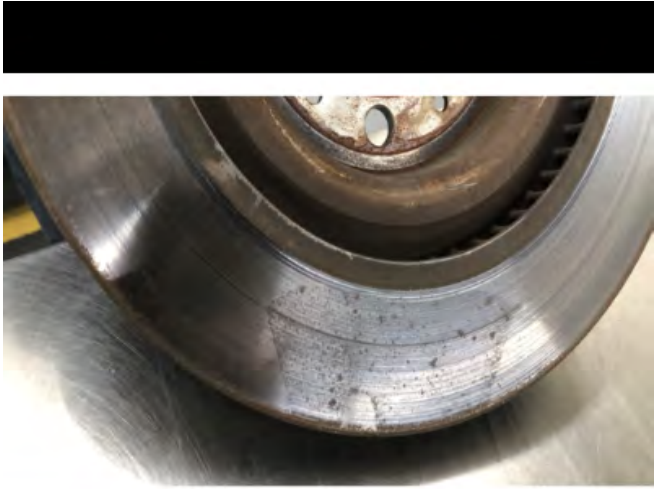
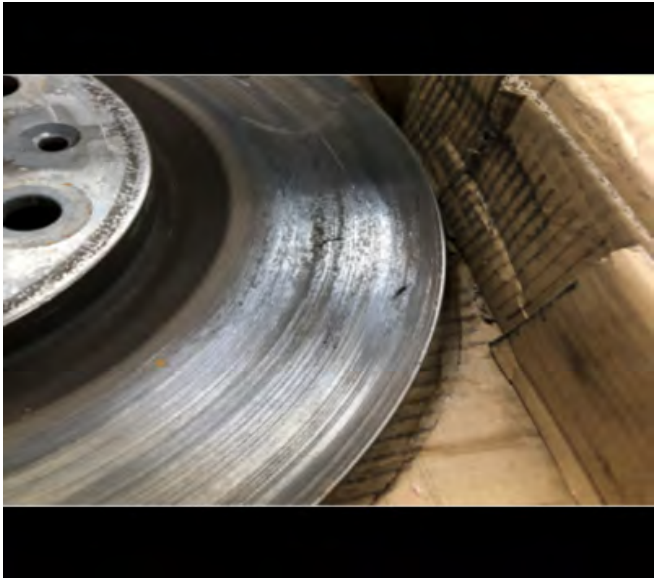
<b>Involved Region or Country</b>	North America, Europe, Middle East, Japan, Australia/New Zealand
<b>Additional Options (RPO's)</b>	Equipped with Performance Brakes (RPO J55 or J56)
<b>Condition</b>	<p><b>Note:</b> This condition may more commonly appear after the vehicle sits for an extended period of time, especially in high humidity.</p> <p>Some customers may comment on feeling a brake pulsation or hearing a noise when applying the brakes. They may also comment on seeing a pitting condition with the brake rotor's surface.</p> <p><u>Following the information below will be helpful with reducing the surface corrosion.</u></p>

<p>5969661</p> <p>5969664</p> <p>The cause of this condition may be corrosion pad spotting and surface grooving on the brake rotor surface.</p>
<p><b>Correction</b></p>	<p>To help restore optimal braking performance and reduce noise, complete the Procedure noted below.</p>

1. The customer or technician should use the Instrument Cluster's DIC performance menu's friction bubble that calls out longitudinal G forces to determine braking forces. Use the Friction Bubble in the DIC display to determine the correct deceleration rates. Apply the brakes 10 times starting at 100 km/h (60 mph) to 50 km/h (30 mph) while decelerating at 0.4g. This a medium brake application. Drive for at least 0.5 km (0.3 mi) between applying the brakes.
2. If further cleanup of the brake discs is needed, repeat this procedure with 0.7g applications.
