# Service Bulletin

Bulletin No.: 22-NA-151

**Subject: DTC P0BBD Diagnosis and Repair**

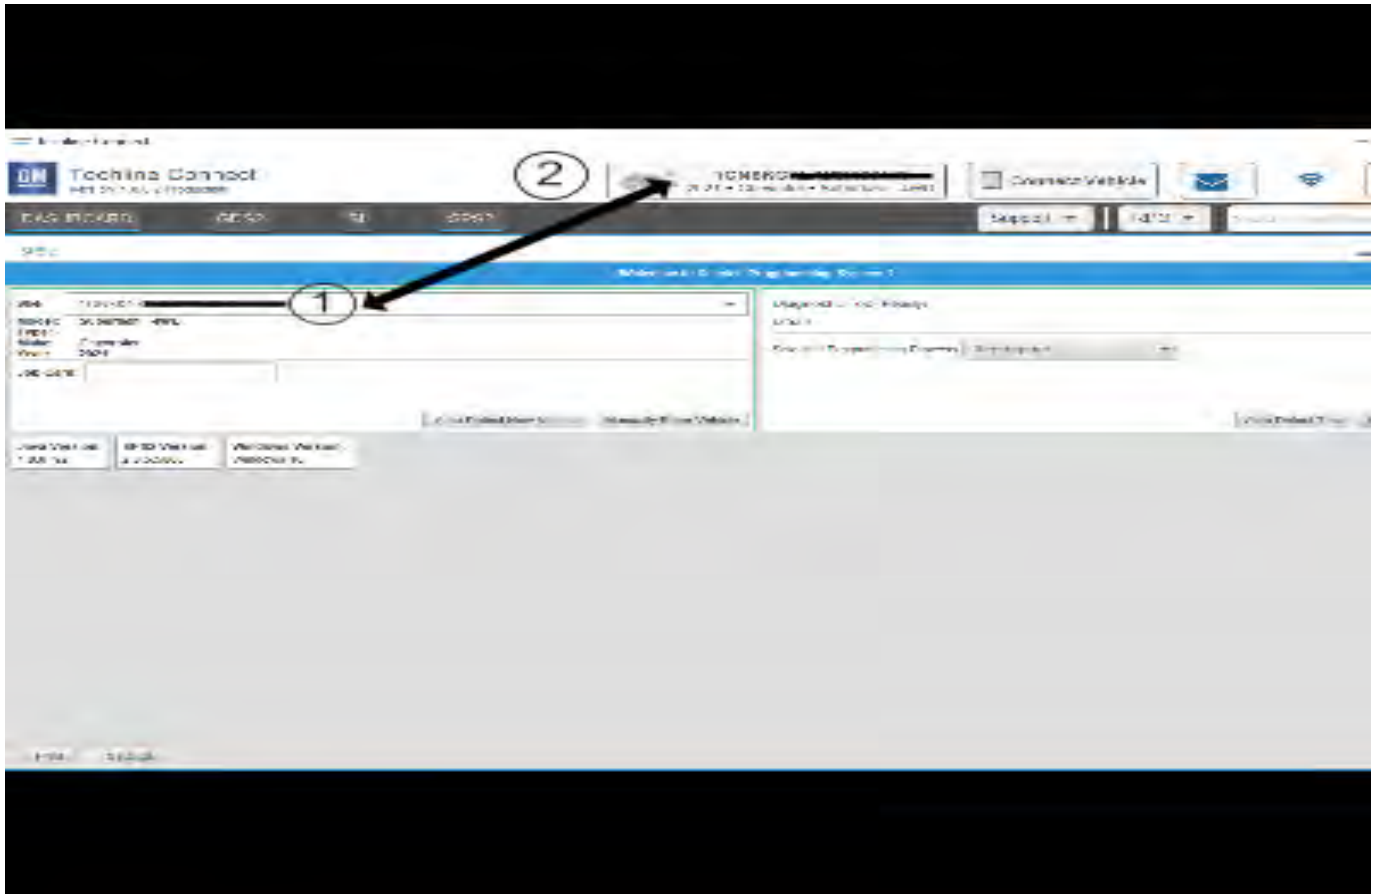
5743643

**Caution:** Be sure the VIN selected in the drop down menu (1) is the same as the vehicle connected (2) before beginning programming.

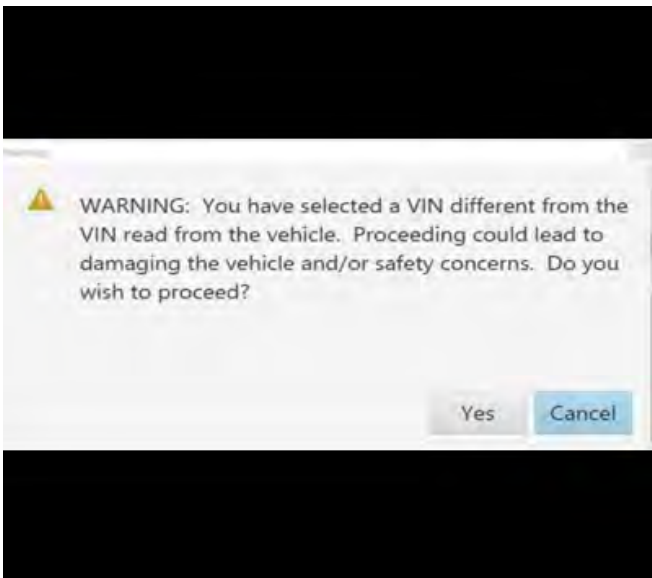
5877000

**Important:** If the vehicle VIN DOES NOT match, the message below will be shown.

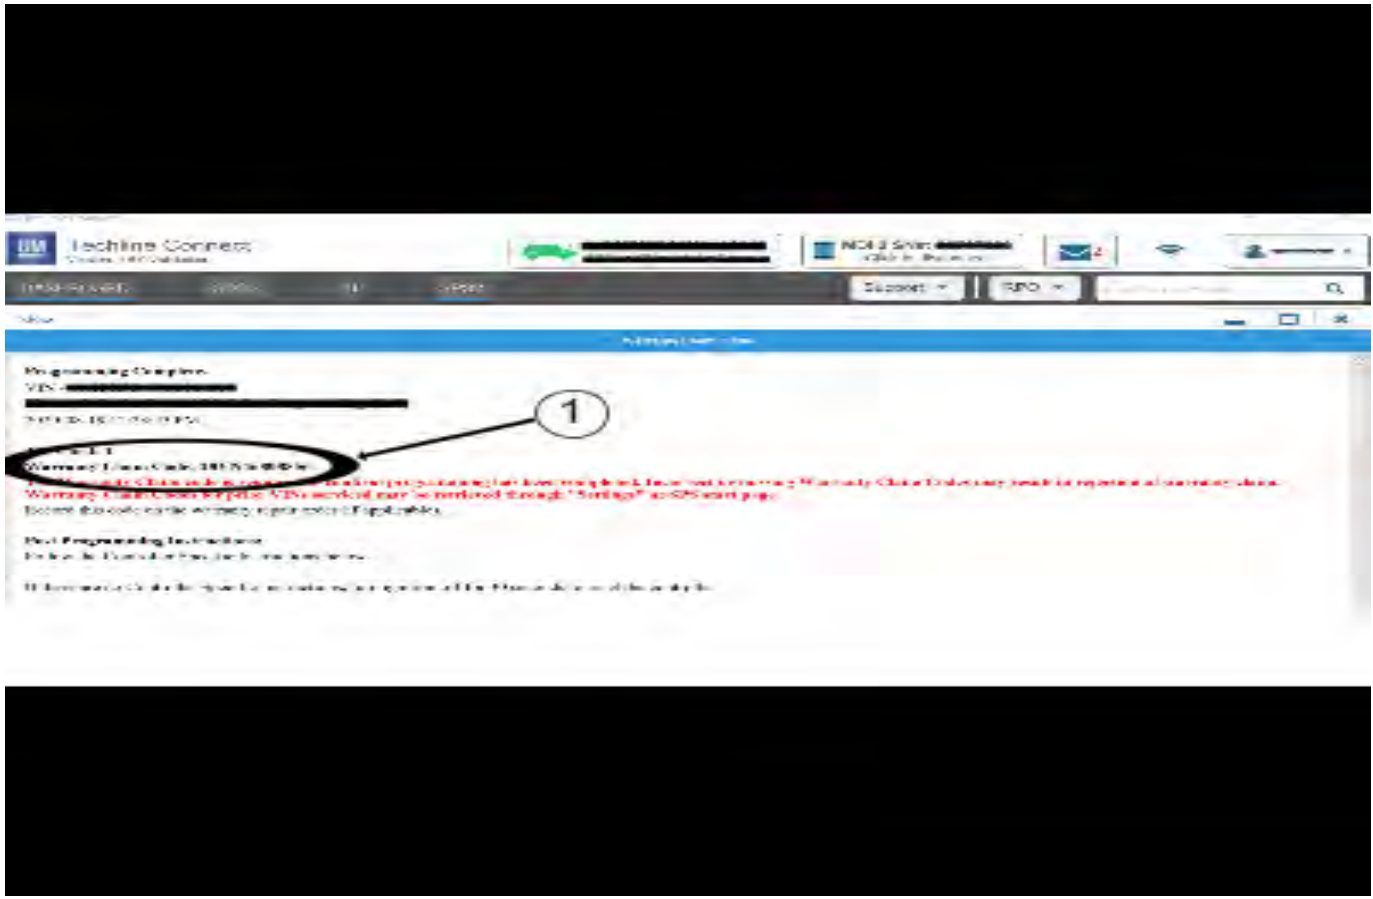
**Note:** The screenshot above is an example of module programming and may not be indicative of the specific module that is being programmed. Module selection and VIN information have been blacked out.

**Important:** To avoid warranty transaction rejections, you **MUST** record the warranty claim code provided on the Warranty Claim Code (WCC) screen shown above on the job card. Refer to callout 1 above for the location of the WCC on the screen.
