Service Bulletin

Bulletin No.: 23-NA-158

Subject: Radio Software Version 170.5.1-M166-SQBR3-187.1 – Multiple Updates for IVD Trucks

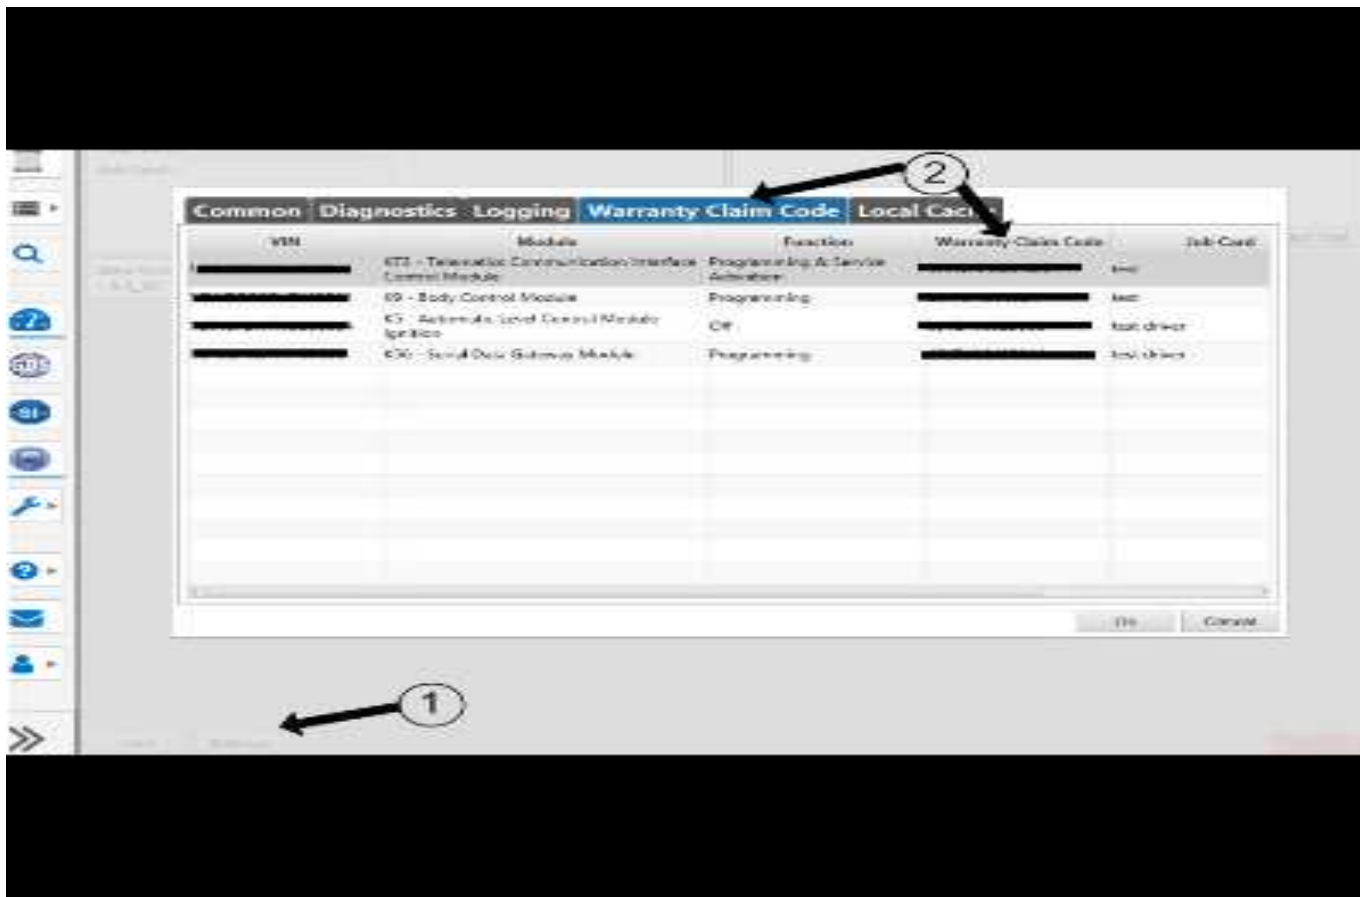
6125774

If the Warranty Claim Code was not recorded on the Job Card, the code can be retrieved in the SPS2 system as follows:

1. Open TLC on the computer used to program the vehicle.
2. Select and start SPS2.
3. Select Settings (1).
4. Select the Warranty Claim Code tab (2).
