**Subject:** Engineering Information - (EI Lite) - (Pictures Only) Second Row Seat is Not Folding, Latching, Seat Binds and/or Difficult to Fold or Open

Brand:	Model:	Model Year:		VIN Breakpoint:		Engine:	Transmission:
		from	to	from	to		
Cadillac	Escalade Models	2023	2024	—	—	—	—
Chevrolet	Suburban	2023	2024	—	—	—	—
	Tahoe						
GMC	Yukon Models

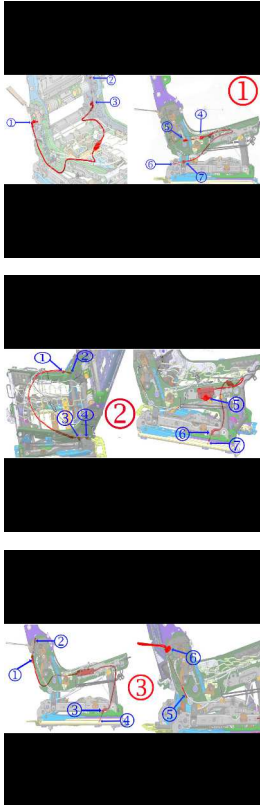
2. Take clear close-up pictures of the concern cable and the location on the seat where it was identified, as shown in the pictures above (1), (2), or (3) in red.
