Technical Service Bulletin

91 MIB2 High: Top view camera setting changes to graphic view intermittently after startup

91 24 79 2053028/5 February 23, 2024. Supersedes Technical Service Bulletin Group 91 number 20-31 dated November 10, 2020 for reasons listed below.

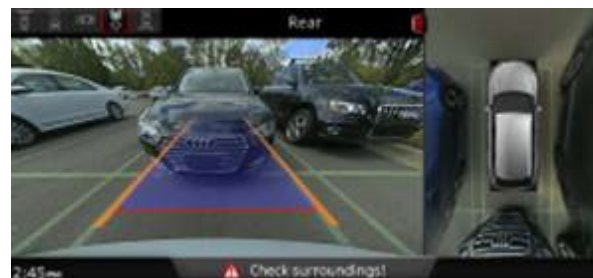
Figure 1. Correct camera view.

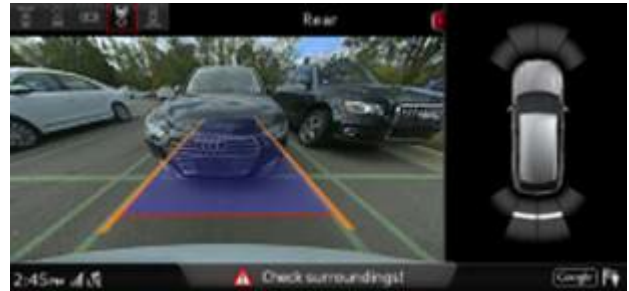
- When the reversing camera is active showing the Top view camera to the right, the display changes intermittently at startup from camera view to graphics view. Compare the images to the right (Figures 1 and 2).

Figure 2. Incorrect graphics view.

The software needs to be updated. The optimized software will correct the view switch.

- Update the MIB2 High infotainment system using either Method 1 or Method 2 according to TSB 2047576: 91 *MIB2 High Software Update Instructions (PR Code 7UG)* and use SVM code MHI2QUS5087.
