From: [Redacted]
Sent: Thursday, February 1, 2024 4:56 PM
To: [Redacted]; [Redacted]@navistar.com; [Redacted]@Navistar.com; [Redacted]@Navistar.com; [Redacted]
Subject: B6.7 EPA24/GHG24 - Oil Pressure Sensor In Range High (FC 435 followed by 143 and 415) Meeting notes

Oil Pressure Sensor In Range High (FC 435 followed by 143 and 415)

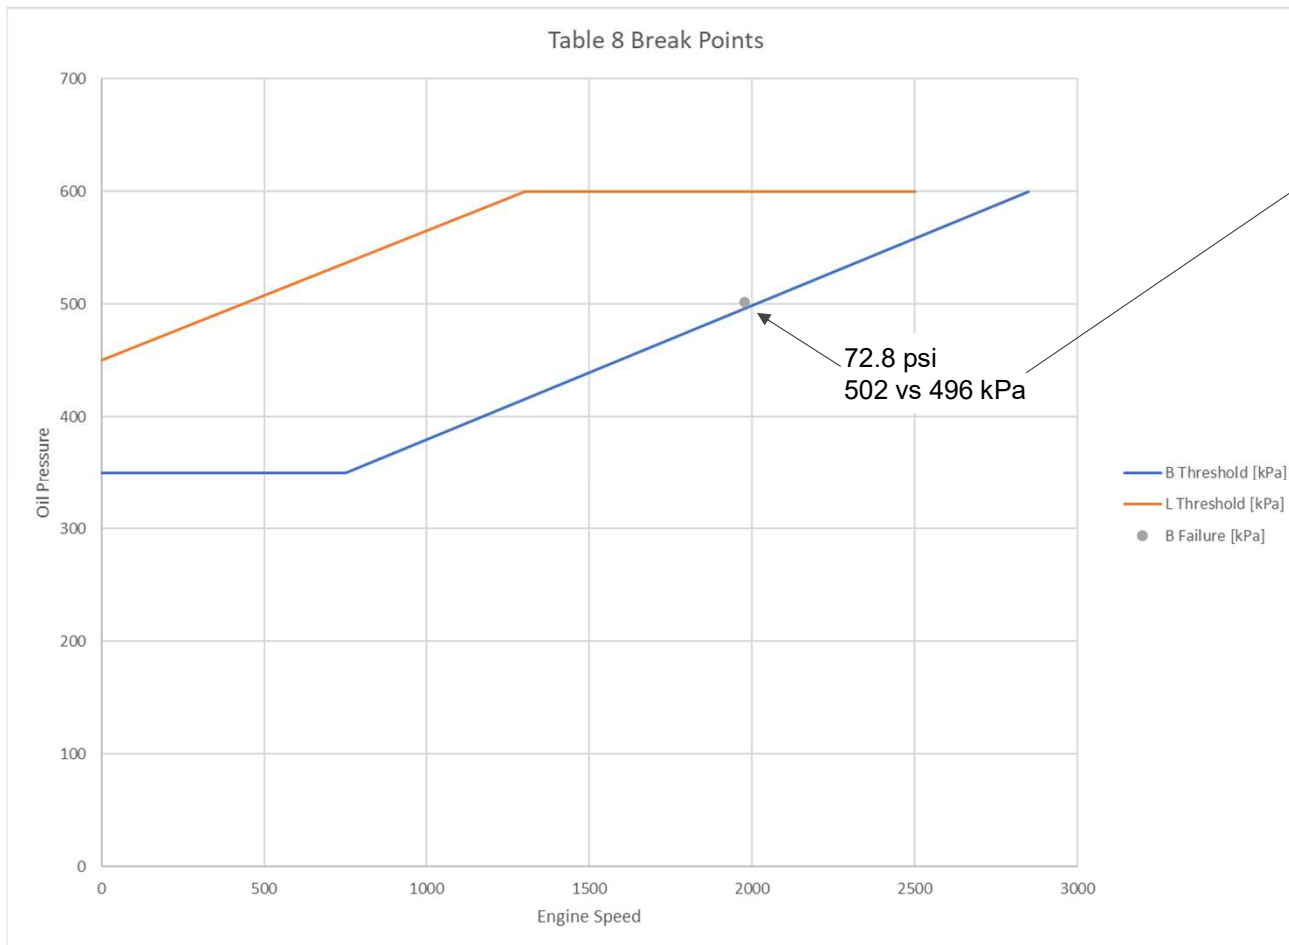
Cal Settings vs Dyno Fault Condition

FC 435

- ECM Time (Key On Time) 000004:21:53
- Engine Oil Pressure 72.8 psi
- Engine Speed 1977 rpm
- Engine Coolant Temperature 197.6 F

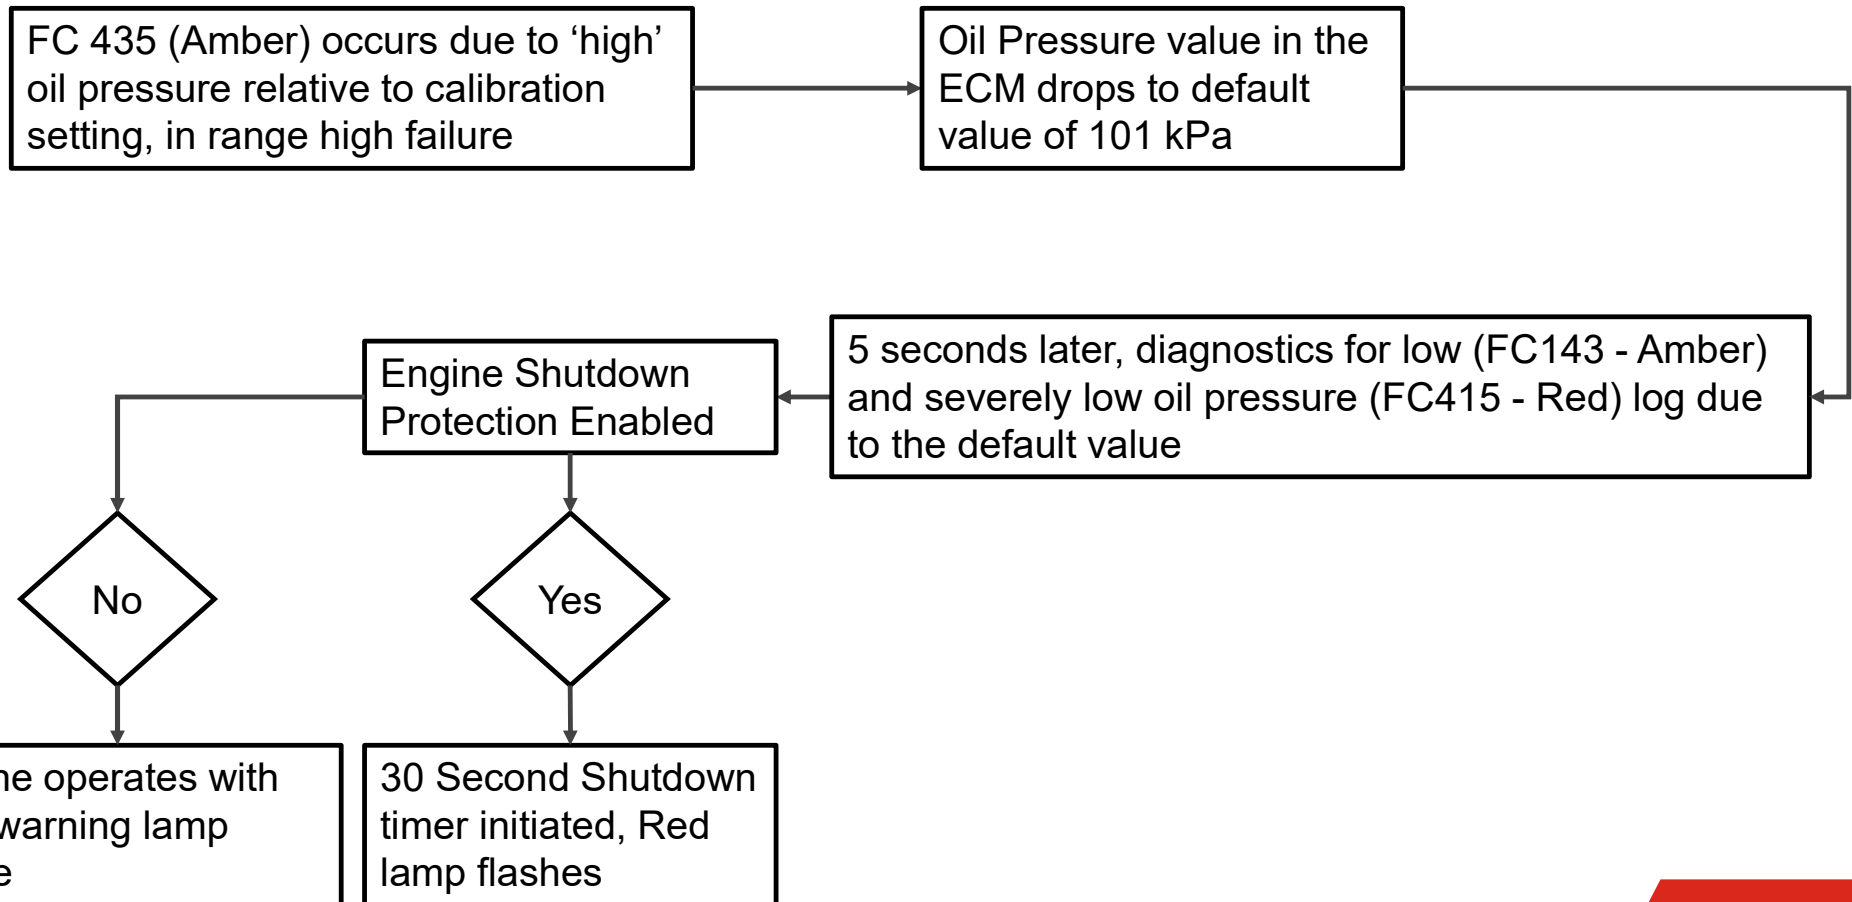
Fault Progression

- Fault Code 435, 143 and 415 being generated. Fault progression on subsequent slide.
 - 435 - Oil Rifle Pressure - Data Erratic, Intermittent, or Incorrect
 - 143 - Oil Rifle Press - Data Valid But Below Normal Operating Range - Moderately Severe Level
 - 415 - Oil Rifle Pressure - Data Valid but Below Normal Operational Range - Most Severe Level
- While fault codes above suggest low oil pressure, engines have adequate oil pressure and no damage has occurred. When FC 435 is active, diagnostic triggers an incorrect default value leading to these additional fault codes.**
