Technical Service Bulletin

40 Rattling or knocking noise from front end when driving over bumps

40 14 43 2035854/4 October 9, 2014. Supersedes Technical Service Bulletin Group 40 number 14-42 dated July 8, 2014 for reasons listed below.

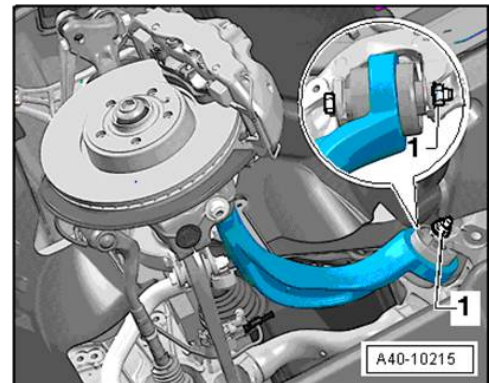
High ambient temperatures at the hydraulic guide links cause the noise.

Figure 1. Lower guide link (1).

- **If the vehicle was produced with M14 ball joints:**
Replace both left and right lower guide links (Figure 1) according to the instructions in *Elsa >> Repair Manual >> Chassis >> Suspension, Wheel, Steering >> Front Suspension >> Removal and Installation >> Guide Link*.
