# Technical Service Bulletin

## 44 Repair Authorization - Model Year 2014 & 2015 alignment

44 14 54 2030275/10 August 26, 2014. Supersedes Technical Service Bulletin Group 44 number 14-53 dated August 13, 2014 for reasons listed below.

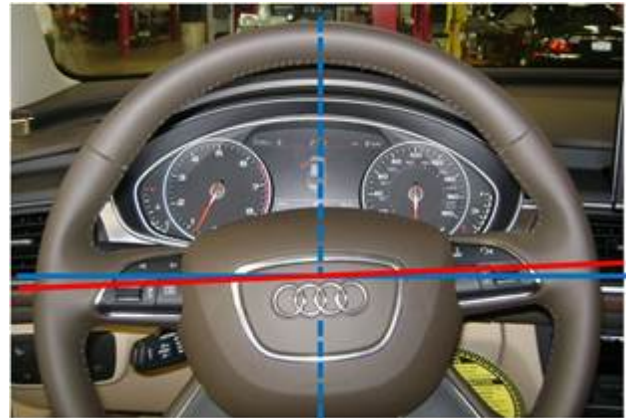
- Vehicle pulls (left or right).
- Steering wheel is not level or is off-center (Figure 1).

*Figure 1. Steering wheel not leveled (off-center)*

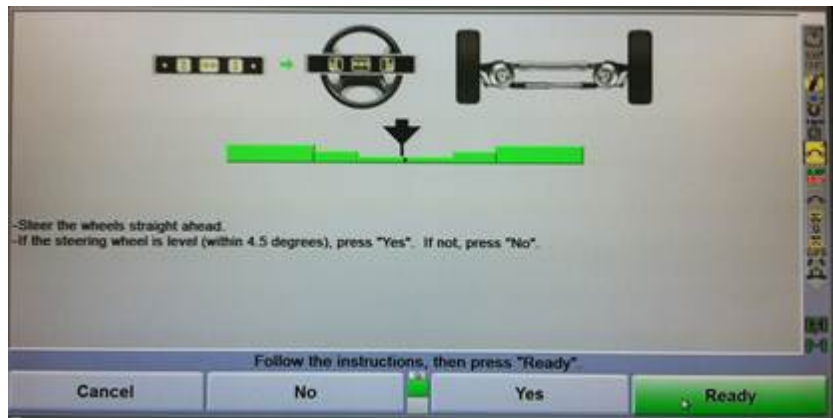
**Figure 2.** Screen shot illustrating the point at which the front wheels must be positioned straight ahead. Screen may vary based on the brand of alignment machine used.

- a. Point the front wheels in a straight-ahead position according to the display on the alignment machine (Figure 2). Disregard the level of the steering wheel at this point.

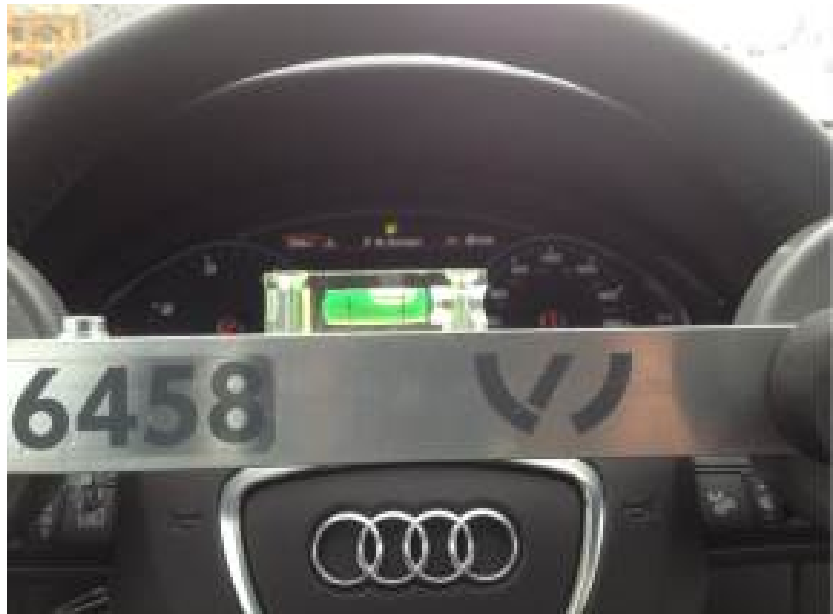
**Figure 3.** Example of a steering wheel that is not level.

- b. Check if the steering wheel is level. If the steering wheel is not level (is off-center) by any degree, take a photo of the steering wheel with the level installed (Figure 3).
