Technical Service Bulletin

44 Repair Authorization - Model Year 2014 & 2015 alignment

44 14 52 2030275/8 August 4, 2014. Supersedes Technical Service Bulletin Group 44 number 14-47 dated January 21, 2014 for reasons listed below.

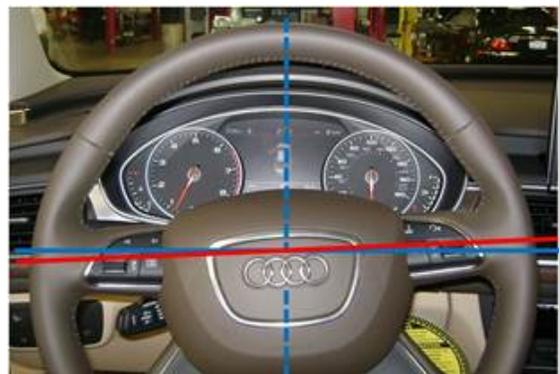
- Vehicle pulls (left or right).
- Steering wheel is not level or is off-center (Figure 1).

Figure 1. Steering wheel not leveled (off-center)

1. Before starting any repairs:
 - a. Verify the concern with a test drive.
 - b. Ensure that the vehicle has fewer than 6000 miles.
 - c. If vehicle is pulling left or right, swap the front wheels from left to right to determine if the pull is caused by the tires. If the tires are directional, the tires should be swapped from front to back.
 - If the tires *are not* the root cause of the pull, continue to the next step.
 - If the tires *are* the root cause of the pull, this TSB does not apply and there is no need to continue.
2. Place the vehicle on the alignment rack and perform the compensation procedure.
3. During the alignment step at which the steering gear center position is checked, perform the following:

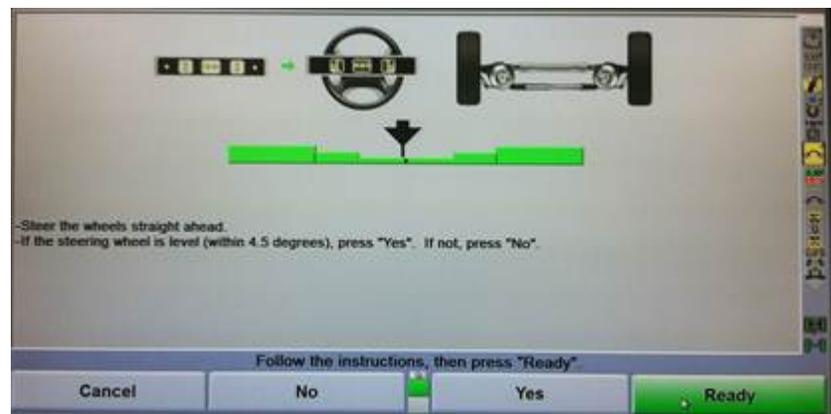
Figure 2. Screen shot illustrating the point at which the front wheels

must be positioned straight ahead. Screen may vary based on the brand of alignment machine used.

- a. Point the front wheels in a straight-ahead position according to the display on the alignment machine (Figure 2). Disregard the level of the steering wheel at this point.

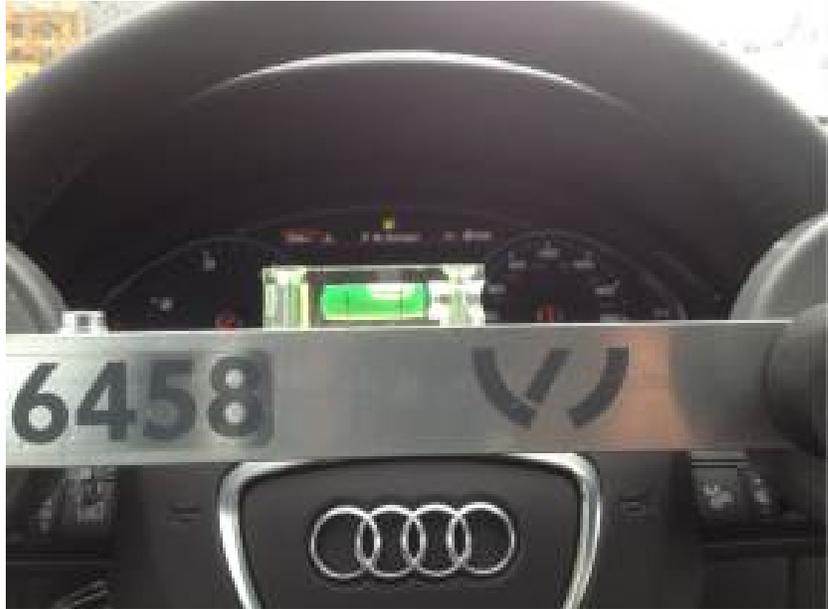
Figure 3. Example of a steering wheel that is not level.

- b. Check if the steering wheel is level. If the steering wheel is not level (is off-center) by any degree, take a photo of the steering wheel with the level installed (Figure 3).
