Tesla, Inc.
Service Bulletin

Tighten Front Frame Rail Bolts

SB-24-10-002

January 23, 2024

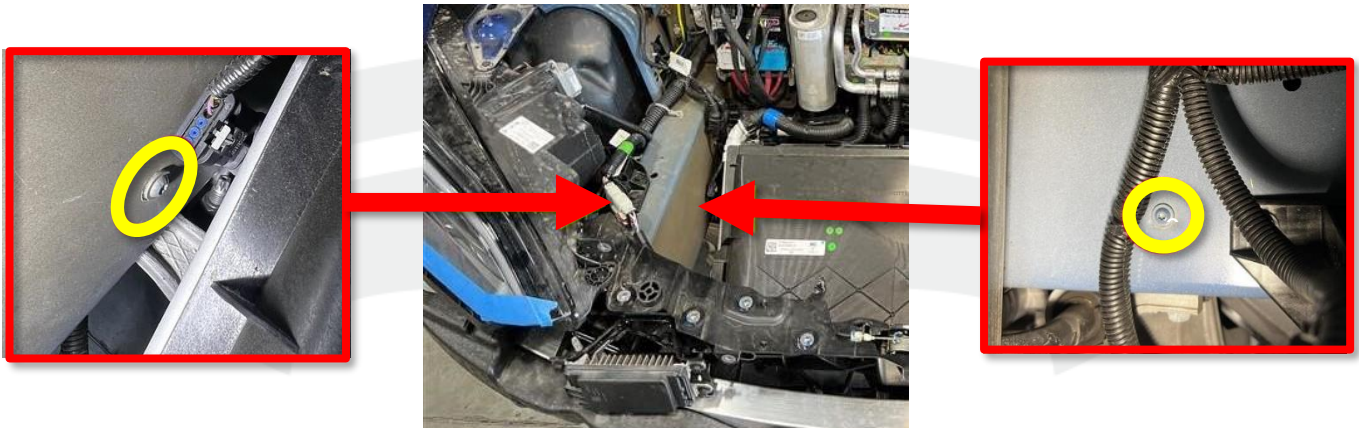
Figure 1 – Bolt locations, RH front frame rail

2. Tighten the T25 bolts (x2) that attach the inner and outer threaded inserts on the RH front frame rail (Figure 1) (torque 7 Nm).

3. Mark the bolts with a paint marker after they are tightened.
4. Repeat step 2 on the LH front frame rail (Figure 2).

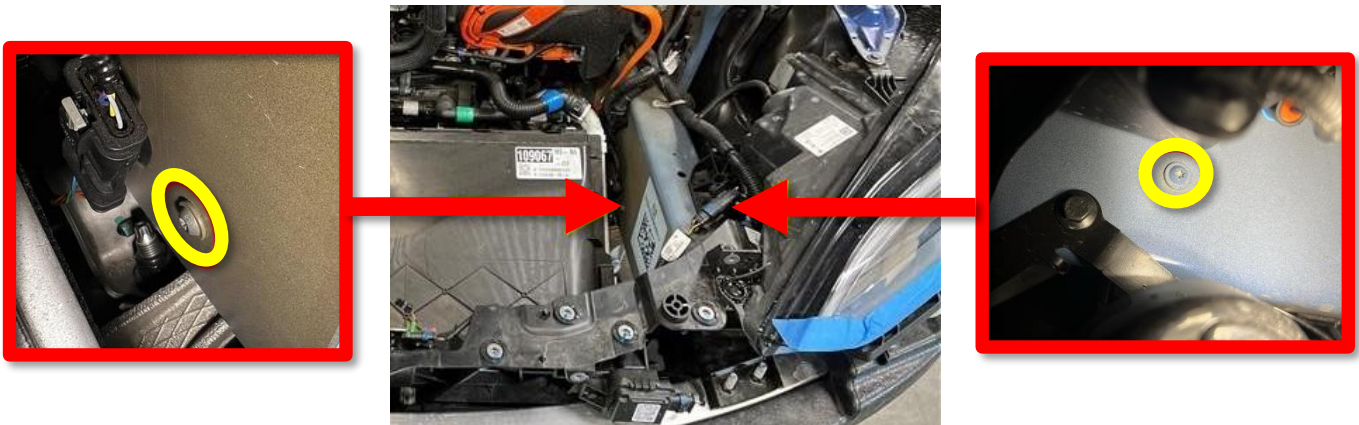
Figure 2 – Bolt locations, LH front frame rail

5. Mark the bolts with a paint marker after they are tightened.
6. Install the cooling fan module (refer to Service Manual procedure 18201312; [Model S](#), [Model X](#)).
